Eight Discipline Report (8D Report)

To: 8D report No.:
 From : Chicony power Technology RMA claim No.: N/A
 CC : N/A Chicony P/N: A090A098P
 Customer P/N:
 Submit date: 2017/11/28 Product description: 90W adapter
 Receive date: 2017/12/11 Defect D/C or Lot No.:
 Subject : ESD Fail * 2pc

CPT P/N: A090A098P-HW01

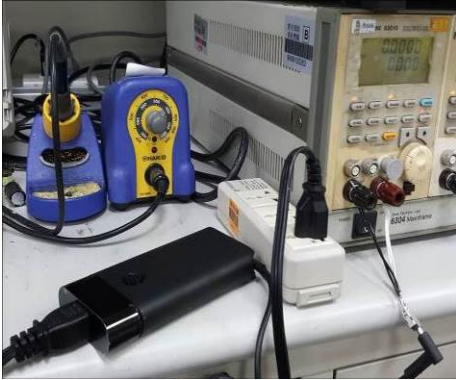
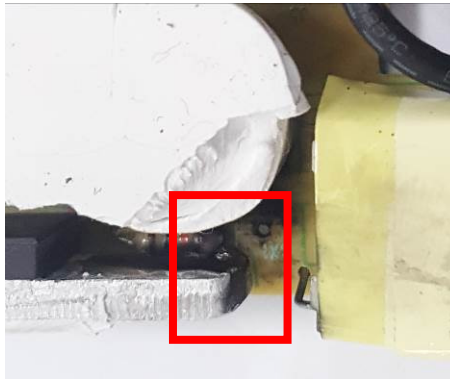
2.1 Open case to check solder surface, and there had burn mark on the location of R28 & HS1.

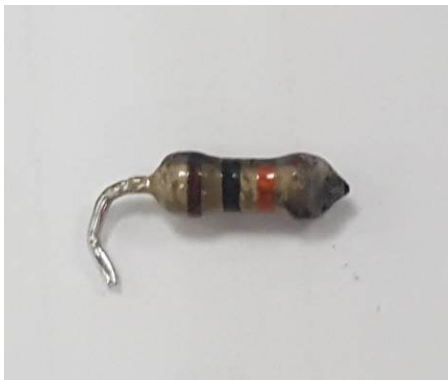
(1) R28 has already broken.

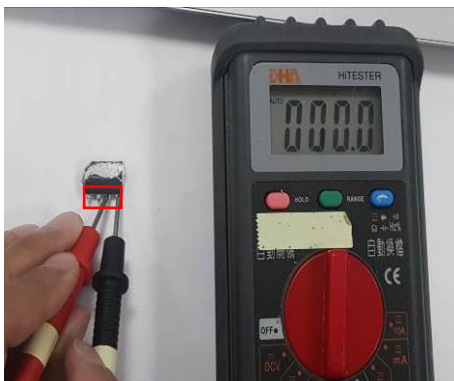
(2) Bridge has short.

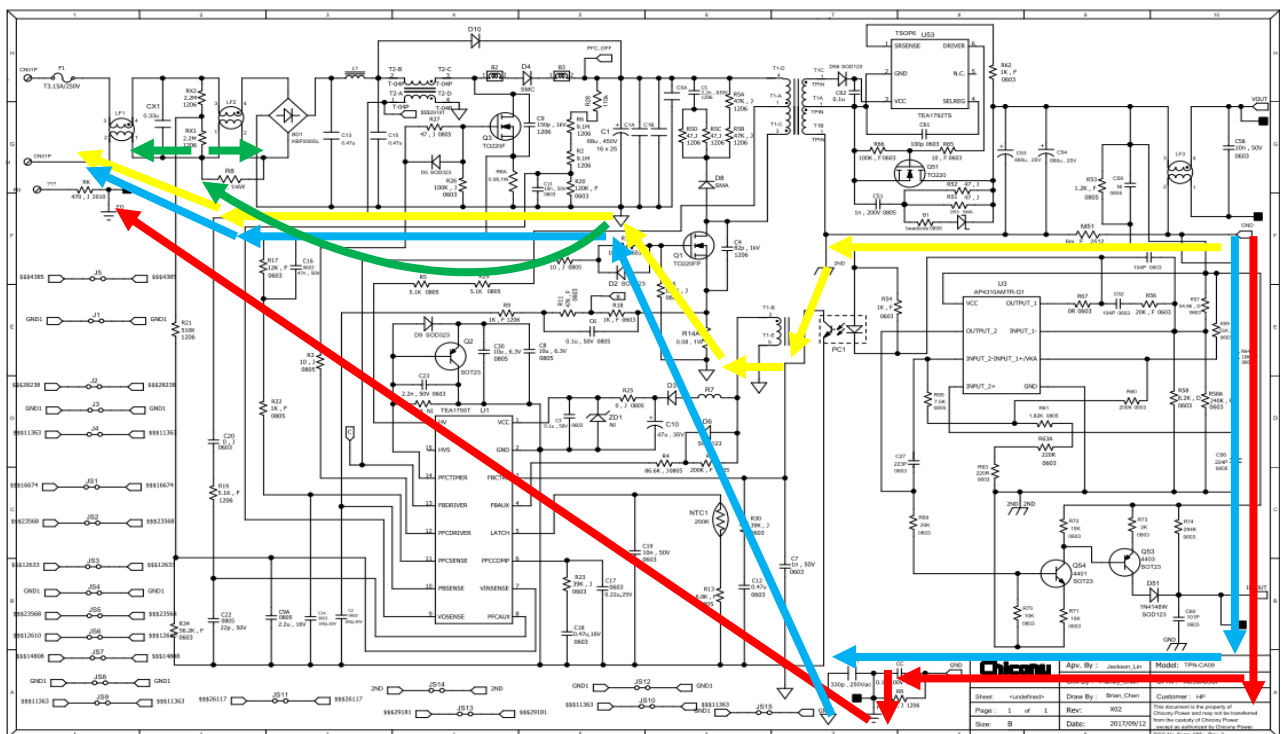
2.3 Static electricity has many release routes as below.

a. Main route 1(red) b. other route 2(yellow) c. other route 3(blue)

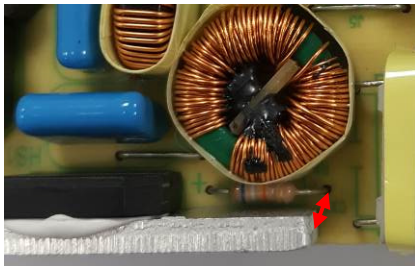
However, the HS1 connects primary ground, and the distance between HS1 & R28 is close. It may produce another abnormal route which energy flows by air as green line.

If energy flows through green route, the components of R28, bridge and fuse will damage probably. (There will occurs arcing phenomenon between HS1 & R28.)

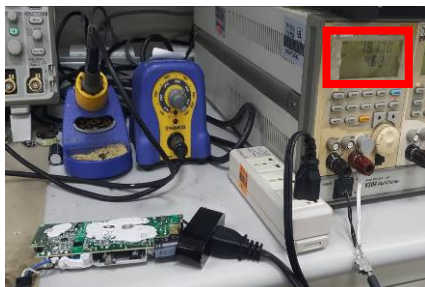
2.4 We repair this damage adapter, then retest ESD item in Taipei DQA.

The results can meet HP criterion $\pm 15\text{kV}$, but there has damage risk which ESD energy is equal to 20kV .

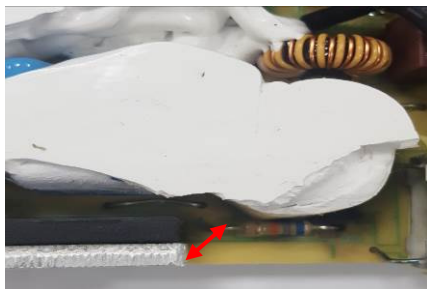
(The ESD energy will not discharge from HS1 to R28.)

2.5 In order to improve ESD design margin, we cut HS1 length to increase distance between HS1 & R28. It can prevent ESD energy from flowing by air.

After HS1 changed, we retest ESD item in Taipei DQA. The result is as below.

Discharge	Polarity	Test Level				
			1	2	3	4	5
			$\pm 2\text{KV}$	$\pm 4\text{KV}$	$\pm 8\text{KV}$	$\pm 15\text{KV}$	$\pm 20\text{KV}$
HS1 length changed	Air	Positive	Pass	Pass	Pass	Pass	Pass
		Negative	Pass	Pass	Pass	Pass	Pass
