Eight Discipline Report (8D Report)

To: Customer
 From: : Chicony Power Technology
 CC : N/A
 8D report No.: CPCQ2000601
 RMA claim No.: N/A
 Chicony P/N: A065RP25P-HW01-0A
 Customer P/N:
 Submit date: 2020/06/24 updated
 Receive date: 2020/06/01
 Product description: 65W adapter
 Defect D/C or Lot No.: 2020/04
 Subject : ESD Test Fail*1pcs

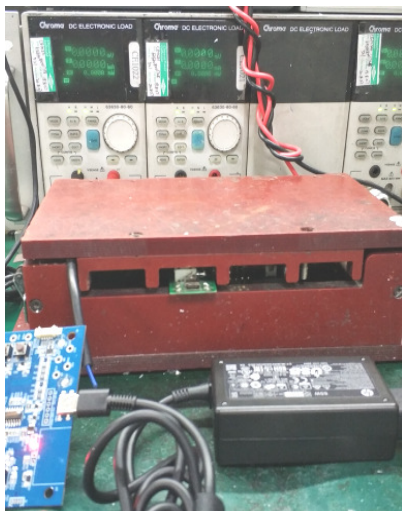
檢查 adapter 外觀無異常,通電測試確認產品無輸出(如下圖).

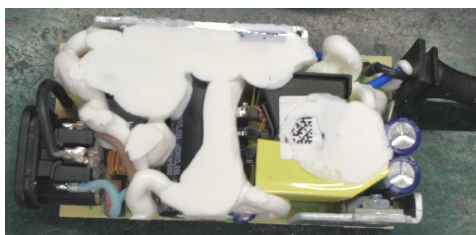
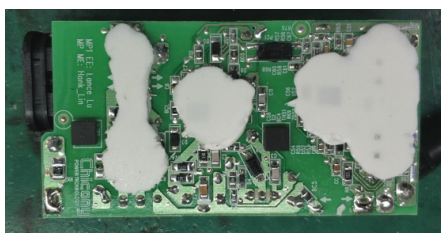
3.1.開殼檢查確認零件面及錫面無異常;逐次量測錫面各個零件(如下圖).

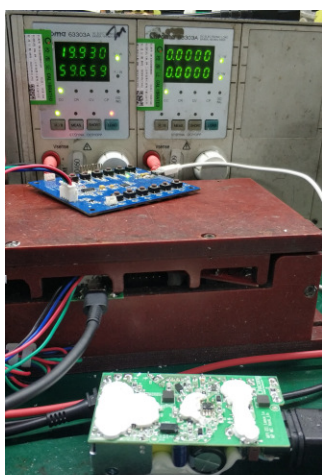
不良 adapter+良品 adapter 的 U1

3.2.逐步排查不良 adapter 錫面各零件,懷疑 U1 Fail;進行交叉驗證,將良品 adapter 的 U1 取下,更換在不良 adapter,通電測試確認該 adapter 輸出無異常(如下圖).

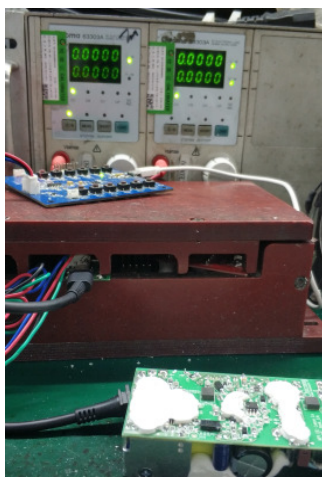
不良 adapter+不良 adapter 的 U1

3.3.將被懷疑不良的 U1 裝回不良 adapter,通電測試確認該 adapter 無輸出(如下圖).初步確認不良 adapter 的 U1 Fail.

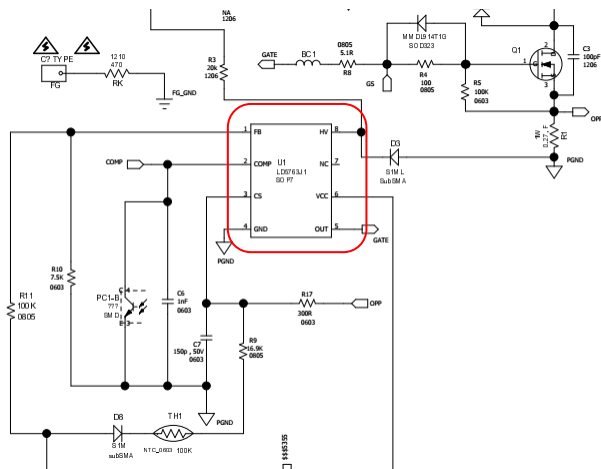
U1 零件不良,導致產品無輸出.

綜合分析:U1 Fail 從而導致產品無輸出.

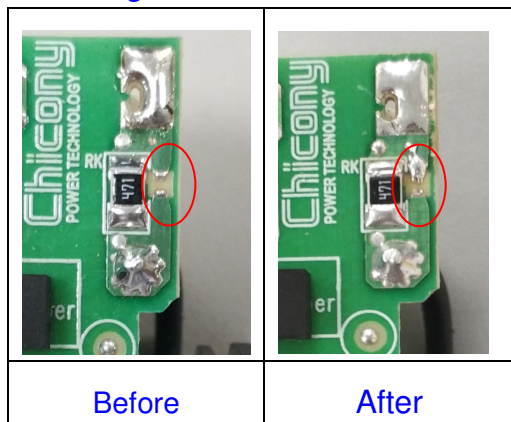
3.2.將 1pcs 良品 adapter,在 PCB 板上 RK 的銅箔尖點處,縮短放電 pin 距離,進行 ESD Air Discharge 測試.驗證到 25KV 產品 Pass.
