Eight Discipline Report (8D Report)

To: 8D report No.: **CPCQ2000601**
From: **Chicony Power Technology** RMA claim No.: **N/A**
CC: **N/A** Chicony P/N: **A065RP25P-HW01-0A**
Customer P/N:
Submit date: **2020/06/24 updated** Product description: **65W adapter**
Receive date: **2020/06/01** Defect D/C or Lot No.: **2020/04**
Subject: **ESD Test Fail*1pcs**

2020/05/29, Q CQ 反饋我司 HP 65W adapter ESD test fail*1pcs.

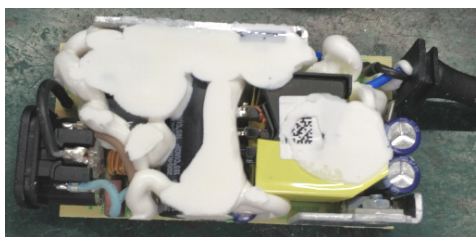
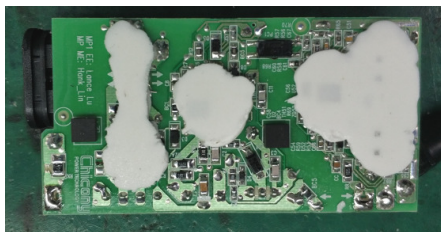
3.1.開殼檢查確認零件面及錫面無異常;逐次量測錫面各個零件(如下圖).

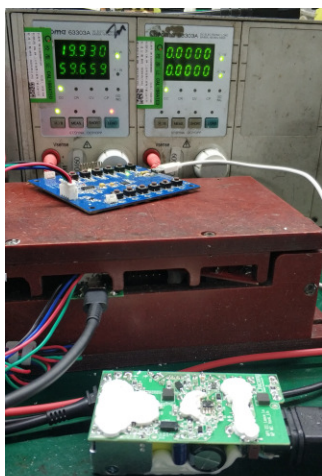
不良 adapter+良品 adapter 的 U1

3.2.逐步排查不良 adapter 錫面各零件,懷疑 U1 Fail;進行交叉驗證,將良品 adapter 的 U1 取下,更換在不良 adapter,通電測試確認該 adapter 輸出無異常(如下圖).

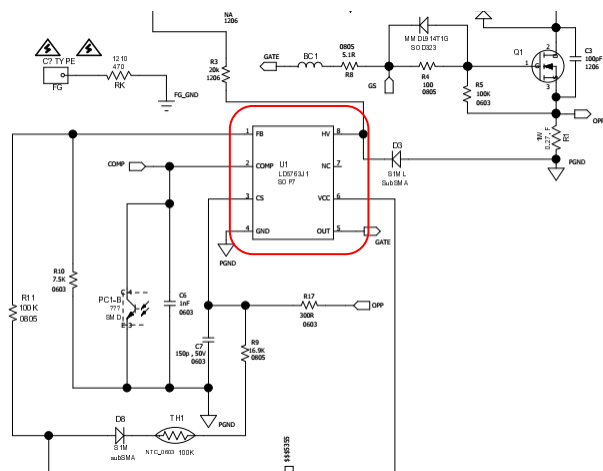
U1 零件不良,導致產品無輸出.

綜合分析:U1 Fail 從而導致產品無輸出.

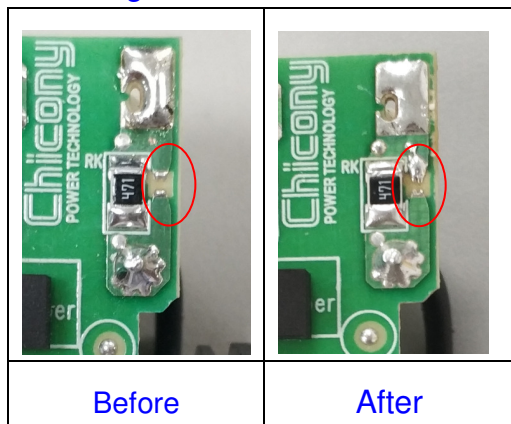
3.2.將 1pcs 良品 adapter,在 PCB 板上 RK 的銅箔尖點處,縮短放電 pin 距離,進行 ESD Air Discharge 測試.驗證到 25KV 產品 Pass.
