Eight Discipline Report (8D Report)

To: 8D report No.:
 From: : Chicony power Technology RMA claim No.: N/A
 CC : N/A Chicony P/N: A090A098P
 Customer P/N:
 Submit date: 2017/09/12 Product description: 90W adapter
 Receive date: 2017/09/29 Defect D/C or Lot No.:
 Subject : ESD Fail * 1pc

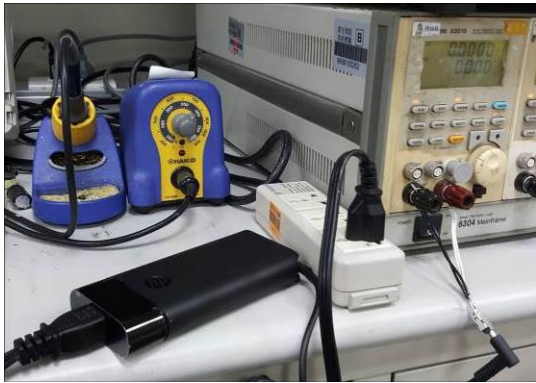
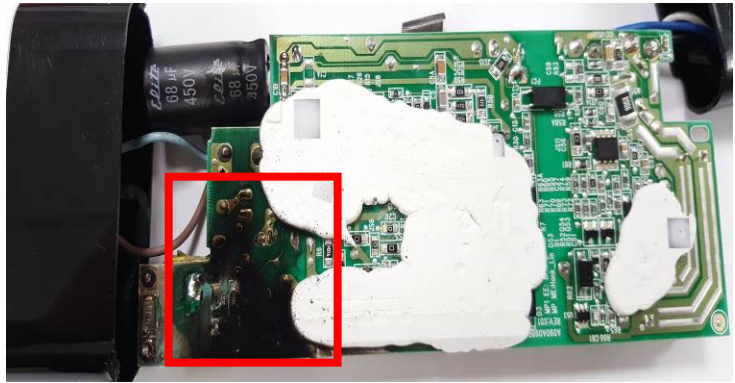
2.1 Open case to check solder surface, and there had burn mark on the location of RX1,RX2.

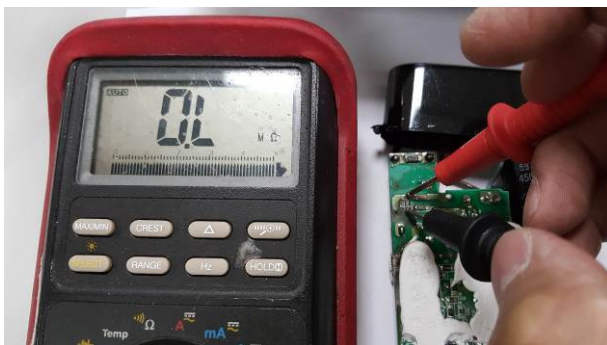
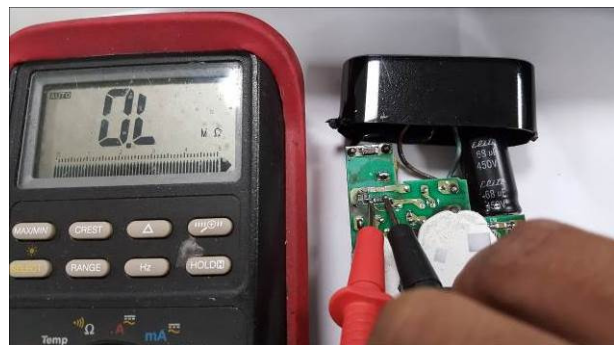
(1) RX1 & RX2 has already died.

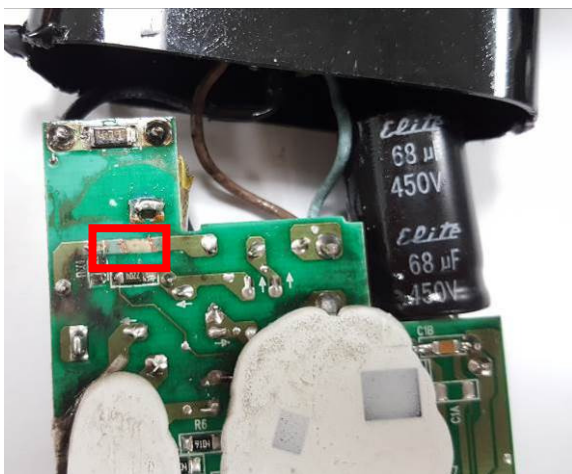
(2) The trace which connects RX1 and LF2 has broken.

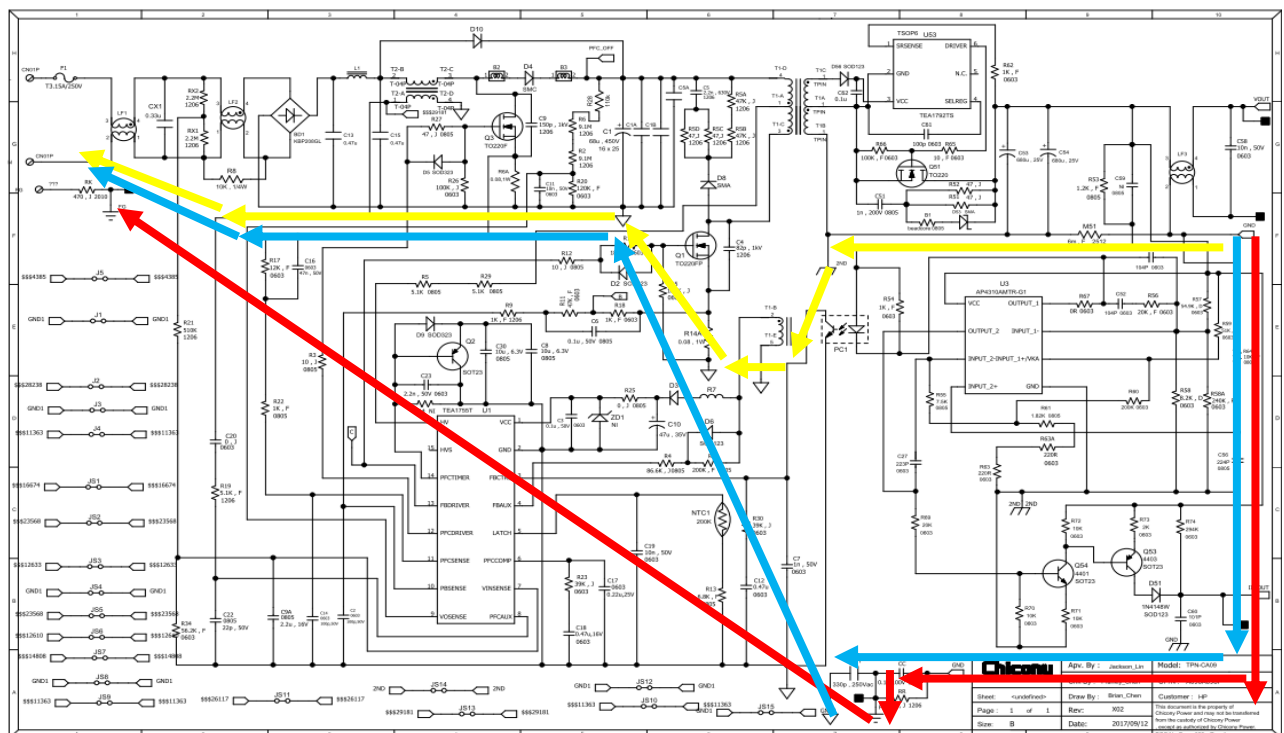
2.3 Static electricity has many release routes as below.

- a. Main route 1(red)
- b. other route 2(yellow)
- c. other route 3(blue)

The ESD has several routes to discharge, most of the energy discharge by route1 (red) and route 3(blue). Then residual energy discharge by route 2(yellow).

On the other hand, the red path will go through RK. If RK occurs abnormal by ESD, the main energy will flow other route. Therefore, it may cause damage to RX1,2.

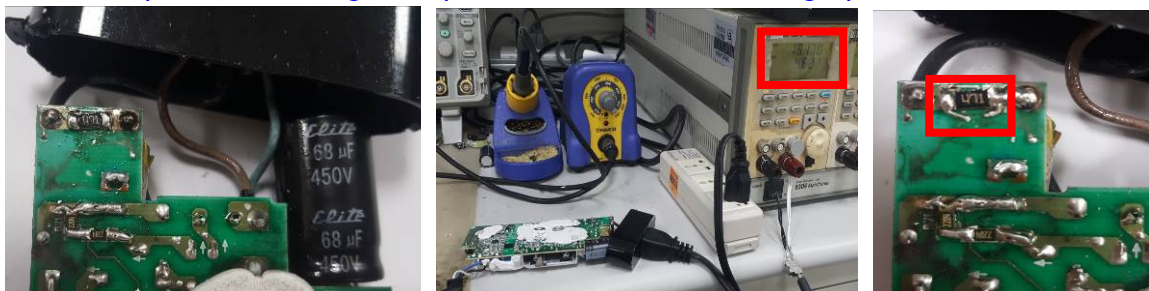
2.5 After retest ESD, the results can be meet HP criterion. In addition, the stage of A090A098P-HW01 is DVT1, and then DQA verification can also meet specification.

2.4 We repair this damage adapter and simulate discharge pin on RK, then retest ESD item.

It will change layout to add discharge pin of RK, the discharge pin as below
