## Eight Discipline Report (8D Report)

To: Customer	8D report No: 20230602
From: : Chicony Power Technology	RMA claim No.:
CC : NA	Chicony P/N: N355A001P-LX01-X2
	Corresponding Customer P/N:
Submit Date: Jun.2 <sup>nd</sup> , 2023	Product description:
Receive Date: Jun.9 <sup>th</sup> , 2023	Defect D/C or Lot No: D/C 2312 (lot:345)

Subject : 1pcs couldn't turn on in customer.(生產/ 焊錫不良, D106 empty solder)

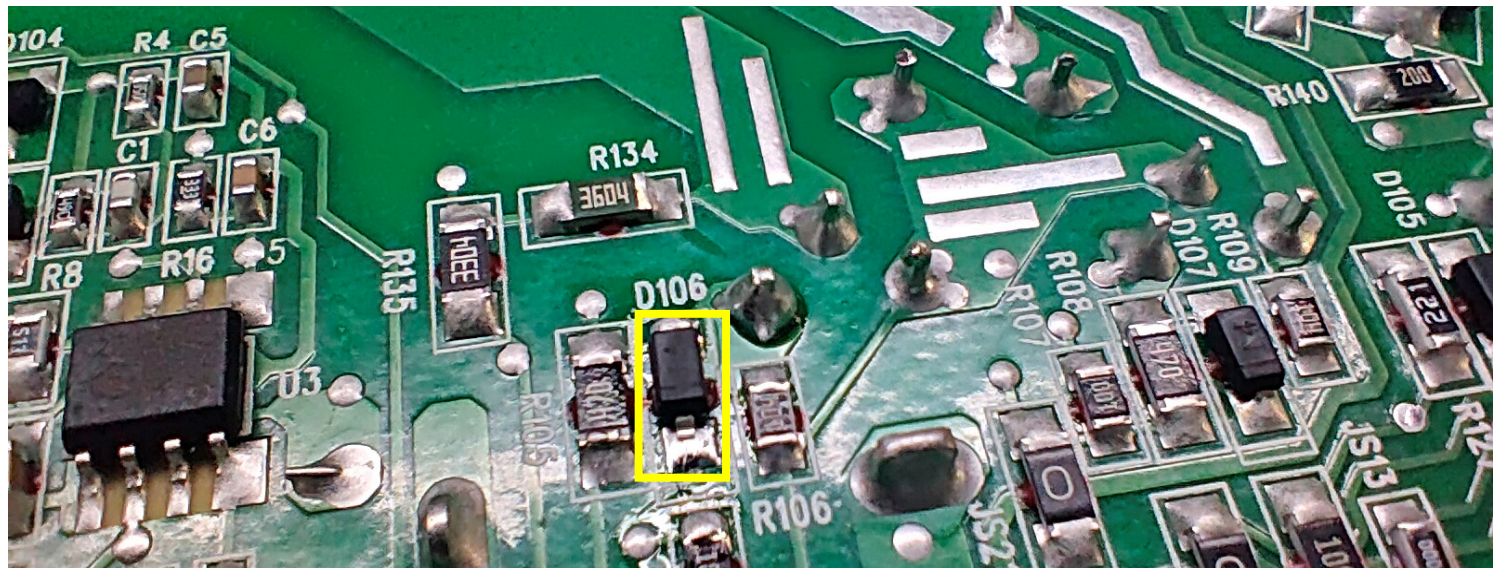
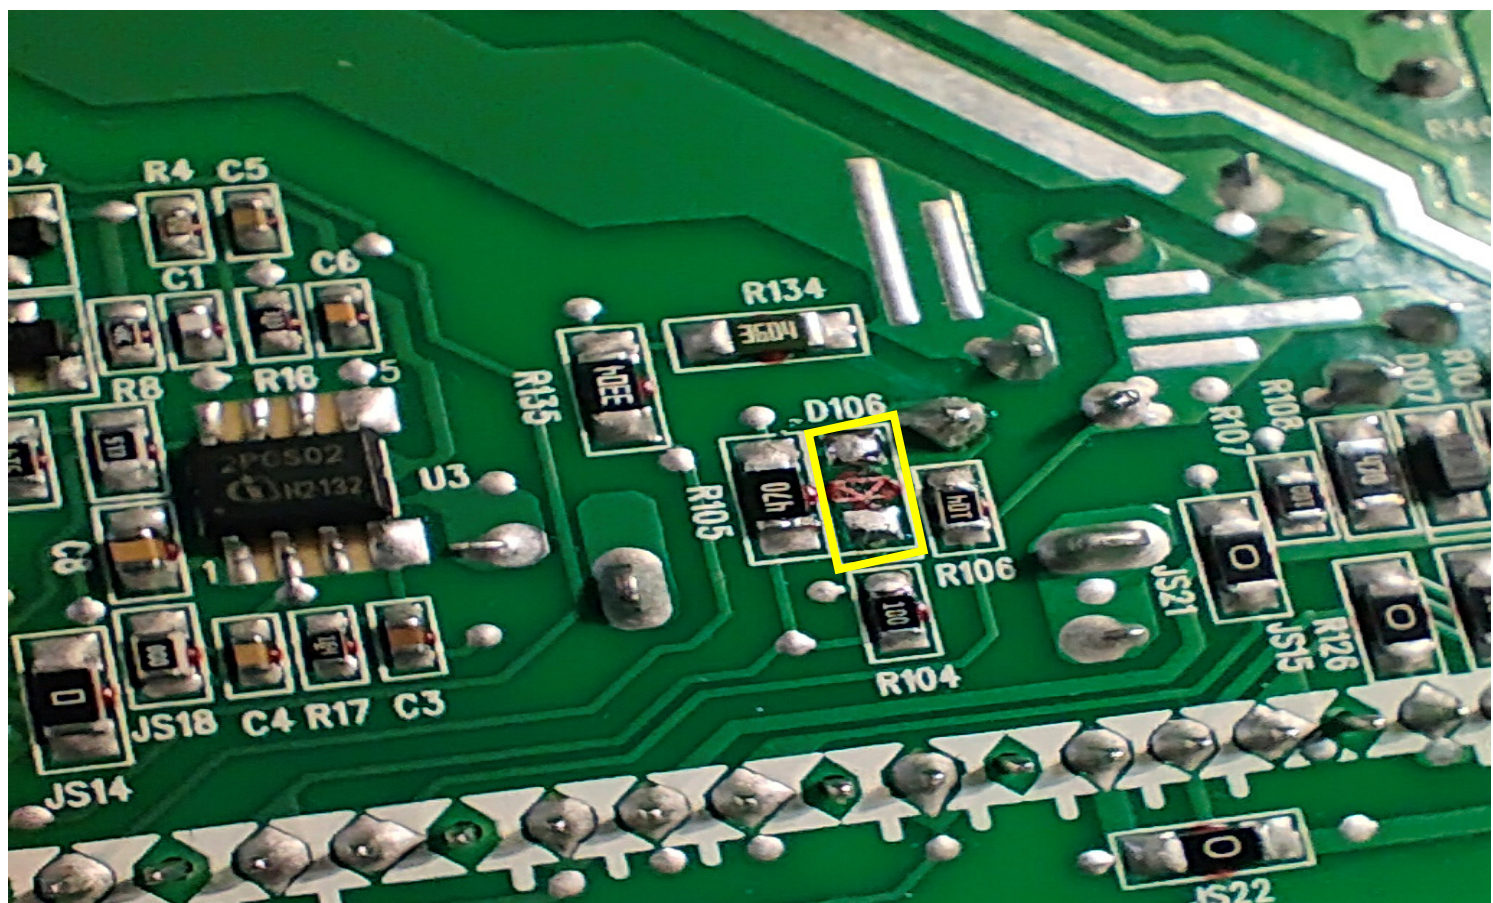
###### 4.3.1 由於不良品在台北端進行分析驗證，工廠端取一臺良品，並將 D106 空焊/缺件，用以模擬不良品

進行分析驗證。

As the defective product was analyzed at the Taipei, At the factory, took a good product and emptied D106 solder or missed D106 part to simulate the defect for analysis.

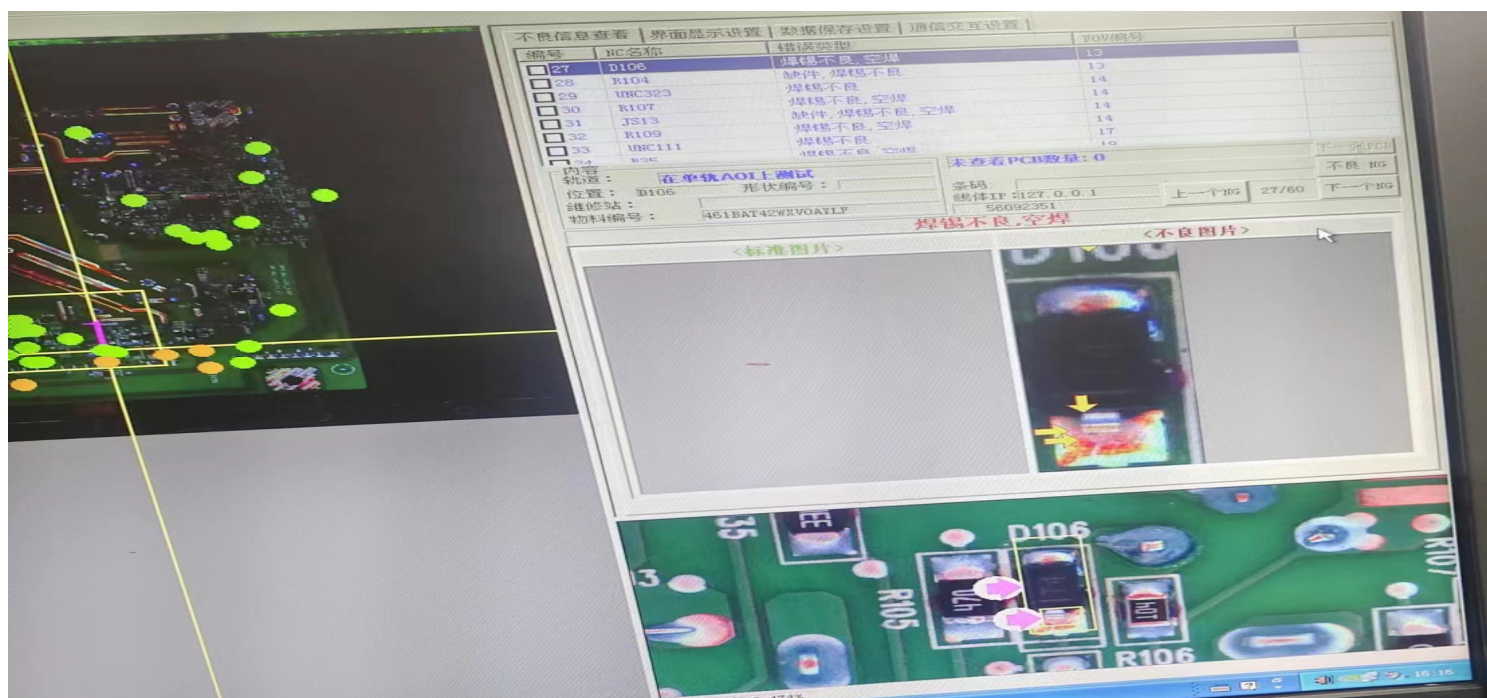
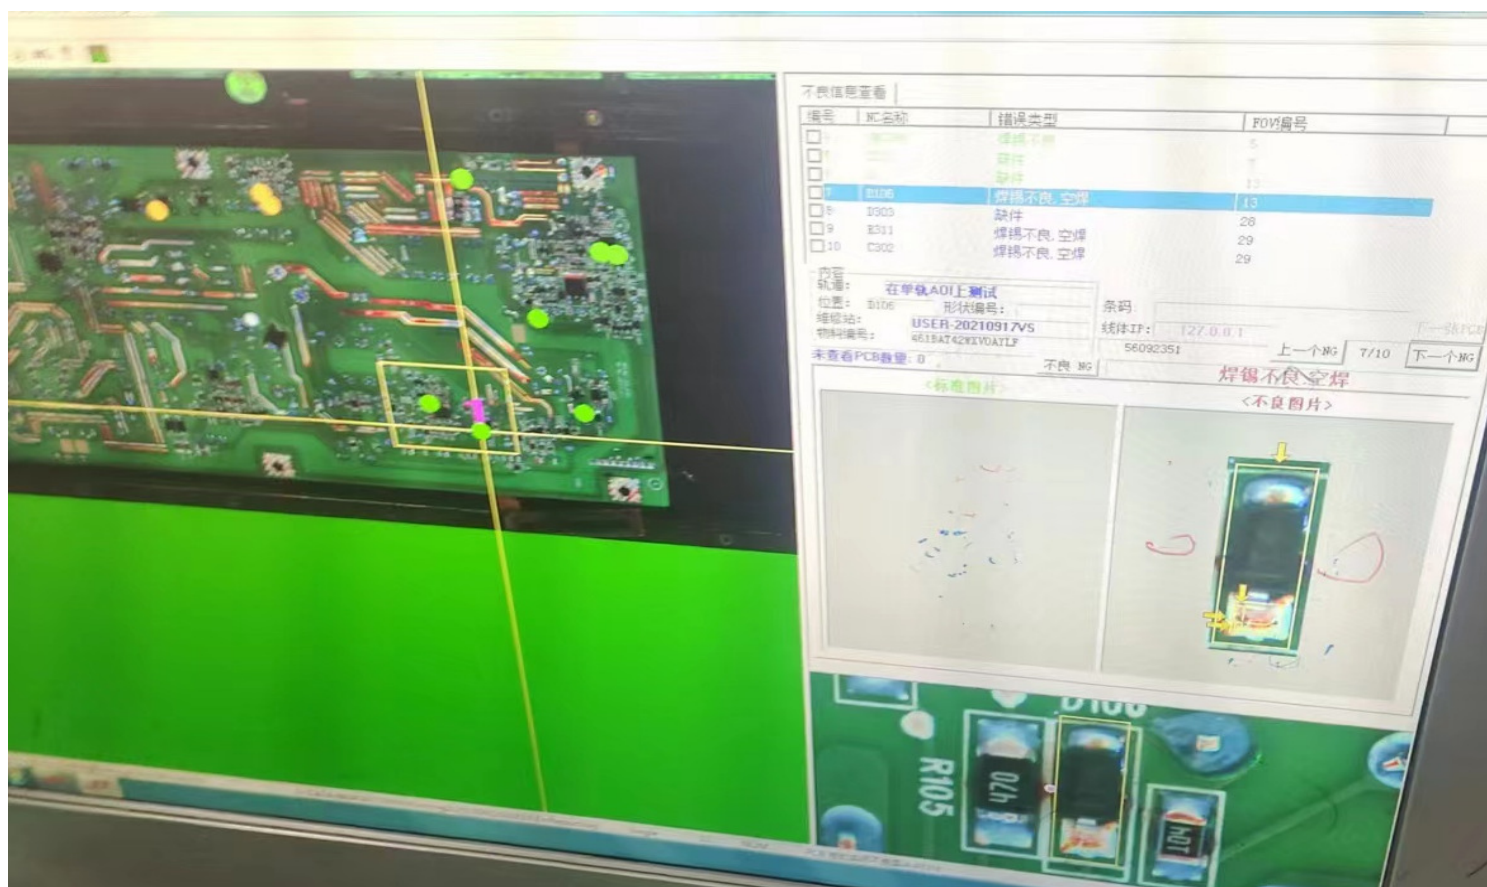
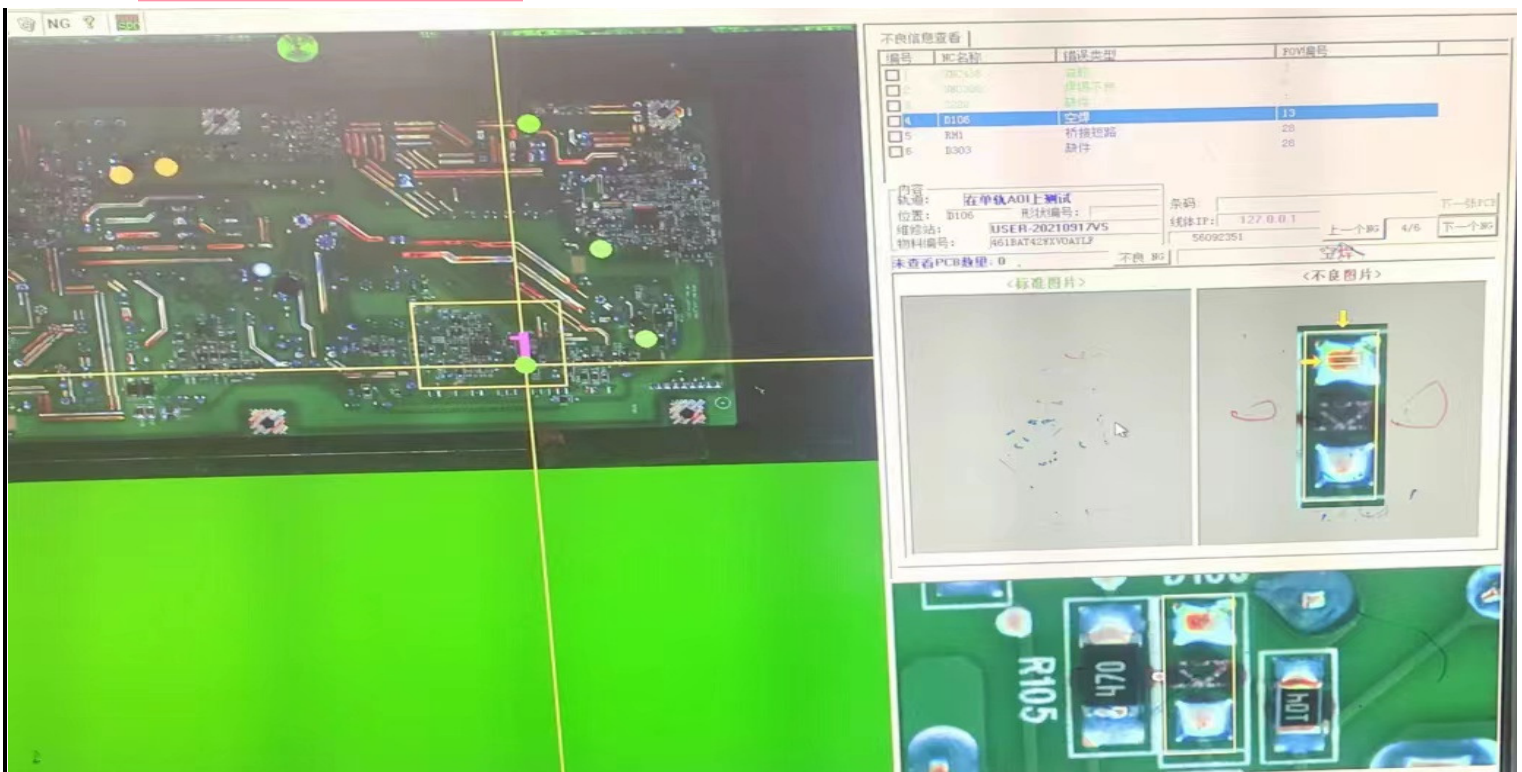
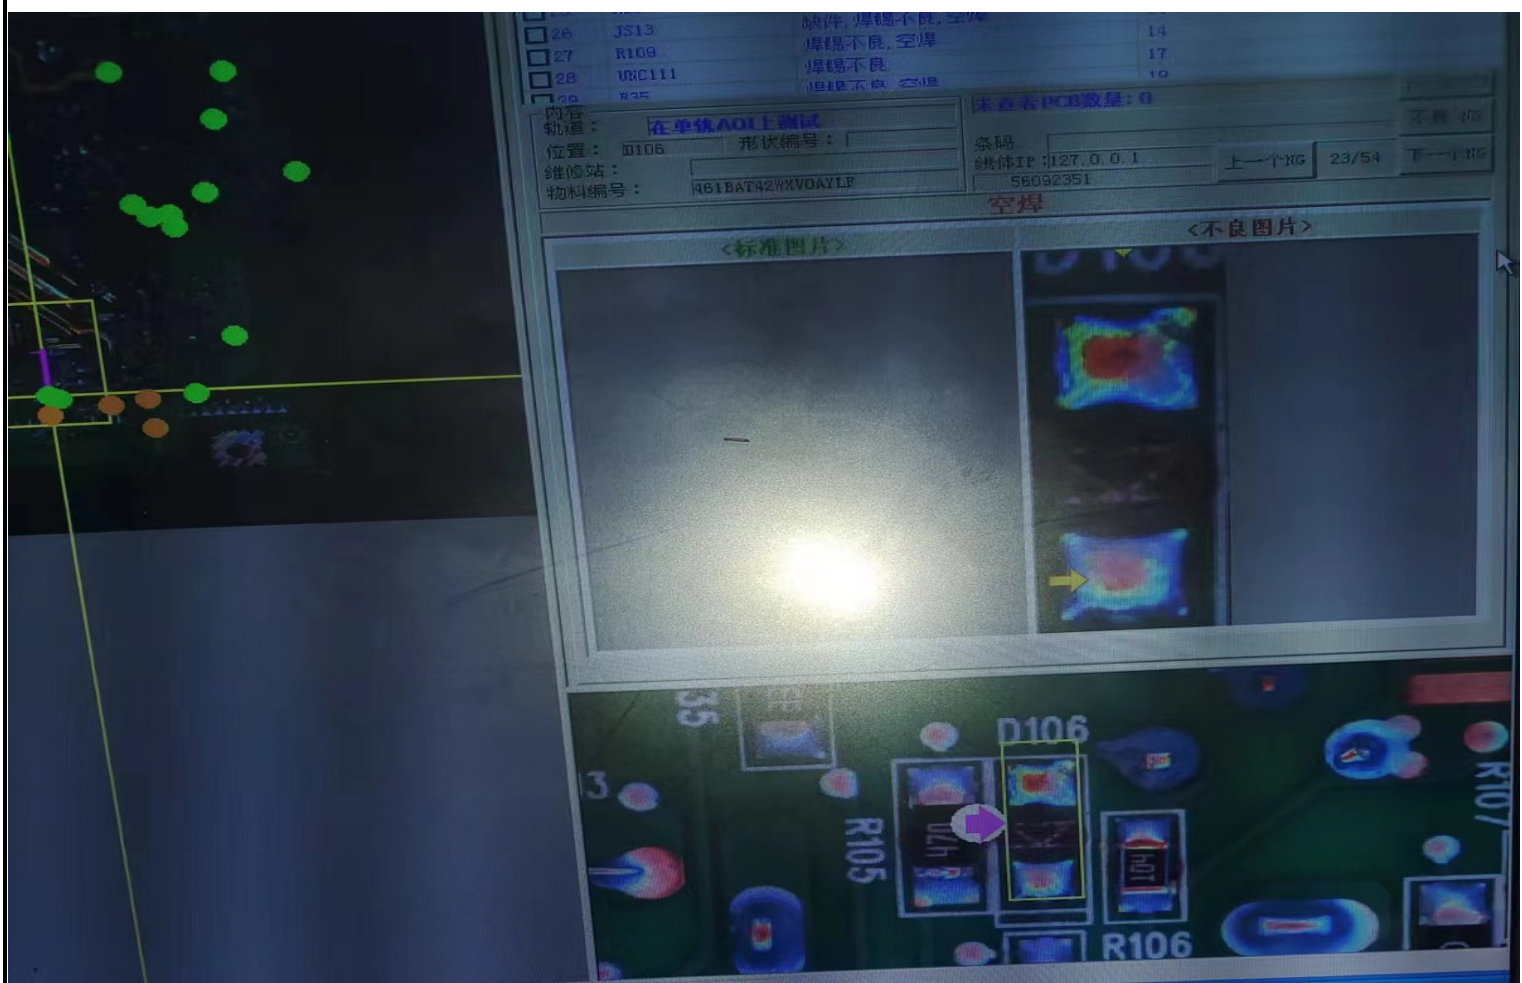
4.3.2 進行 AOI1, AOI2 測試，D106 空焊/缺件不良均可測出。

In the AOI1, AOI2 test, D106 empty solder or missing part could be tested.
