Eight Discipline Report (8D Report)

To: 8D report No.: **CPJ0303**

Submit date: **2019/3/7** Product description: **65W adapter**

Subject : **abnormal output * 1pc**

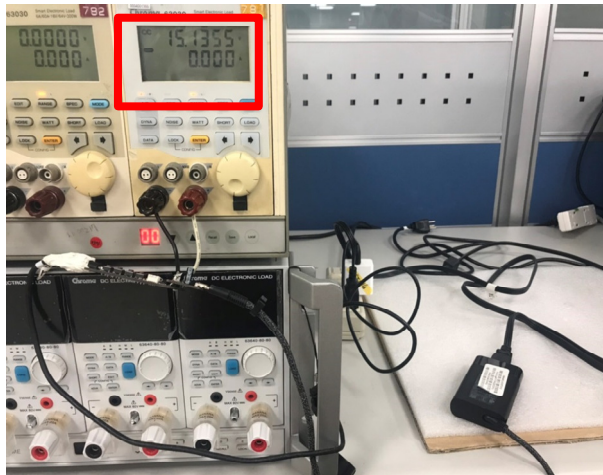
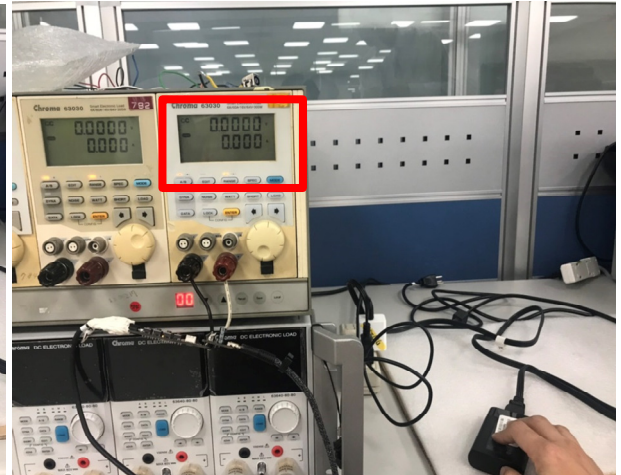
- Take the PSU to do the turn on test, it can power on normally. But when touch to the SR it hasn't the output, after release hand the defective symptom disappeared.**

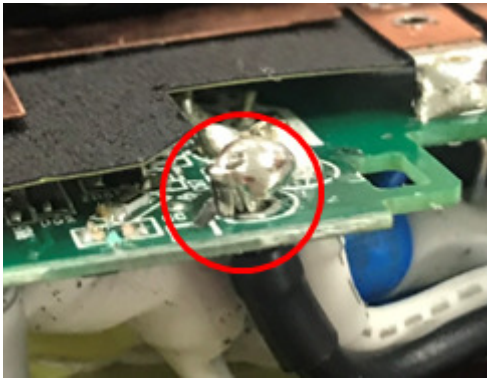
3. Open the case to observe the soldering side and the component side, see the negative pole of the DC cable was false solder that cause it open in the circuit.

The operator cannot repair well caused the DC cable's negative pole false solder and then caused it open in the circuit and the PSU output abnormally.

1. To do the educational and training for the operator of the repair station.

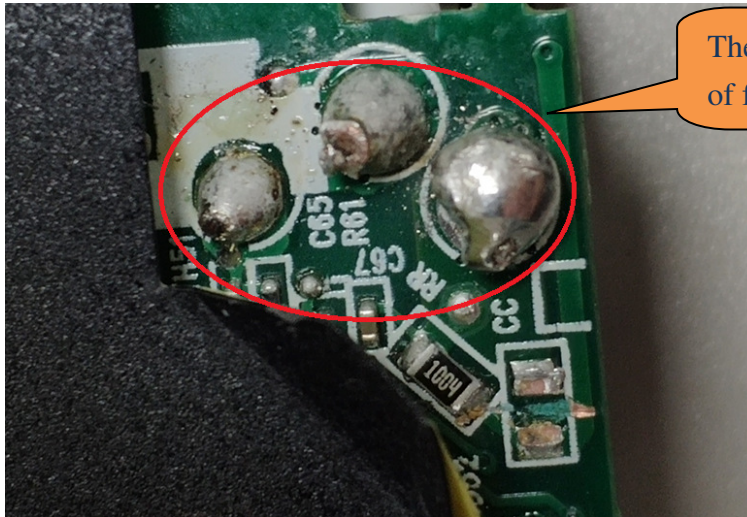
Observe the defective soldering; the PCB has the traces of flux. This failure is similar as the operator cannot repair well then causes the false solder.

The PCB has traces of flux.
