## Eight Discipline Report (8D Report)

To:	8D report No.:
From: : <b>Chicony Power Technology</b>	RMA claim No.: <b>N/A</b>
CC :	Chicony Power P/N: <b>A180AP01Q-FW01</b>
	Customer P/N: <b>PK37A019500</b>
Submit date: <b>2023/8/18</b>	Product description: <b>180W PD</b>
Receive date: <b>2023/7/20</b>	Defect D/C or Lot No.:
<b>Subject : 客戶通知有一台 adapter 無輸出也無溝通 (MOSFET)</b>	
<b>D1.) 問題解決成員: Use Team Approach</b>	
主持者 (Team Leader) : <b>Cf Liu</b> 內部成員 (Internal Team Members): <div style="text-align: center; margin-top: 10px;"> <b>CQS: Jack Wang</b>  <b>QE: Kitty Zhang</b>  <b>MFG: Xiaohui Du</b>  <b>PE: Yong Liu</b>  <b>Sales: Gordon Wang</b>  <b>RD: Chris Wu</b> </div> 外部成員 (External Team Member):	
<b>D2.) 問題說明: Problem Description:</b>	
(Note: Use <b>who, what, when, where, why, how, how many</b> to specify the Customer's problem.)	
<b>2023/7/20 客戶告知:</b> <p style="margin-top: 10px;">我們這邊有一顆 Adapter 壞掉了，不論怎麼插拔都沒有辦法回覆，連溝通都沒有了</p> <p>Adapter 就插著充電，突然就沒有充電了</p> <p>產品序號: <a href="https://fr.mw/FRANCNCH71312100BY">https://fr.mw/FRANCNCH71312100BY</a> 檢視樣機外觀並無異常。</p>

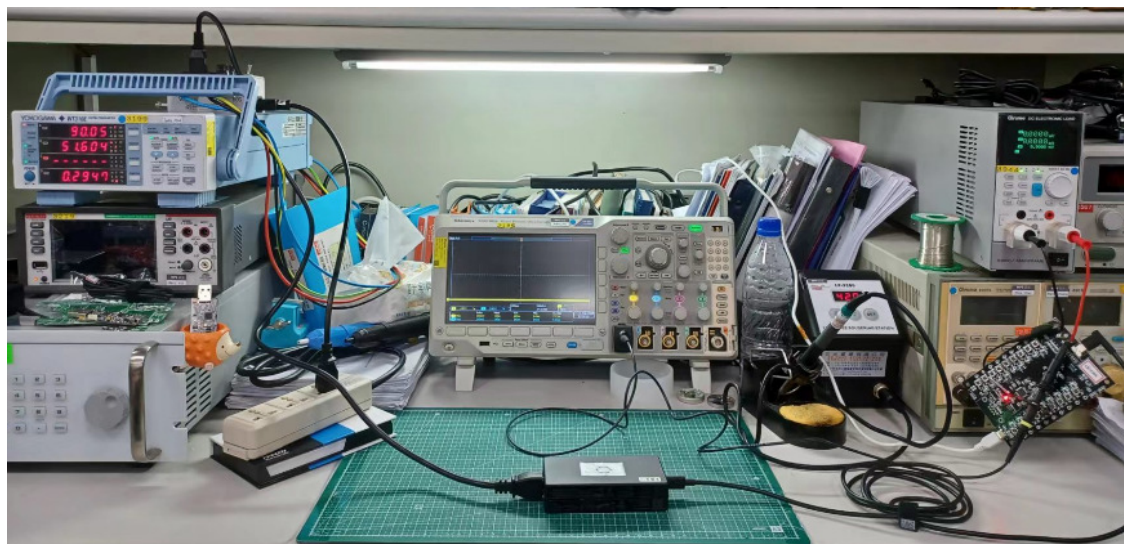
1. 透過追蹤我們SFCS中的SN (FRANCNCH71312100BY)，該樣機通過了生產線中的所有測試站。
2. AC Source送電開機亦無輸出，與客戶反應的狀況一致。

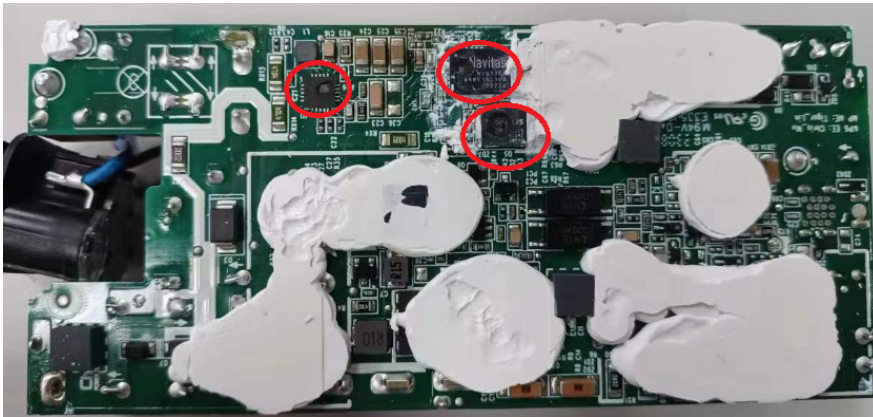
3. 打開外殼，觀察元件面跟鉚錫面，元件面看起來無異常，鉚錫面挖膠後明顯發現U1, S1, S3 損壞

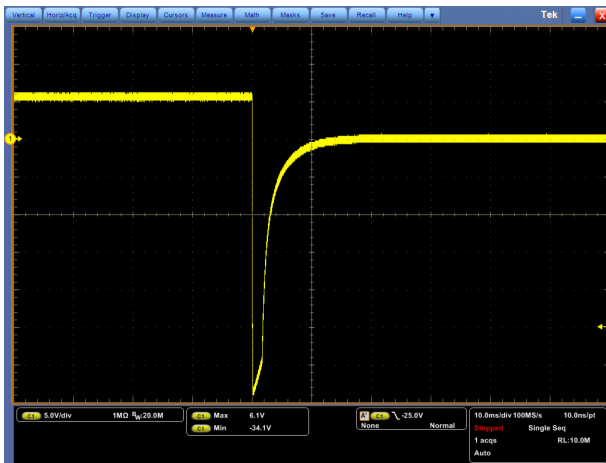
4. 問題復現: Adapter開機到 36V輸出後, 在DC cable unplug時, 量測 Q61 (Blocking MOS )  
Vgs=-34.1V, 超出零件規格 (規格為-20V), 導致 S1 & S3 short through , 造成 PSU 損壞

5. 解決對策: 180W PD 輸出電壓規格最大為36V, 當DC cable unplug 時, 瞬間逆向電壓較大, 故須使用二極體及放小 Rg 電阻, 讓 Q61 Vgs 快速放電

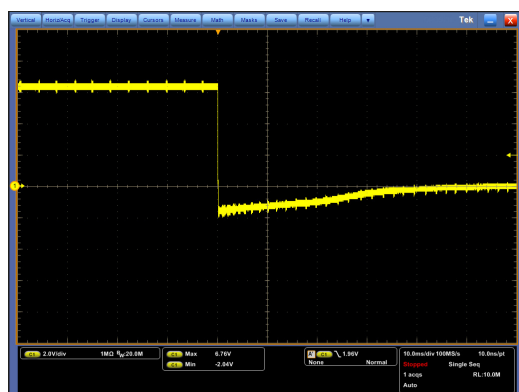
### 6. 對策驗證Q61(Blocking mos )Vgs:-2.04V, 符合規格:+/-20V
