Eight Discipline Report (8D Report)

To: ODM	8D report No.: CPE0601
From: : Chicony Power Technology	RMA claim No.: N/A
CC :	Chicony Power P/N: A048R001L-DR01-0E
	Customer P/N: EPS44R3-15
Submit date: 2015/07/23	Product description: 48W
Receive date: 2015/06/01	Defect D/C or Lot No.: CL44E1513C2116, CL44E1513C2122
Subject : No power*2pcs (EMC / Surge , surge failure, D52 shorted)

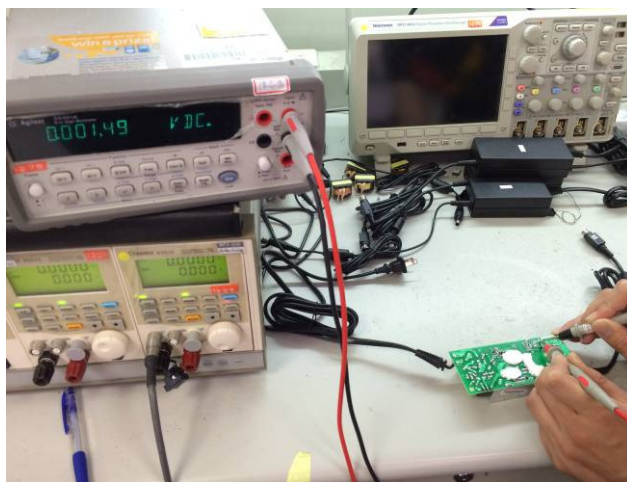
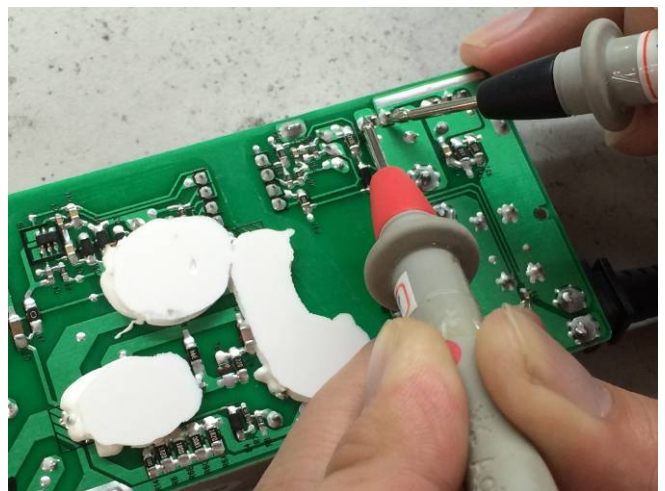
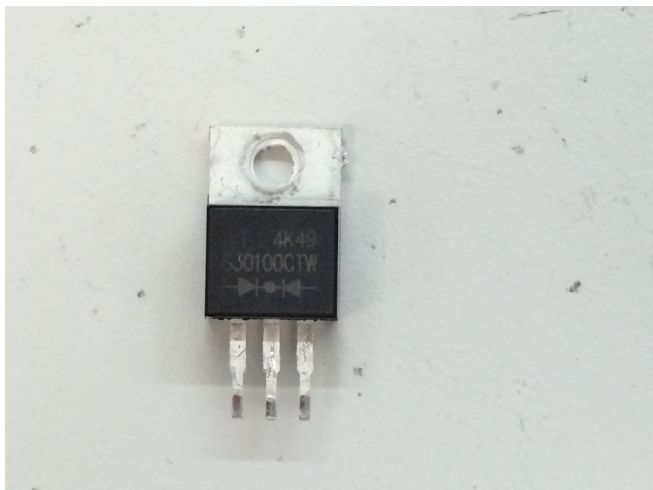
1. Turned on the PSU - noted the adapter has no power output which matches the customer's feedback.
2. When we open the case and examined the PCBA, we see found that the exterior is OK for both the SMD component side and the through hole component side.
3. Measure the key components of the circuit and found that both adapter's component D52 are NG.

Location	Symptom	Description
D52	Short between Anode to Cathode Pin at right side	Schottky Diode

5. After replacing D52 the unit functioned normally.

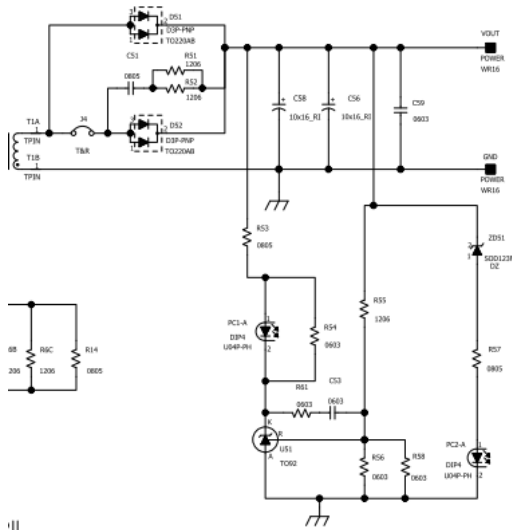
4. Continue to analyze the circuit of the defect adapter, we found if the D52's Anode Pin short to Cathode Pin, the voltage and current can not be rectified then the adapter will exhibit a no power condition.

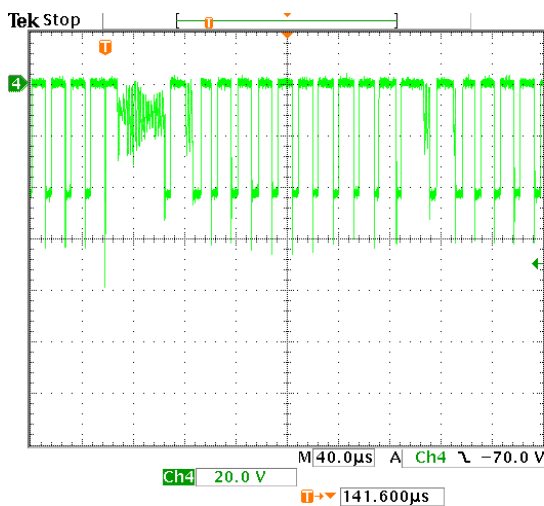
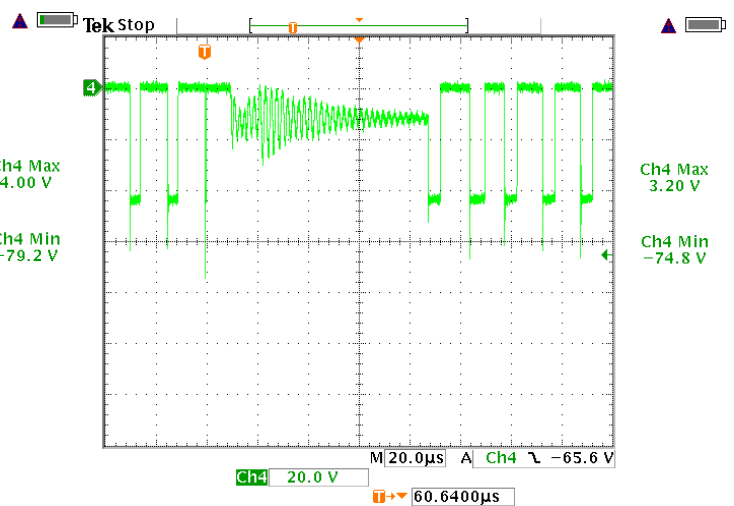
7. Measured the voltage waveform of D52 during surge testing, it did not over D52's reverse voltage spec. (100V), please refer to the waveform below.

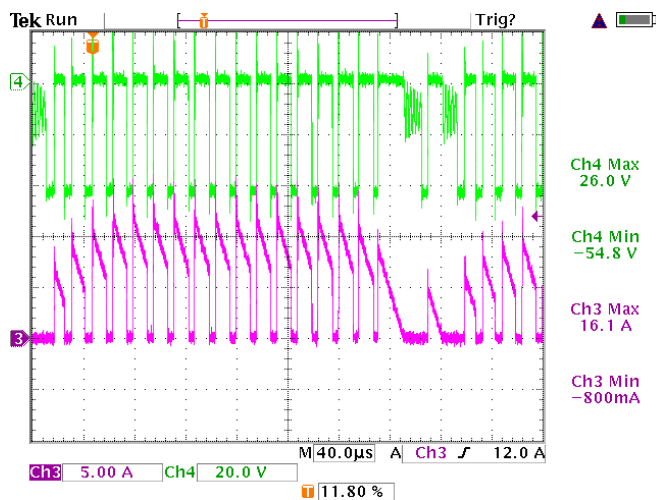
8. We arranged a co-test with LiteOn engineer for surge including voltage and current, but from waveform observation below, it showed no over stress on D52. We asked LiteON to assess which parameter is related to surge. Below is the waveform of voltage and current on D52 during surge 6KV test.

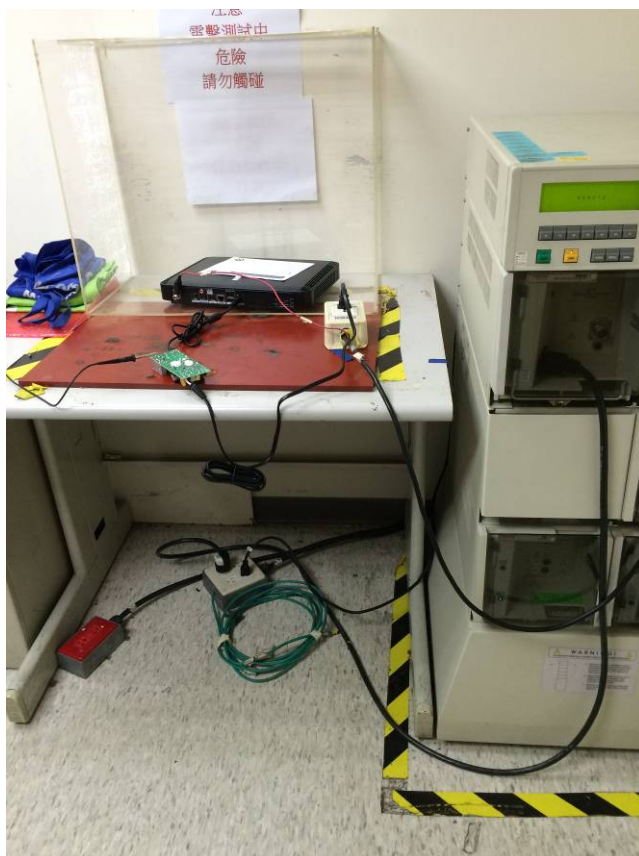
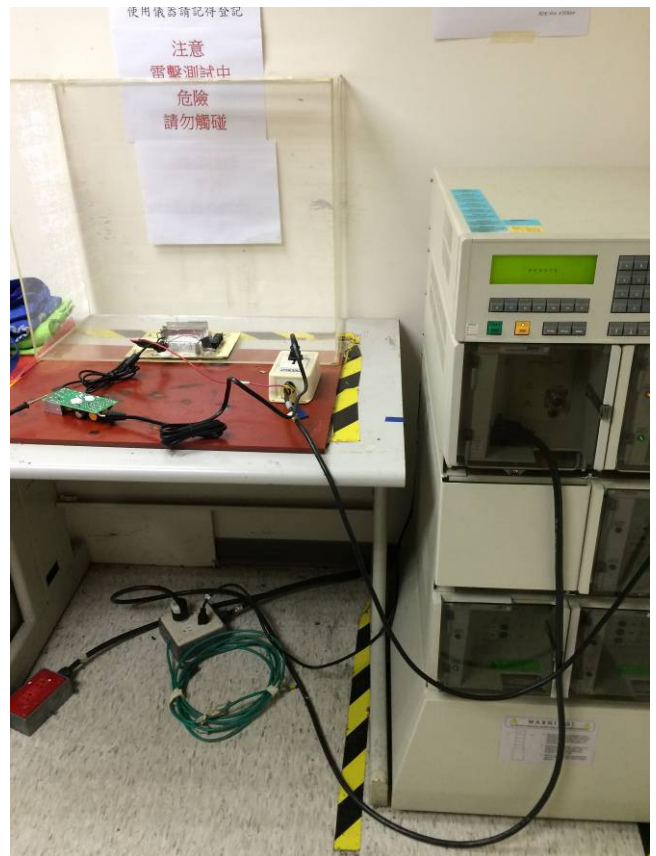
9. We went to ODM to witness the surge test, they prepared a HR54 STB but did not include the TV simulator. We compared the stress on D52, it showed no obvious difference when we used resistive load or HR54 STB during testing.

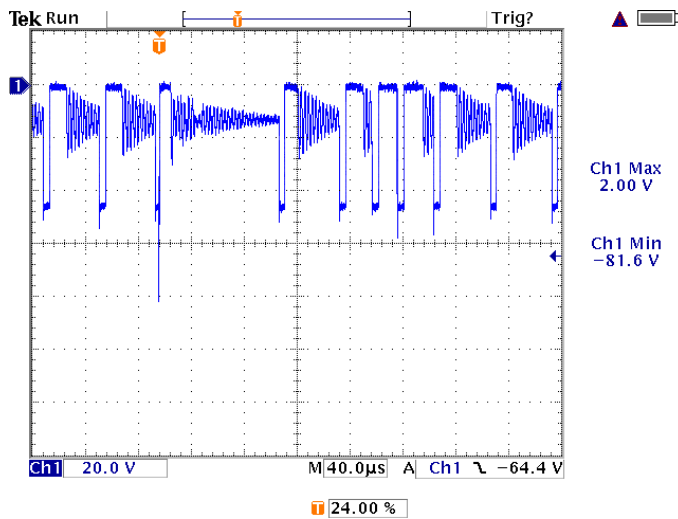
Below is the voltage waveform on D52 when tested with HR54 system.

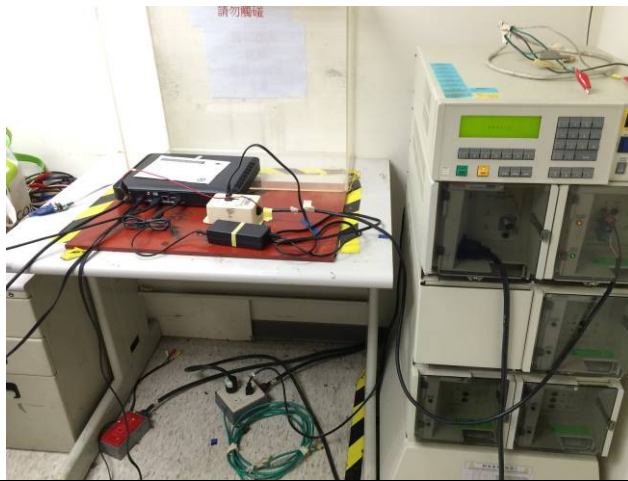
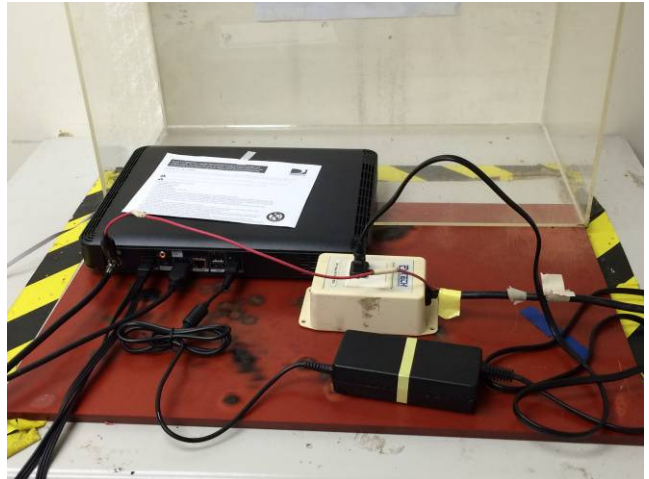
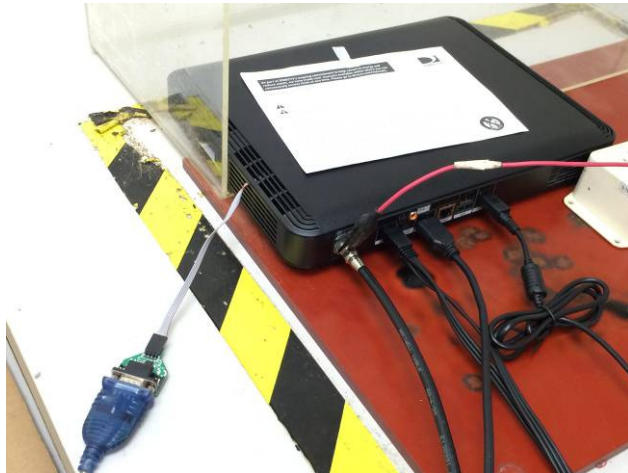
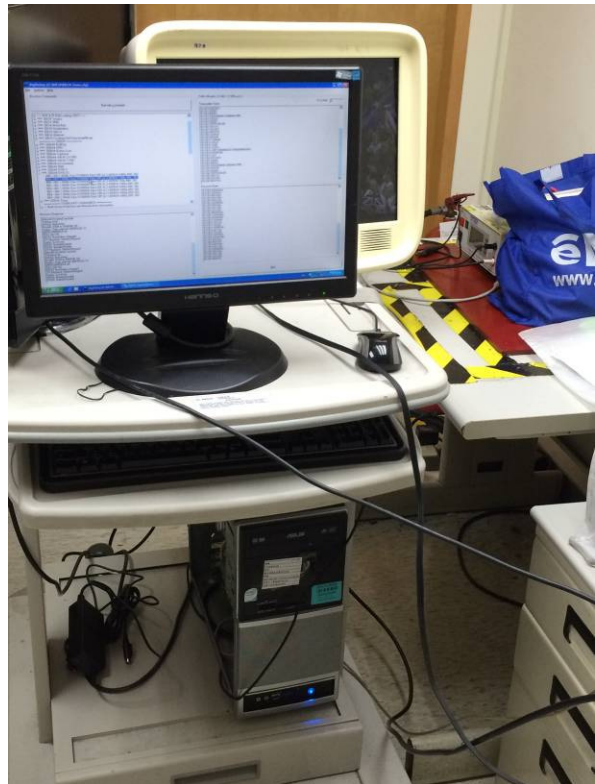
11. We went to ODM to witness the surge test again. They prepared a full setup for test including HR54 STB, PC, TV, and monitor, but still not included TV simulator.

(a) Adapter passed the full system surge at this setup.

(b) We measured the stress on D52 during this setup, it showed no obvious difference on stress of D52 compared to PSU stand alone.

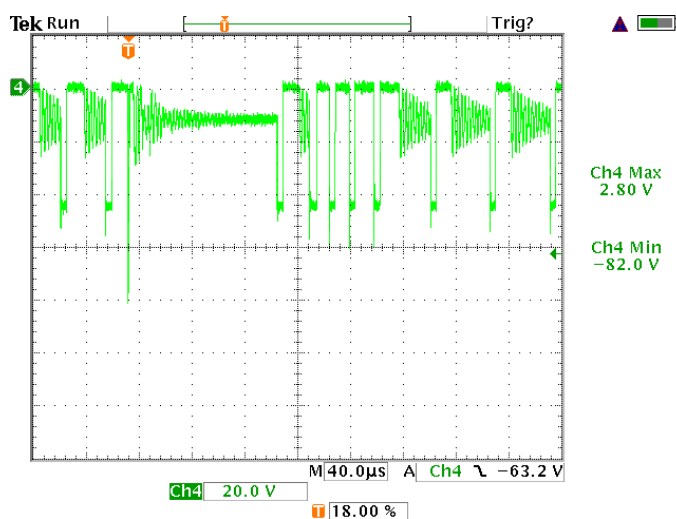
Below is the voltage waveform on D52 when tested with full system at ODM.

Change output schottky from LITEON G30100CTW to Vishay V30100C to enhance surge capability.
