## Eight Discipline Report (8D Report)

To: <b>Customer</b>	8D report No.: <b>CPG1205</b>
From: : <b>Chicony Power Technology</b>	RMA claim No.: <b>N/A</b>
CC :	Chicony Power P/N: <b>A015R008L</b>
	Customer P/N: <b>A9T80-60008</b>
Submit date: <b>2016/12/12</b>	Product description: <b>15W</b>
Receive date: <b>2016/12/09</b>	Defect D/C or Lot No.: <b>161017</b>
<b>Subject : No power*2pcs, (R10 is poor soldering with the worse carrier due to the shadow effect) (BD1 short caused the adapter no power).</b>

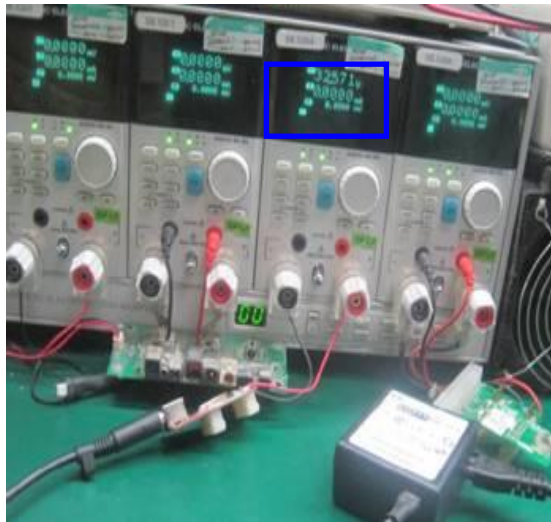
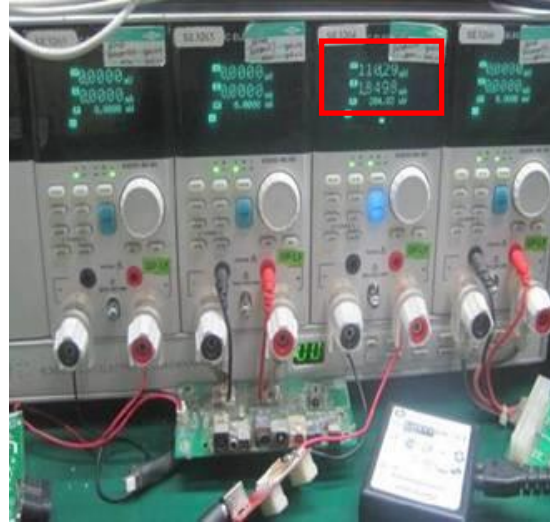
2. Test this adapter, it can power on with No Load and not power on with Full Load.

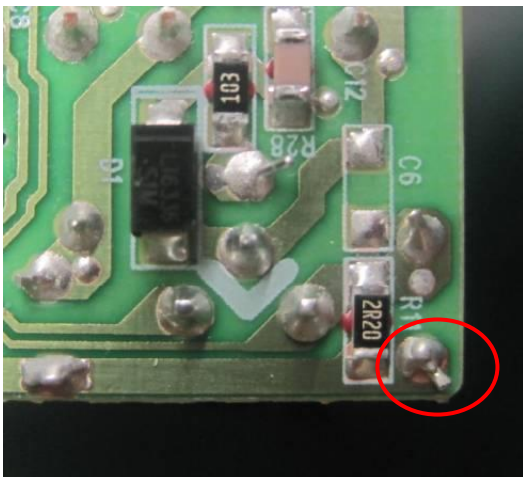
3. To open the case, observe the soldering side and the component side. Seen from the soldering side, one pin of R10 is poor soldering.

R10 poor soldering caused the adapter no power.

**5. Re-solder the R10, and this unit can power on.**

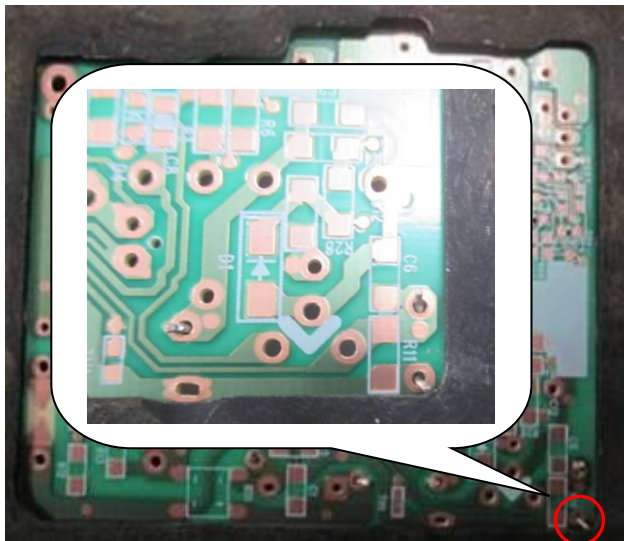
As the above NG picture shown, R10 is very closed to the edge of the carrier. There's possibility to cause R10 poor soldering with the worse carrier due to the shadow effect.

ME modify one hole of the worse carrier by polishing the carrier around R10, to avoid R10 poor soldering. (Please kindly refer to the partial enlarged pictures in D4-4)

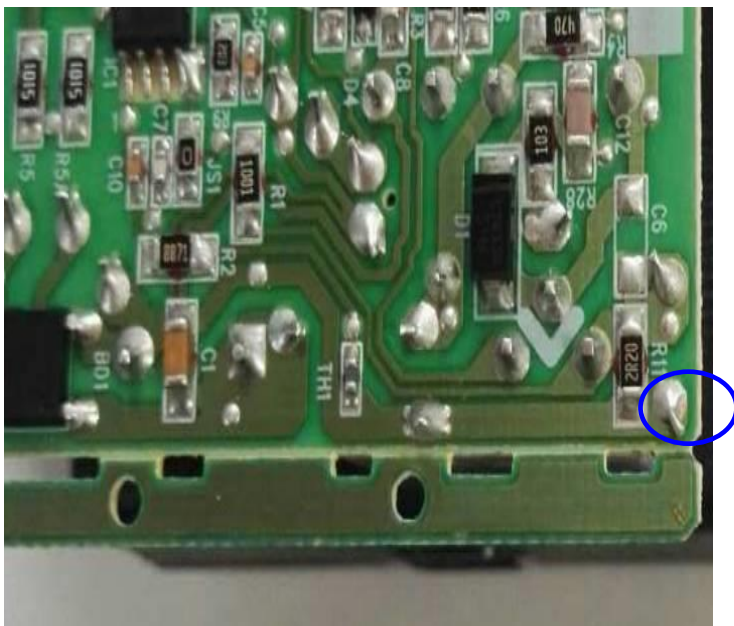
To use the carriers of the production line to run the adapters of this mode one day and no soldering defect found and only 1pc like below picture.

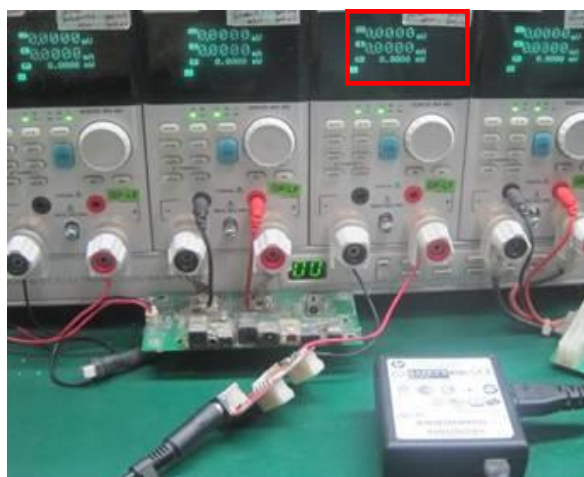
### 9. Test this adapter, it can not power on.

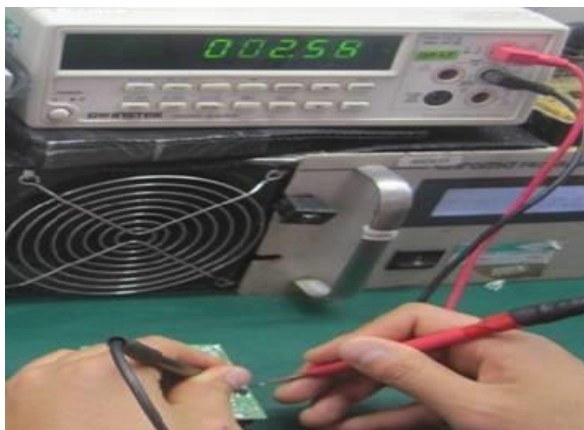
### 10. To open the case, observe the soldering side and the component side. There's no defect on both sides. And measure the related components, BD1 is short(as below picture). And F1 is open.

Vendor's conclusion: Burn mark can be observed on the failed dies after sample decaped, it was suspected that the electrical over stress impact caused the failure in application.

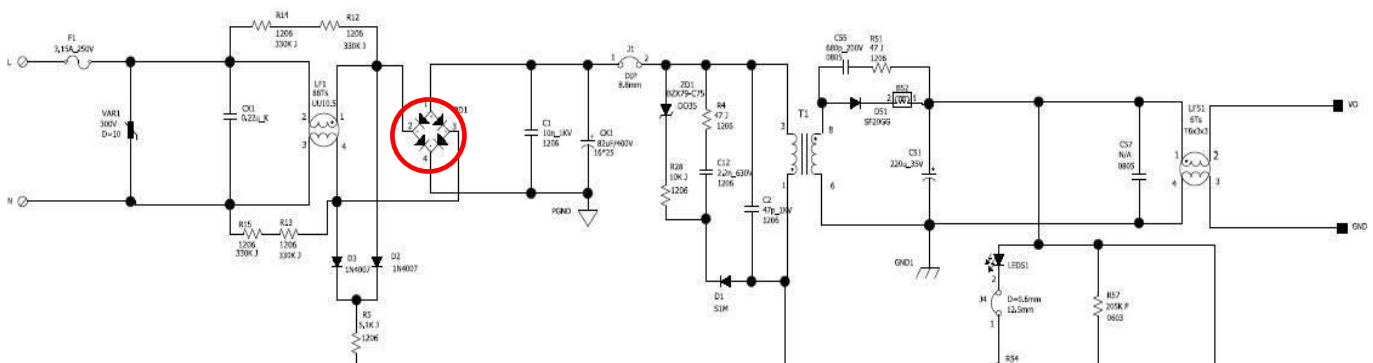
## 12. Schematic Analysis

When BD1 is short, and F1 open, then it will cause the adapter no power.
