## Eight Discipline Report (8D Report)

To: Customer	8D report No: 20230602
From: : Chicony Power Technology	RMA claim No.:
CC : NA	Chicony P/N: N355A001P-LX01-X2
	Corresponding Customer P/N:
Submit Date: Jun.2 <sup>nd</sup> , 2023	Product description:
Receive Date: Jun.9 <sup>th</sup> , 2023	Defect D/C or Lot No: D/C 2312 (lot:345)
Subject : 1pcs couldn't turn on in customer.( D106 empty solder)	
<b>D1.) 問題解決成員(Use Team Approach)</b>	
<p>主持者 (Team Leader) : JT_Ho</p> <p>成員 (Internal Team Members) :</p> <p>MFG: Jt_Ho ,Pai_Peng</p> <p>ENG: BP_Feng , Zheng_Xie, Bailong_Pan, CL_Chen</p> <p>MQA: Anny_Li</p> <p>RD: Jack_Chen,Nick_Wu</p>	
<b>D2.) 問題說明(Problem Description)</b>	
(Note: Use who, what, when, where, why, how, how many to specify the problem)	
<p>6 月 2 收到反饋 1 台 N355A001P-LX01-X2 不良 · RD 分析為 D106 空焊.</p> <p>On Jun 2<sup>nd</sup>, Recevied the feedback 1pcs Chicony Landscape LVPS (Chicony P/N: N355A001P-LX01-X2) was defective,</p> <p>RD analysis was D106 solder empty.</p> <p>SN: 20L4360-07-N-000-3068-0141</p>

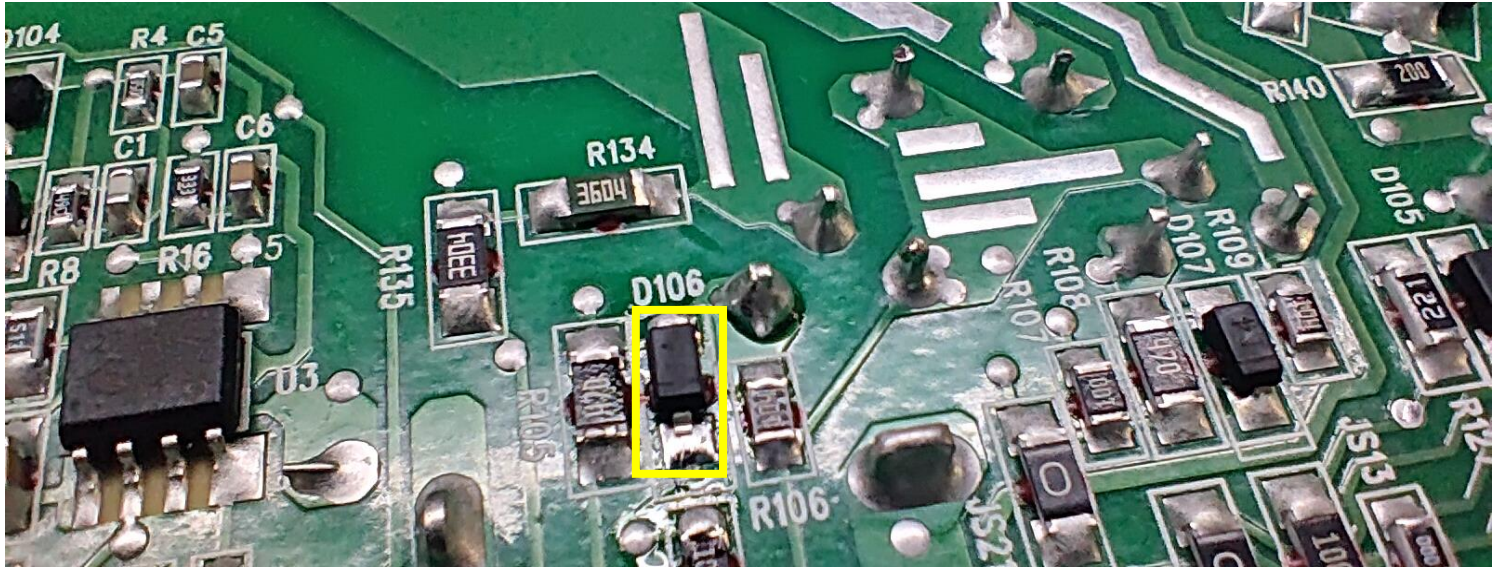
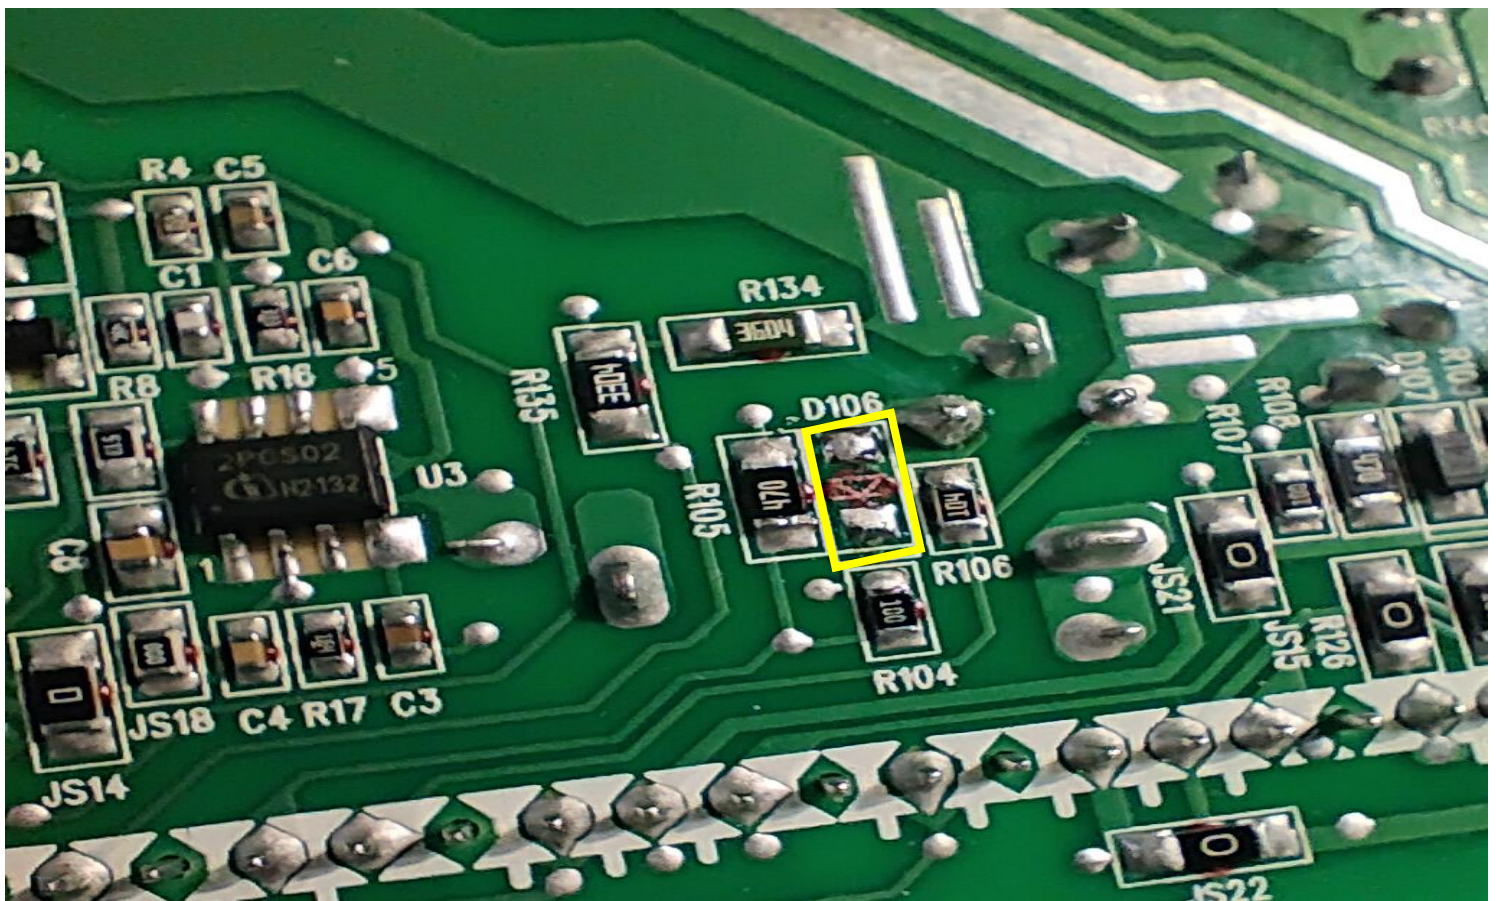
###### 4.3.1 由於不良品在台北端進行分析驗證，工廠端取一臺良品，並將 D106 空焊/缺件，用以模擬不良品

進行分析驗證。

As the defective product was analyzed at the Taipei, At the factory, took a good product and emptied D106 solder or missed D106 part to simulate the defect for analysis.

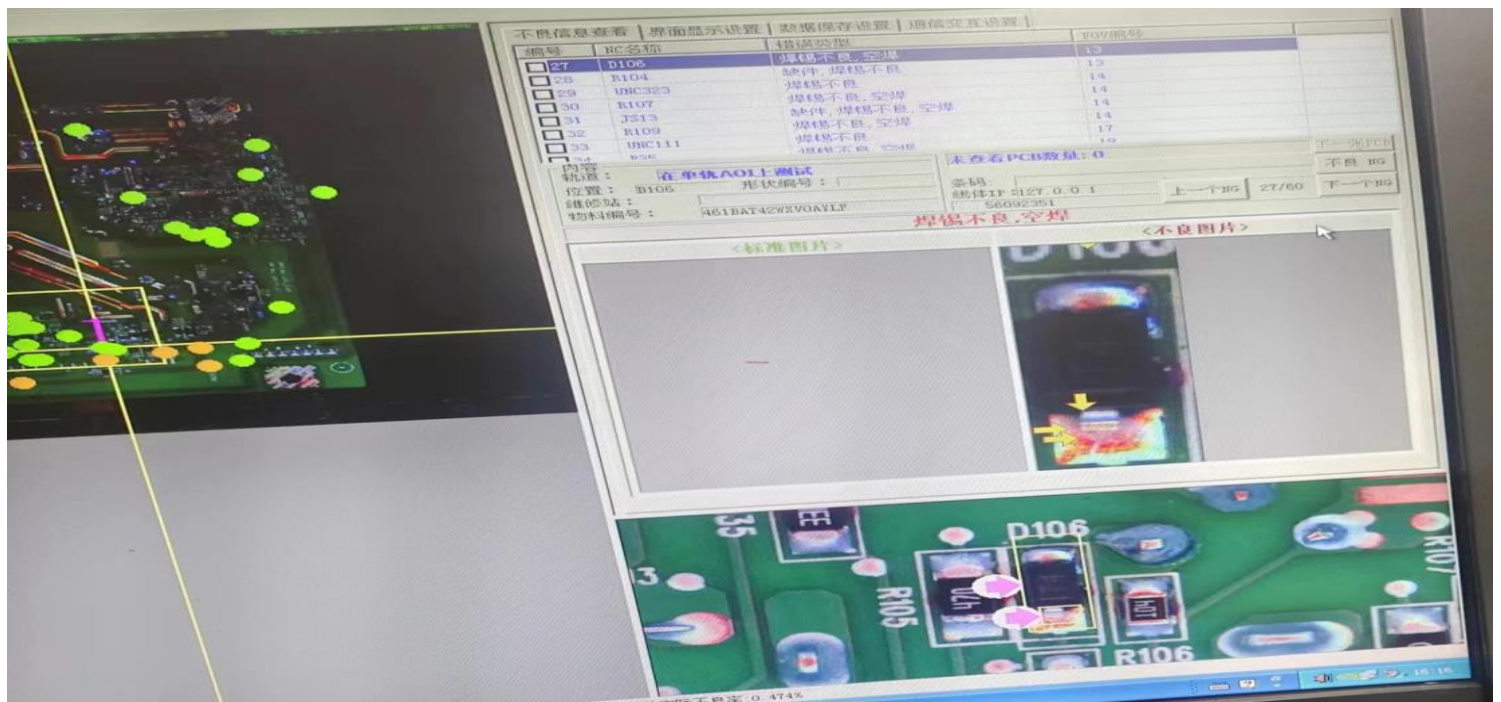
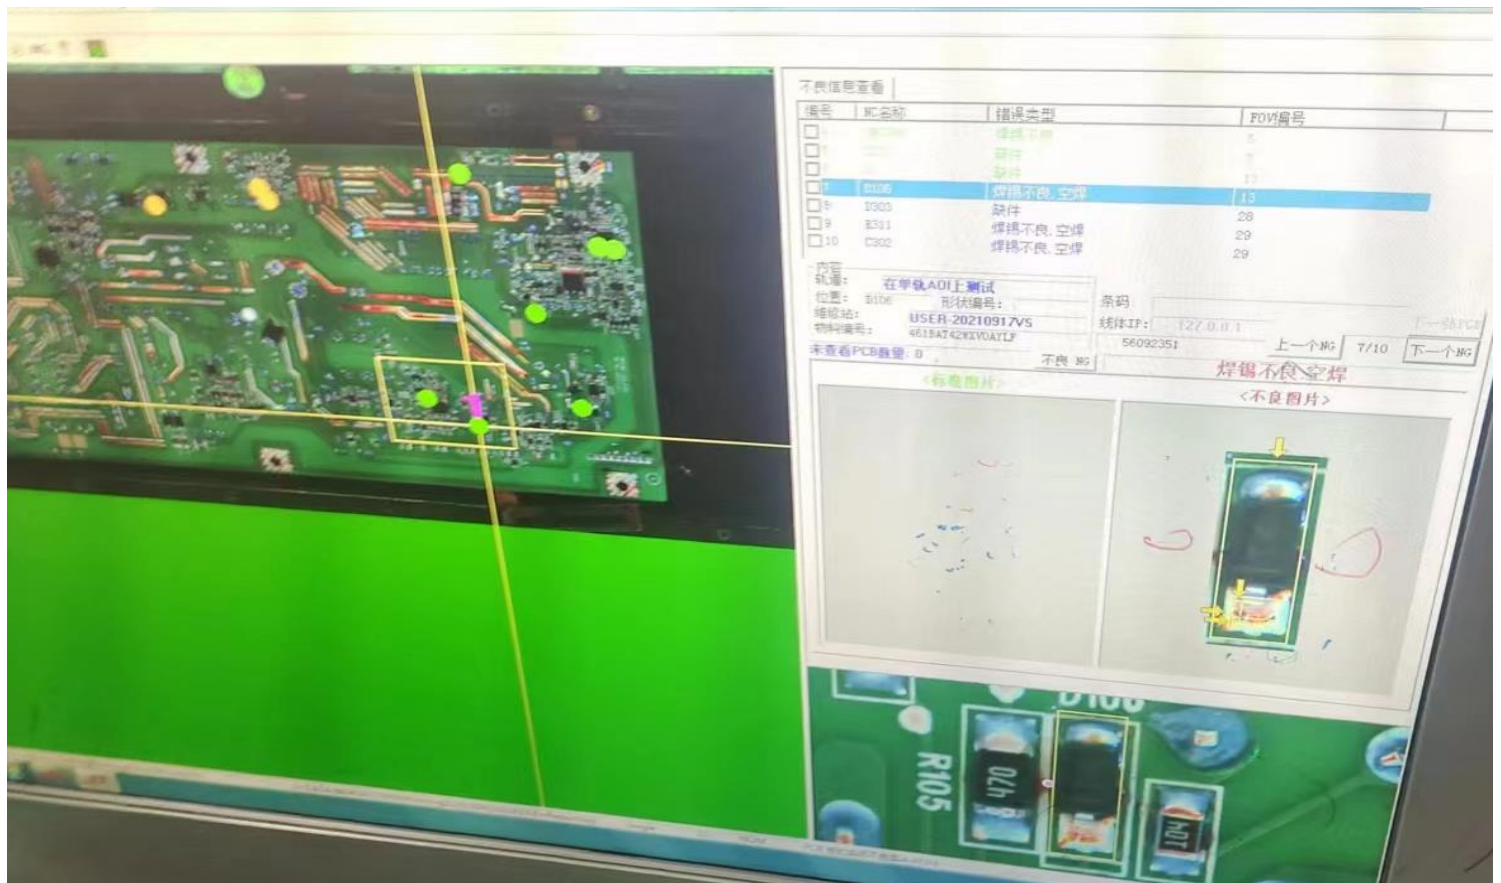
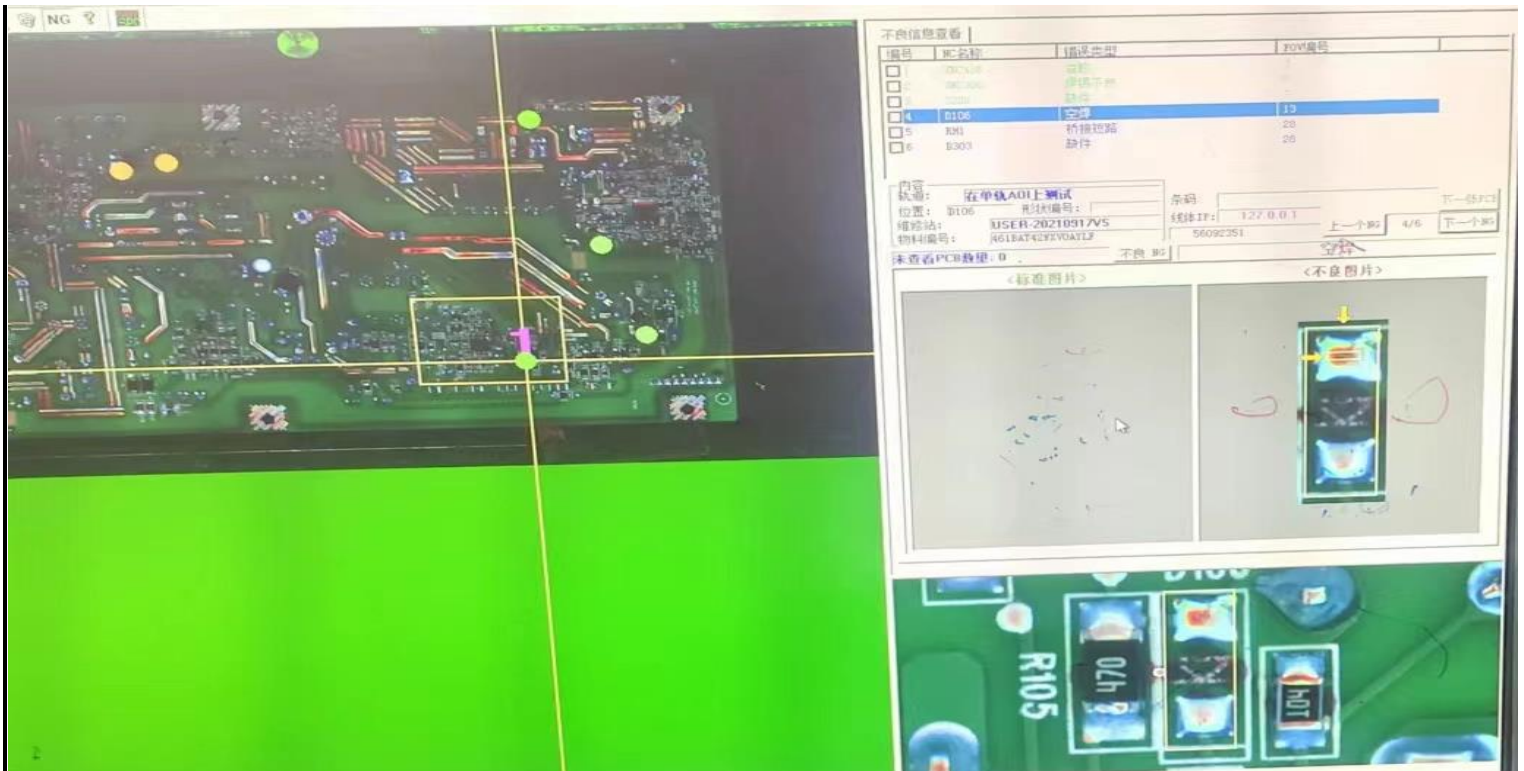
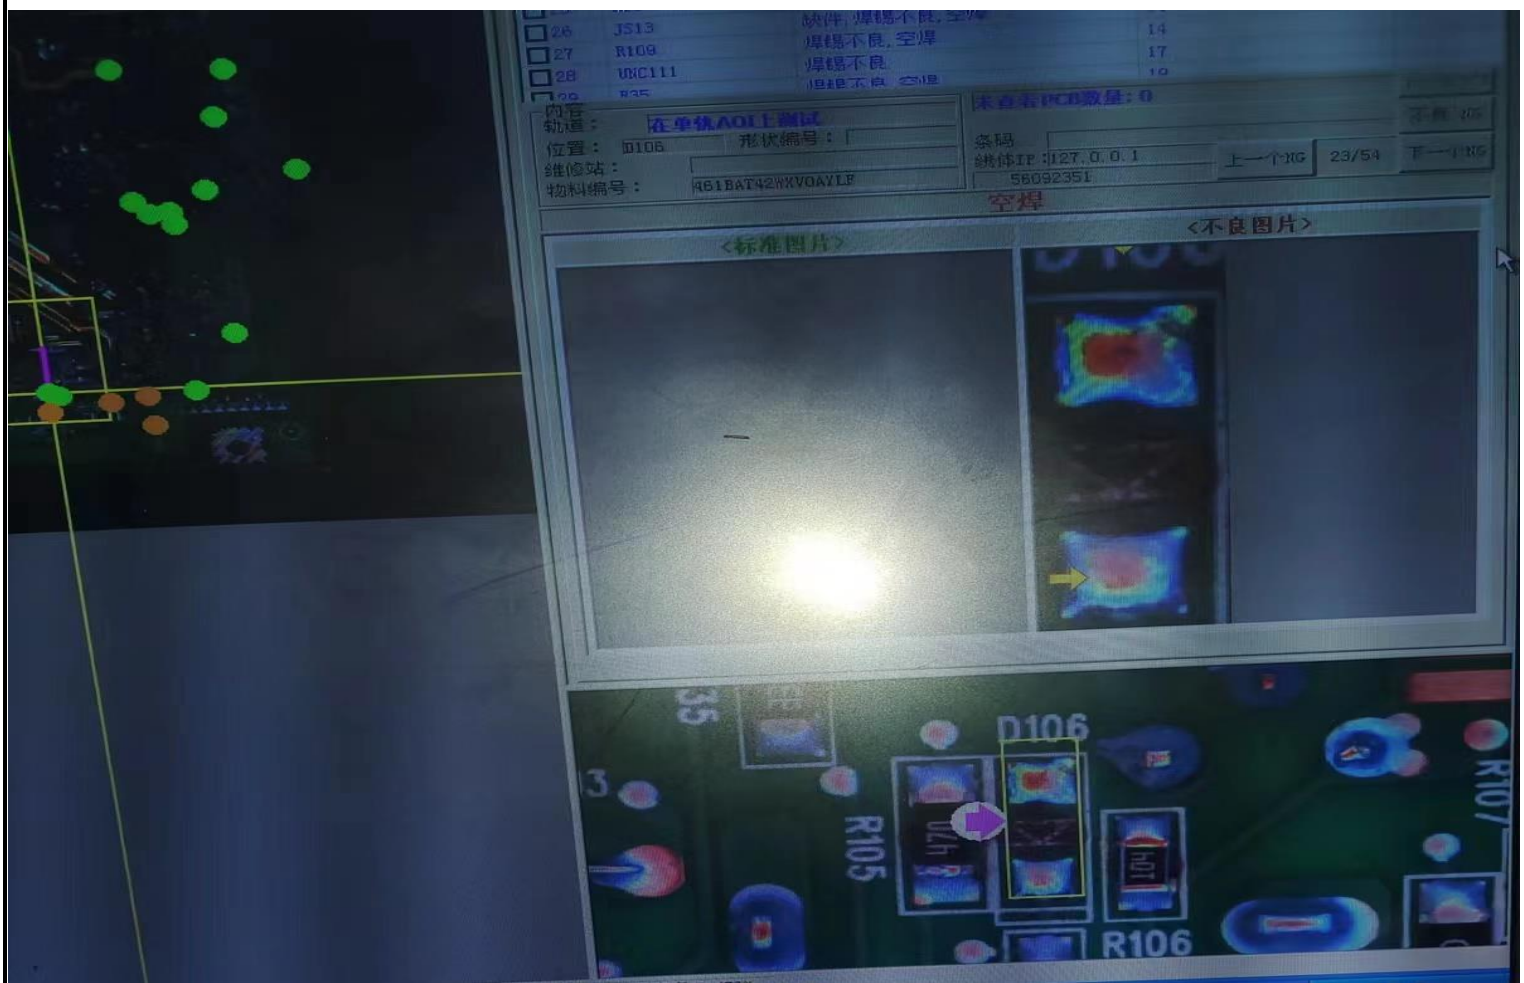
4.3.2 進行 AOI1, AOI2 測試 · D106 空焊/缺件不良均可測出。

In the AOI1, AOI2 test, D106 empty solder or missing part could be tested.
