Eight Discipline Report (8D Report)

To:	8D report No.:
From: : Chicony Power Technology	RMA claim No.: N/A
CC :	Chicony Power P/N: A180AP01Q-FW01
	Customer P/N: PK37A019500
Submit date: 2023/8/18	Product description: 180W PD
Receive date: 2023/7/20	Defect D/C or Lot No.:
Subject : 客戶通知有一台 adapter 無輸出也無溝通

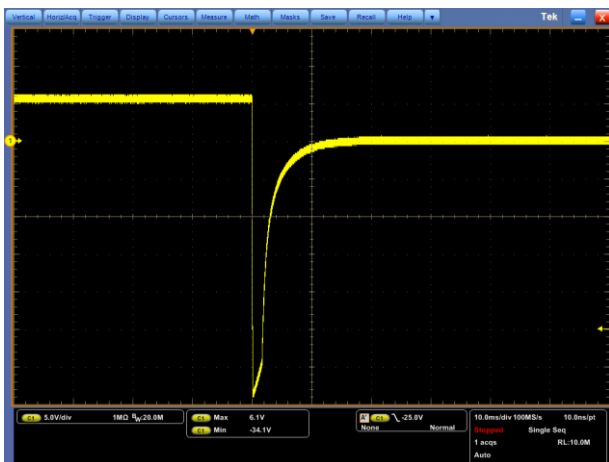
4. 問題復現: Adapter開機到 36V輸出後，在DC cable unplug時，量測 Q61 (Blocking MOS)

V_{gs}=-34.1V，超出零件規格 (規格為-20V)，導致 S1 & S3 short through，造成 PSU 損壞

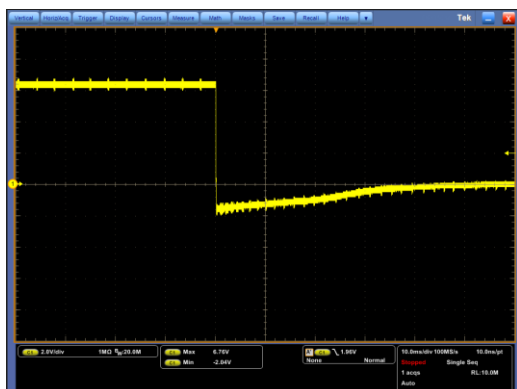
6. 對策驗證Q61(Blocking mos) V_{gs}:-2.04V，符合規格: +/-20V
