Eight Discipline Report (8D Report)

To:	8D report No.: 202206101
From: : Chicony Power Technology	RMA claim No.: N/A
CC :	Chicony Power P/N: A180A062P-AX01-X3
	Customer P/N: A20-180P1A
Submit date: 2022/6/10	Product description: 180W Adapter
Receive date: 2022/6/5	Defect D/C or Lot No.:
Subject : 客戶反饋系統驗證 ESD 測試時, PSU no power 共 3pcs	
D1.) 問題解決成員: Use Team Approach	
主持者 (Team Leader) : Cf Liu 內部成員 (Internal Team Members): <div style="text-align: center; margin-top: 10px;"> CQS: Jack Wang QE: Kitty Zhang MFG: Xiaohui Du PE: Yong Liu Sales: Justin Yu RD: Jacky Hsu </div> 外部成員 (External Team Member):	
D2.) 問題說明: Problem Description:	
(Note: Use who, what, when, where, why, how, how many to specify the Customer's problem.) 2022/6/5 CPT has received 3pc no power PSU from Customer for analysis. 問題描述: 客戶測試 ESD 3pcs fail sample , 測試過程中出現聲響就沒輸出了, 測試條件 air +10KV , 次數 > 50 下 S/N: 0A001-00265100141200039(D/C:2141) Version :A03 0A001-00265200124235848(D/C:2124) Version :A02 0A001-00265200124222244(D/C:2124) Version :A02

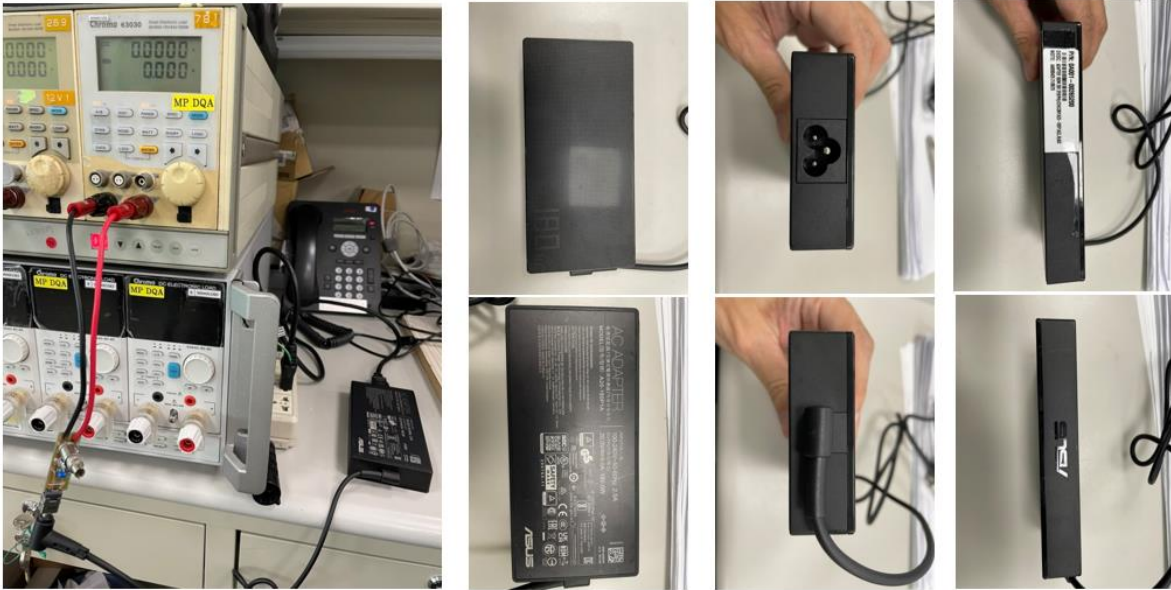
三台樣機 覆判無輸出，外觀無異狀

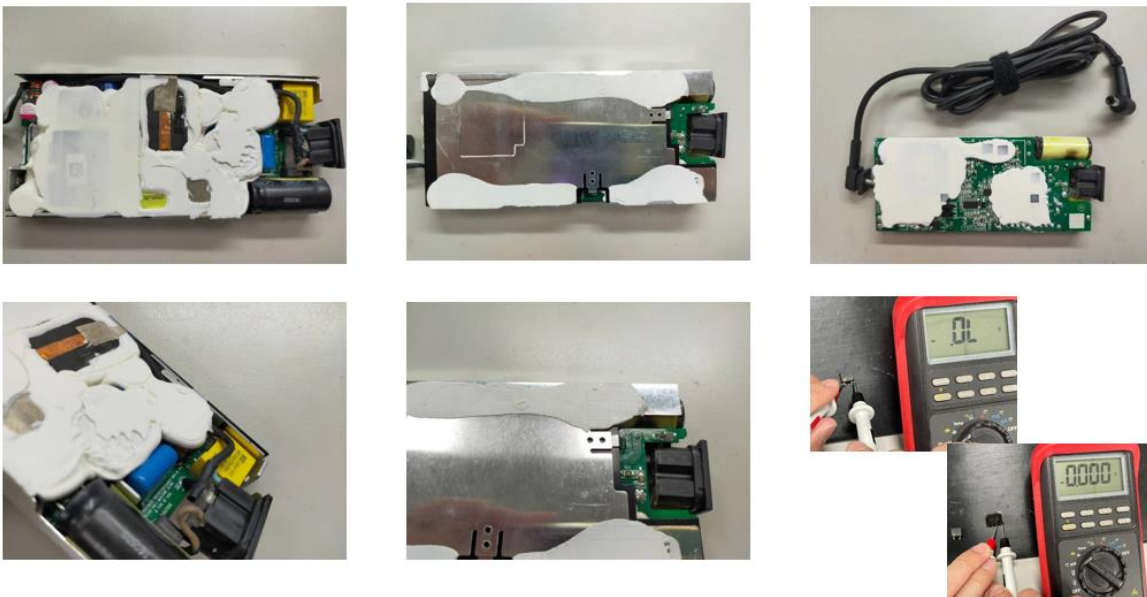
開蓋檢查內部，檢查異常位置，確認損壞元件為 F1 OPEN, BD1 Pin3(~) & 4(-) short

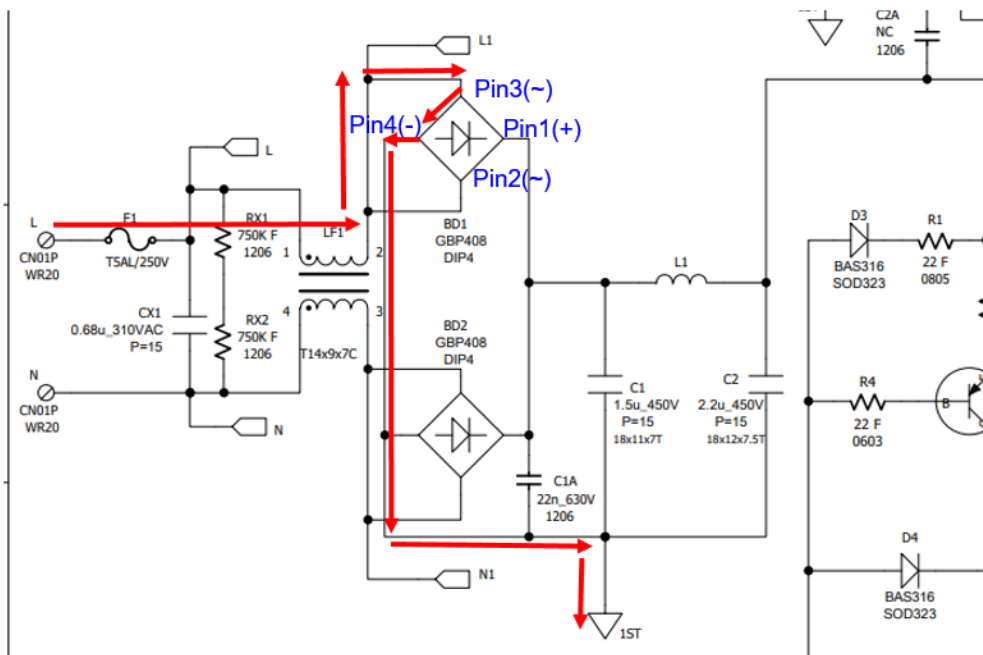
Schematic analysis

因為 BD1 Pin3(~) & 4(-) short，導致 F1 OPEN，造成 PSU 無電壓輸出

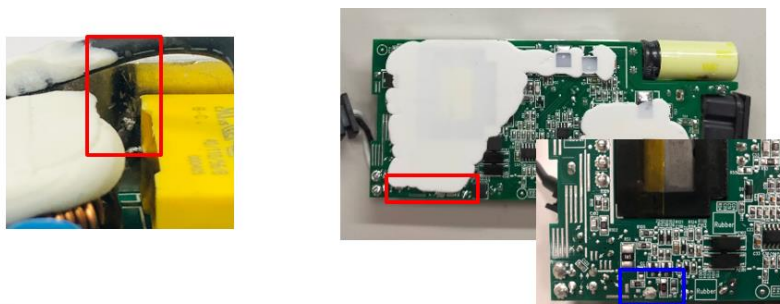
- a. 在 CX1 與 HS1 (鎖附BD1) 間有跳火痕跡
- b. 以 ESD 測試時, 發現在 CX1 與 HS1 間會有電弧產生放電路徑,
進而造成 AC 對地短路現象
- c. 檢查二次側放電pin 位置被膠覆蓋住, 可能造成預設的放電路徑被改變了, 而導致電弧發生
- d. 將二次側放電pin 覆蓋膠的區域清除, 再進行 ESD 測試即Pass

3. 加強對策: HS1 (鎖附BD1) 加貼 tape, 避免與CX1 間跳火短路

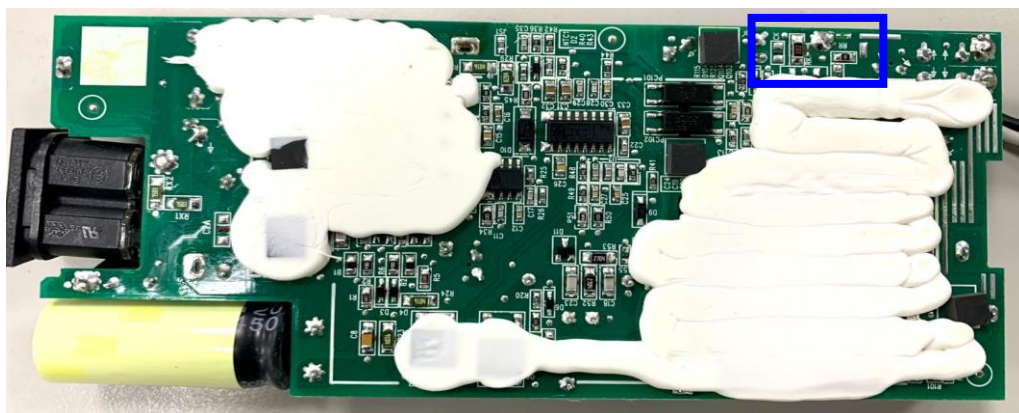
4. 取先前ESD 測試Pass 樣機拆解, 確認其點膠狀況:

二次側放電pin 位置沒被膠覆蓋, ESD 放電路徑可依照原先設定路徑洩放

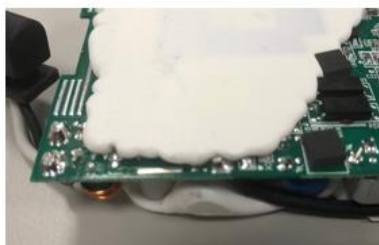
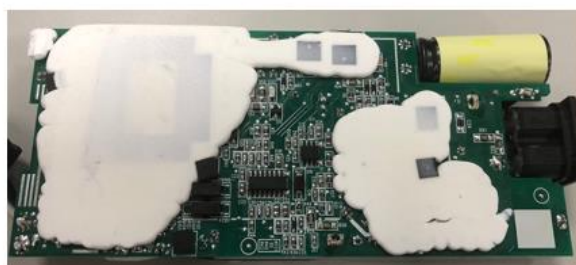
6. 將“2次側放電pin 膠覆蓋”的樣機做靜態測試,

確認CX1與HS1之間有沒有發生電弧現象

Sample	Air 8KV
1	No arc
2	No arc
3	No arc
4	No arc
5	No arc
6	No arc
7	No arc
8	No arc
9	No arc
10	No arc
