Eight Discipline Report (8D Report)

To: ODM	8D report No.: 20140227
From: : Chicony Power Technology	RMA claim No.: N/A
CC :	Chicony Power P/N: W015R004L-PG01
	Customer P/N: IPV5K6K
Submit date:	Product description: 15W adapter
Receive date: 20140220	Defect D/C or Lot No.:
Subject : No power*1pcs (surge failure, Q1, R1, R1A, ZD5, R16 damaged)

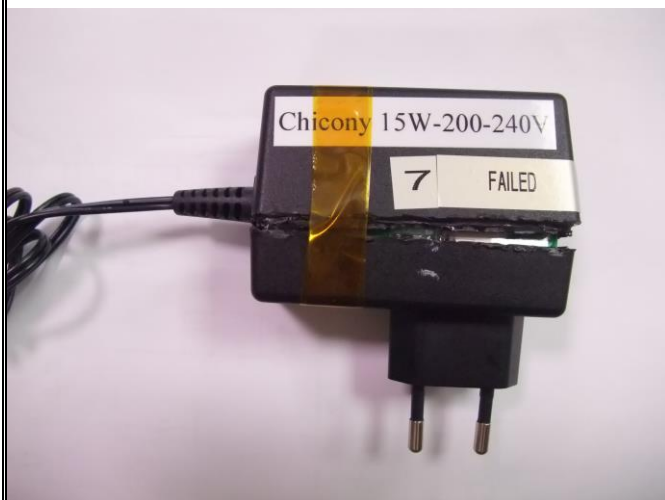
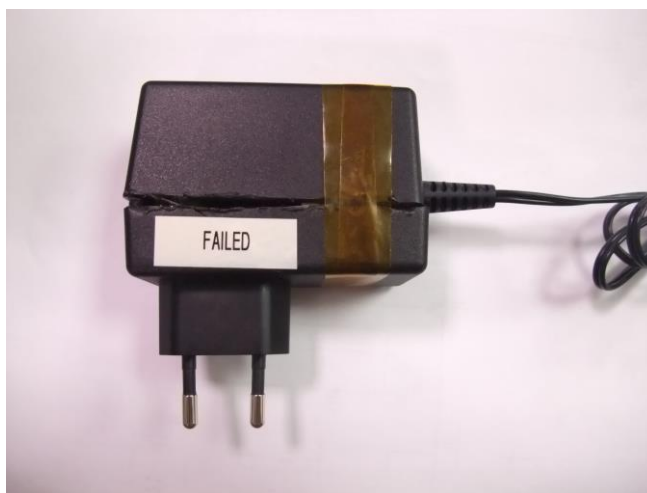
Customer already opened the case while failed unit received.

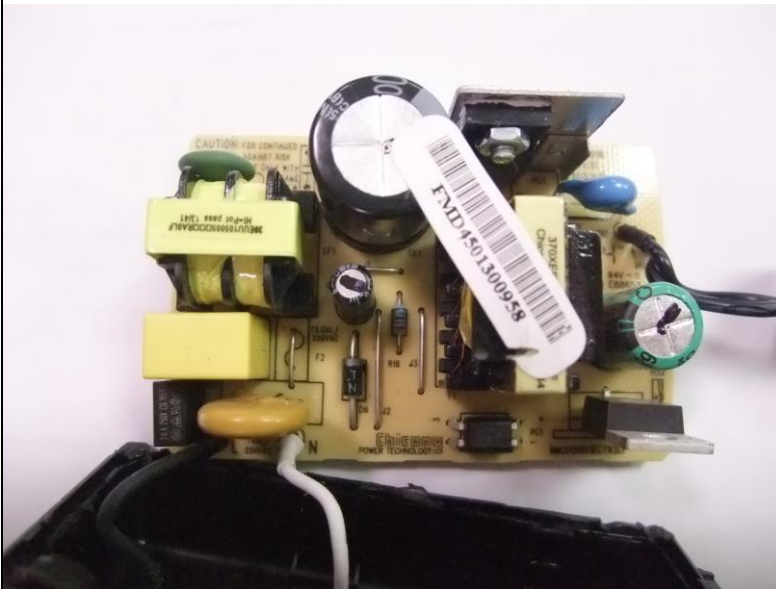
At component side, there is no burning mark or loose parts.

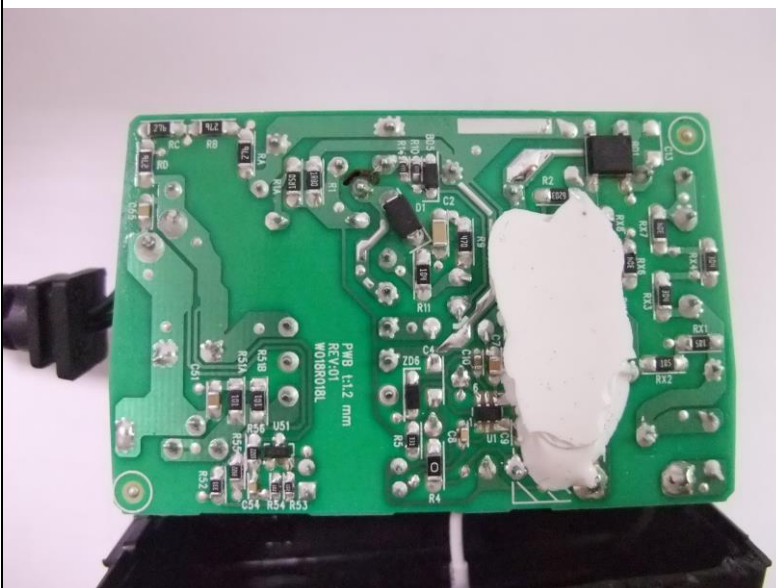
At solder side, there is no burning mark or loose parts.

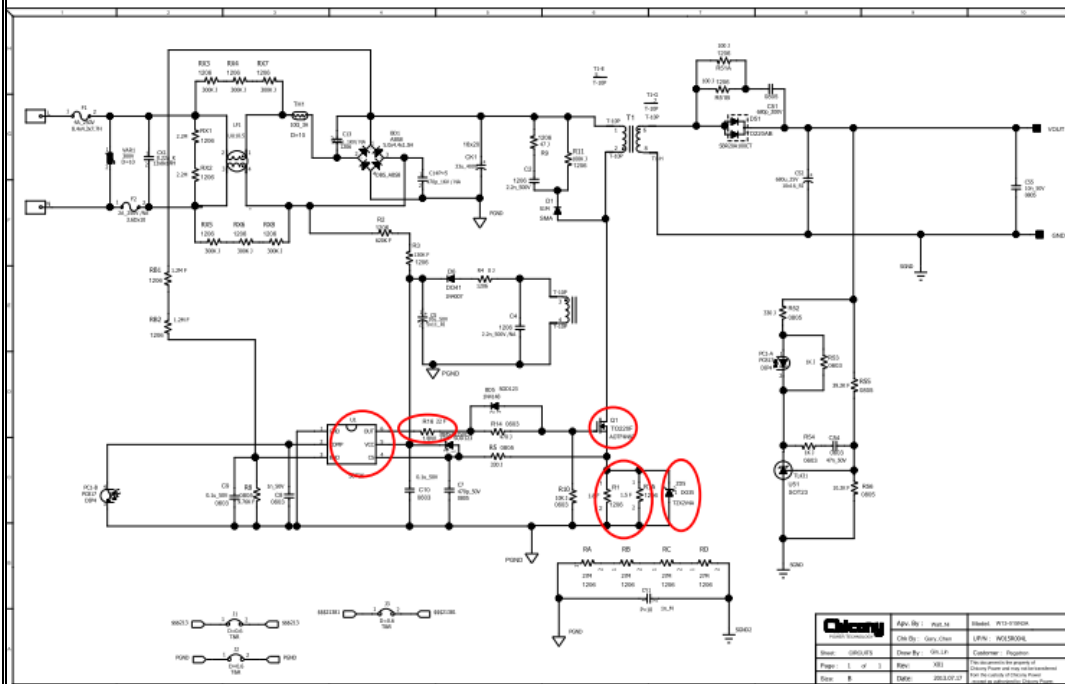
After further checking, the damaged components are: Q1, R1, R1A, ZD5, R16,

This failure looks like a noise influence → MOSFET blow → R-sense burnt open and PWM damaged.
