Eight Discipline Report (8D Report)

To:	8D report No.:
From: : Chicony Power Technology	RMA claim No.: N/A
CC :	Chicony Power P/N: A180AP01Q-FW01
	Customer P/N: PK37A019500
Submit date: 2023/8/18	Product description: 180W PD
Receive date: 2023/7/20	Defect D/C or Lot No.:
Subject : 客戶通知有一台 adapter 無輸出也無溝通

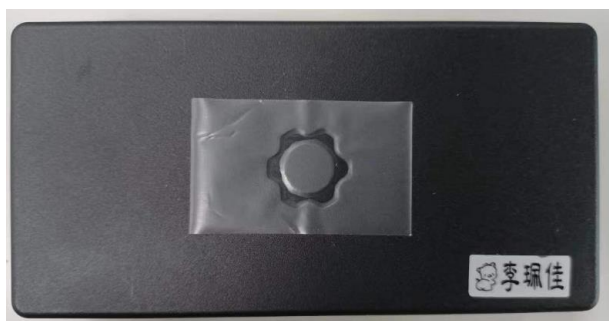
產品序號:<https://fr.mw/FRANCNCH71312100BY> 檢視樣機外觀並無異常。

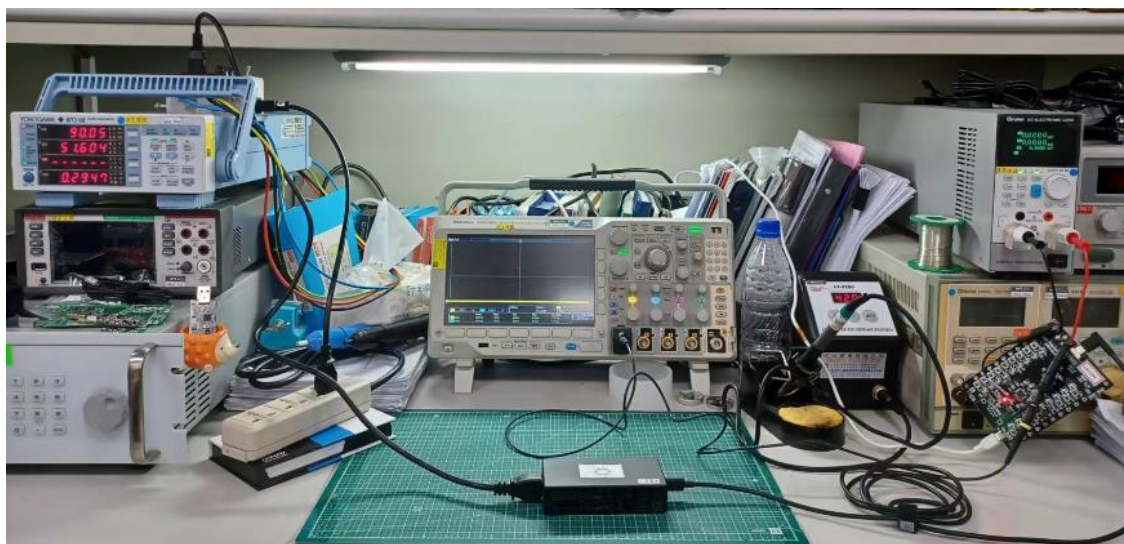
1. 透過追蹤我們SFCS中的SN (FRANCNCH71312100BY)，該樣機通過了生產線中的所有測試站。
2. AC Source送電開機亦無輸出，與客戶反應的狀況一致。

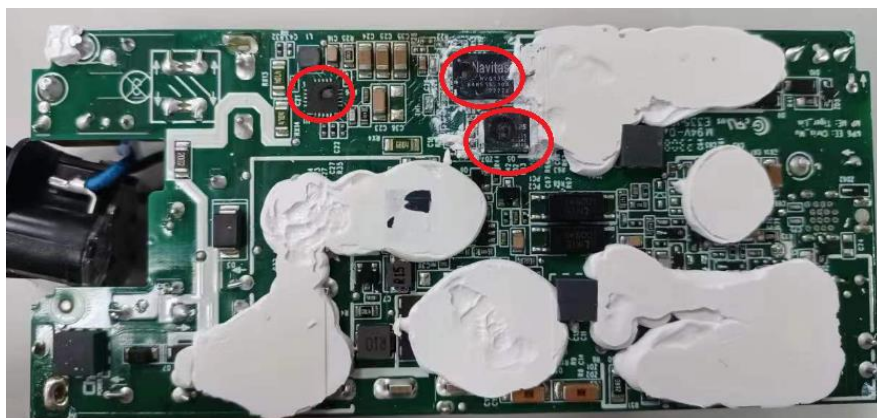
3. 打開外殼，觀察元件面跟鉚錫面，元件面看起來無異常，鉚錫面挖膠後明顯發現U1, S1, S3 損壞

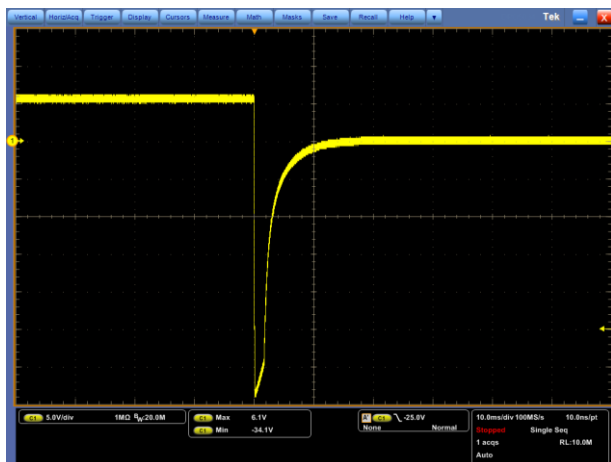
4. 問題復現: Adapter開機到 36V輸出後, 在DC cable unplug時, 量測 Q61 (Blocking MOS)

V_{gs}=-34.1V，超出零件規格 (規格為-20V)，導致 S1 & S3 short through，造成 PSU 損壞

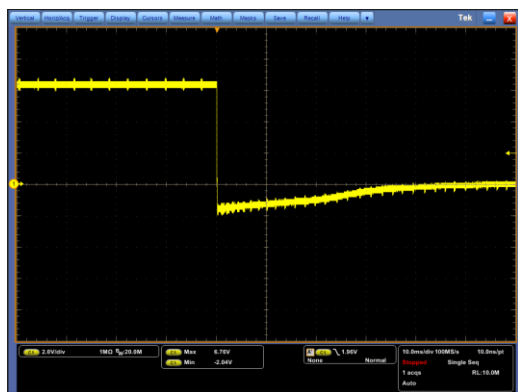
6. 對策驗證Q61(Blocking mos) V_{gs}:-2.04V，符合規格: +/-20V
