Eight Discipline Report (8D Report)

To:	8D report No.:
From: : Chicony Power Technology	RMA claim No.: N/A
CC :	Chicony Power P/N: A180AP01Q-FW01
	Customer P/N: PK37A019500
Submit date: 2023/9/21	Product description: 180W PD
Receive date: 2023/9/5	Defect D/C or Lot No.:
Subject : 客戶反饋 DVT1 樣機搭配系統系統測試時, PSU 無輸出

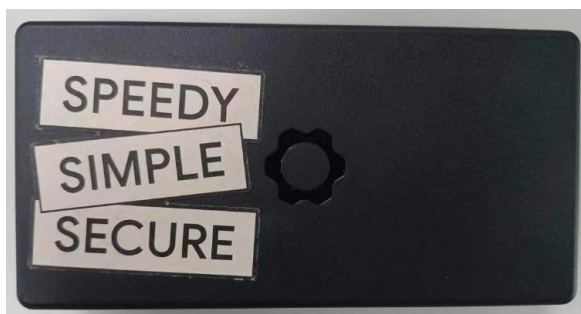
Check the sample appearance and find no abnormality.

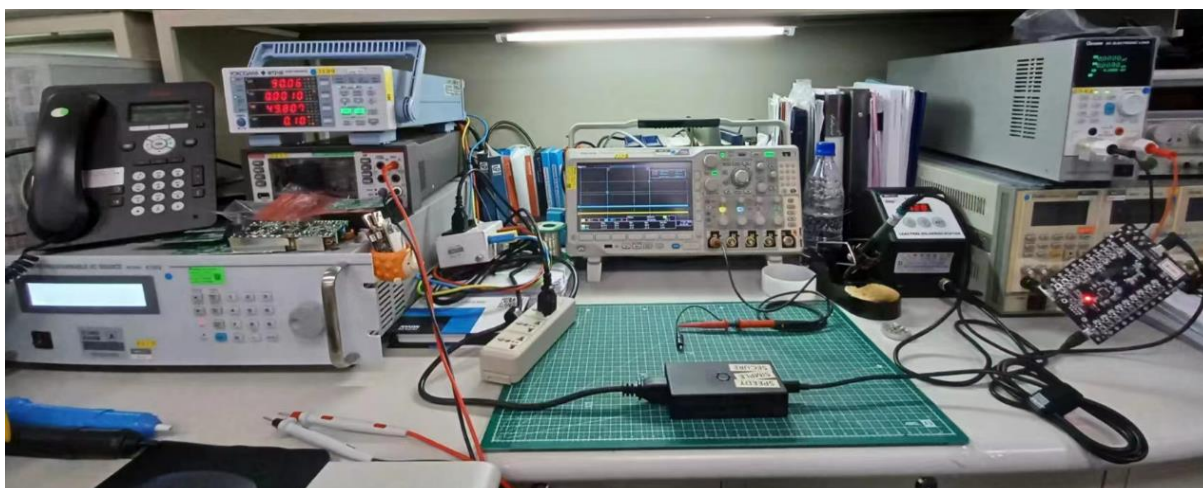
Check the sample function and find no output when AC source is on.

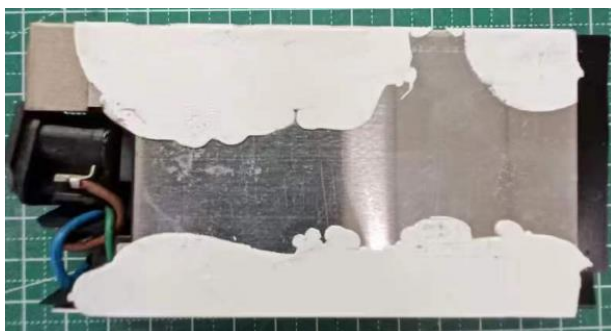
(Top side)

2. Check the RTV glue and find no abnormality when the case is opened.

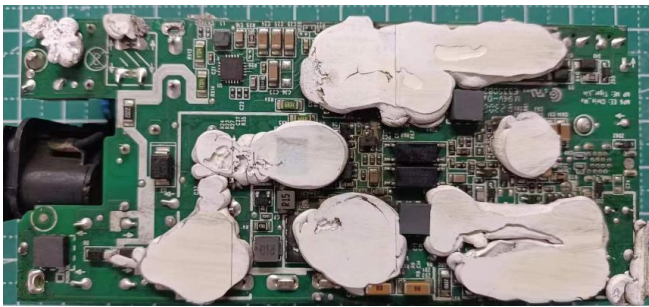
(Before the removal of RTV glue)

3. After the shielding is removed, and removed RTV glue. S1, S3 are found damaged upon visual inspection and F1, U1 also damaged through measurement.

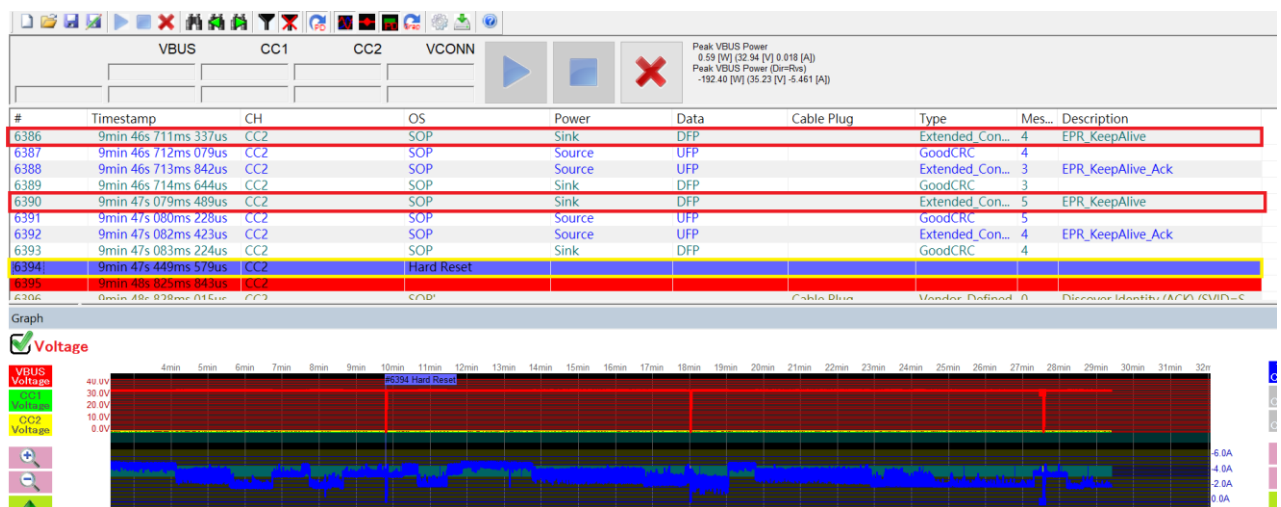
- When the adapter works with the system for charging with output voltage of 36V, the “Hard Reset” issue was recorded for 3 times during the 4%~40% battery power.
- Such “Hard Reset” issue will lead to the output voltage drop from 36V to 0V and make the PD IC on the Adapter side turn off the Blocking MOSFET, so it is equivalent to DC cable unplug.

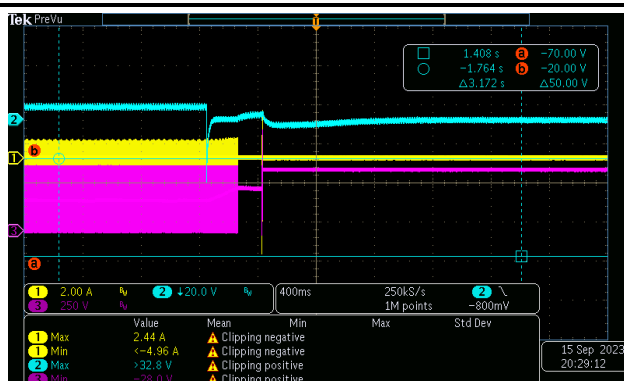
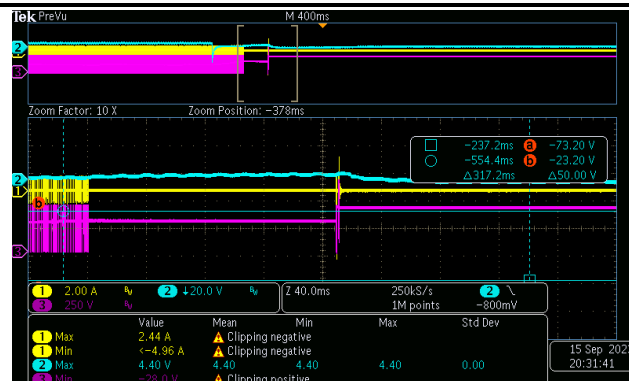
- After the Adapter is unplugged DC Cable or “Hard Reset” at 36V output, the Q61 (Blocking MOS) Vgs is measured as -32.8V, which exceeds the component spec of +/-20V.

After the Blocking MOS is turned off for about 400ms, it is turned on again and causing the withstand voltage of S1 & S3 (AHB GaNFET) exceeds the spec, so the PSU damages

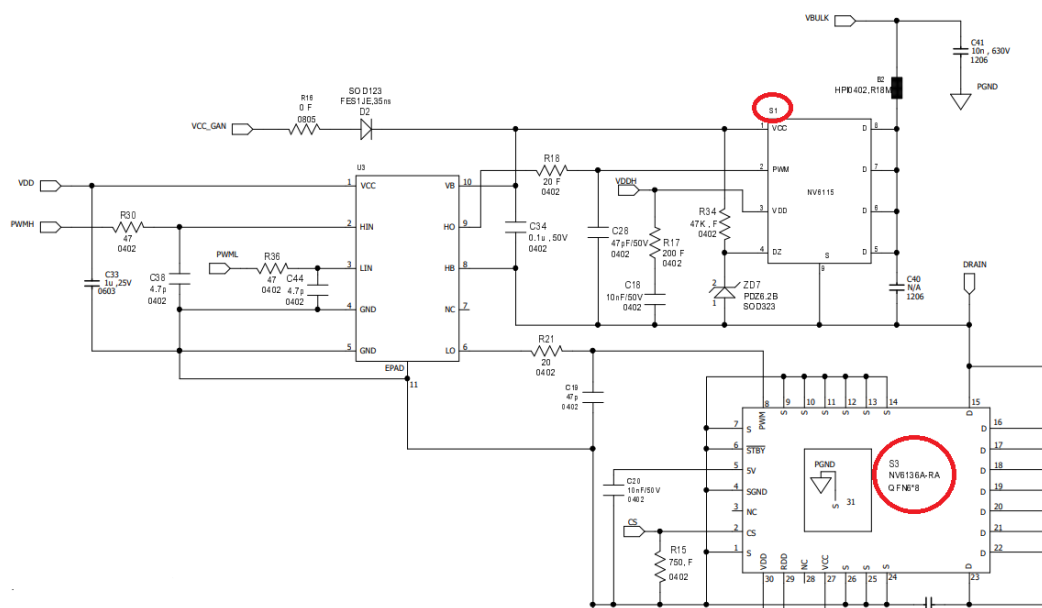
- S1 is high side GaNFET & S3 is low side GaNFET

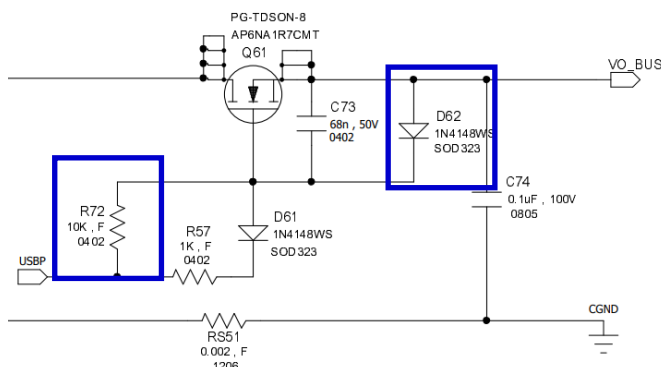
- The 180W PD is designed with maximum output voltage spec of 36V. When the output voltage drops from 36V to 0V, there is a instantaneous reverse voltage spike, which should be solved by use of a diode and a smaller Rg resistor, so as to allow for rapid discharge of Q61 Vgs.

Component Change:

1.R73=1M-->D62=1N4148WS

2.R72=30K-->10K

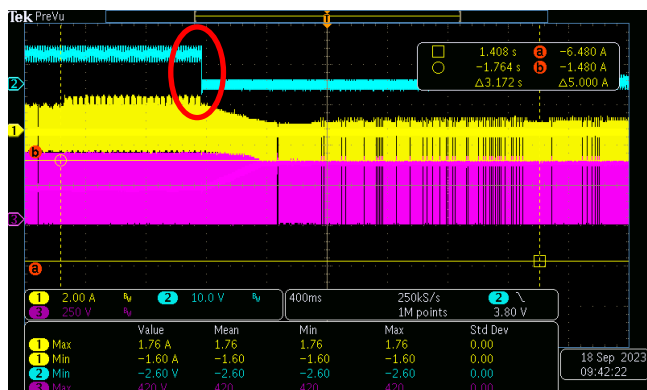
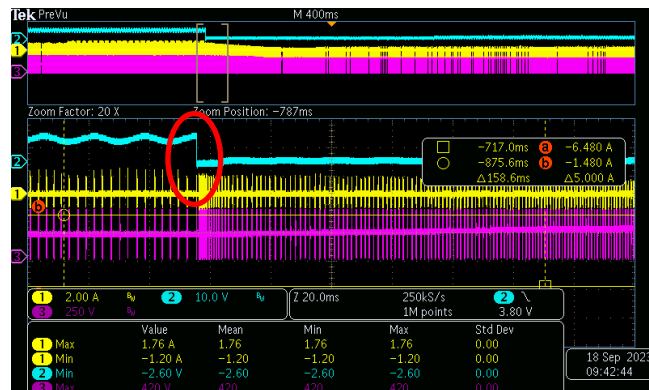
With the introduction of corrective action, after the adapter is turned on to 36V output and the DC cable is unplugged, the Q61 (Blocking MOS) Vgs is measured as -2.6V, which meets the component spec of +/-20V.

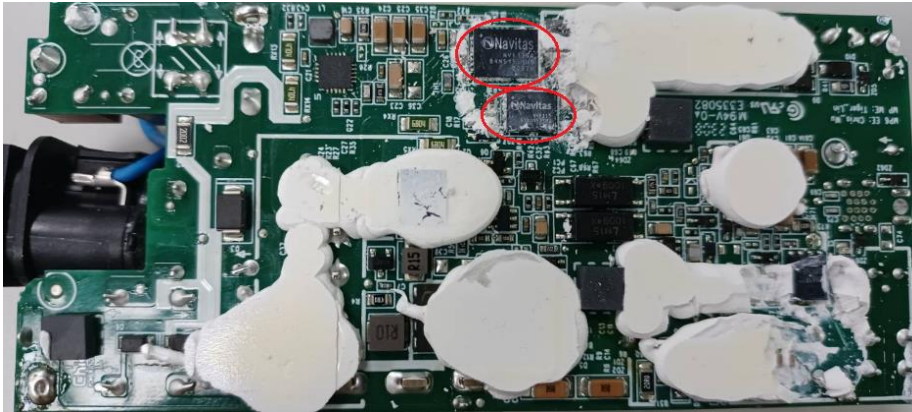
For DVT1 sample DC cable unplug find no output when AC source is on. After the bottom side is removed with RTV find no abnormality , but S1,S3 damaged through measurement.

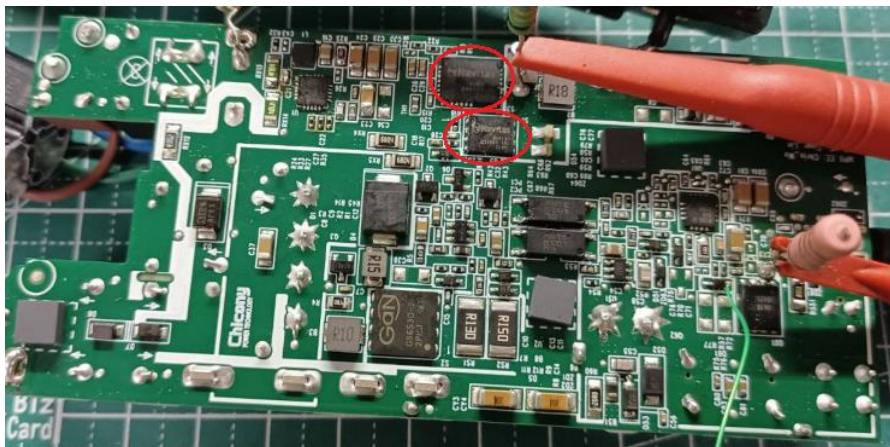
For DVT2 sample DC cable unplug find no output when AC source is on. After the bottom side find no abnormality, but S1,S3 damaged through measurement.

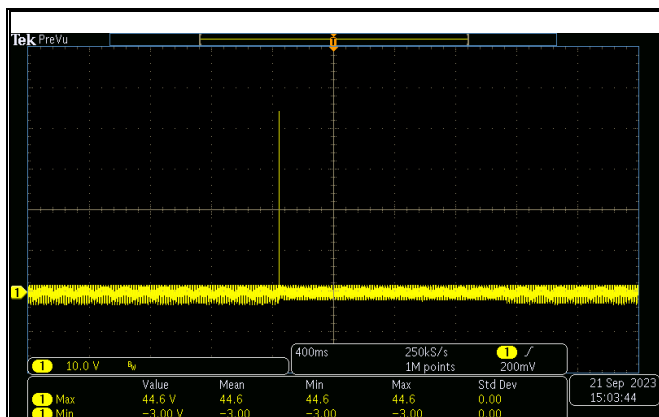
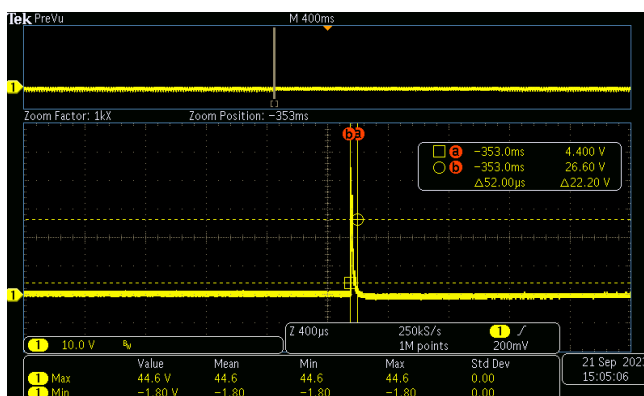
For DC Cable unplug USBP to discharge the VO_BUS,
pull down resistor 1Kohm of this pin pluse voltage is 44.6V, calculate maximum current is 44.6mA ,WT6676F
Pin12 GPIO2/GATE <50mA
