Eight Discipline Report (8D Report)

To: **XX** 8D report No.: **CPCQ20220801**
From: **Chicony Power Technology** RMA claim No.: **N/A**
CC : **N/A** Chicony P/N: **A111AP01P-HW01-0A**
Customer P/N: **XXXXXX-XXX**
Submit date: **2022/08/04 updated** Product description: **110W adapter**
Receive date: **2022/08/01** Defect D/C or Lot No.: **2022/02**
Subject : **Adapter failed*2pcs 高壓距離不足造成一次側零件跳火**

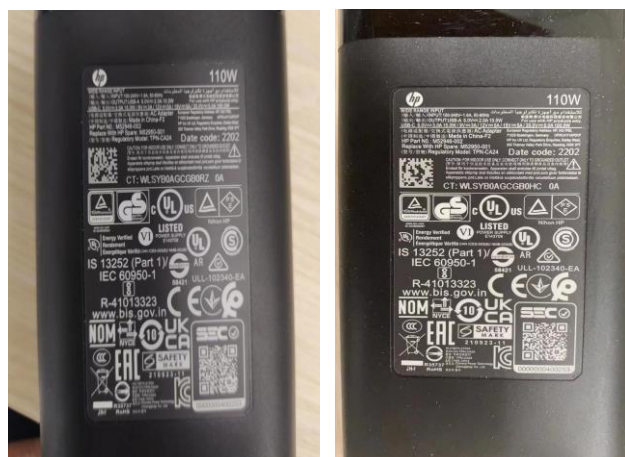
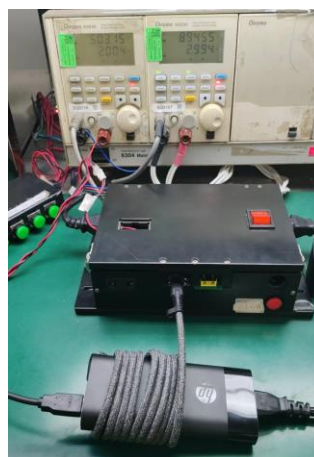
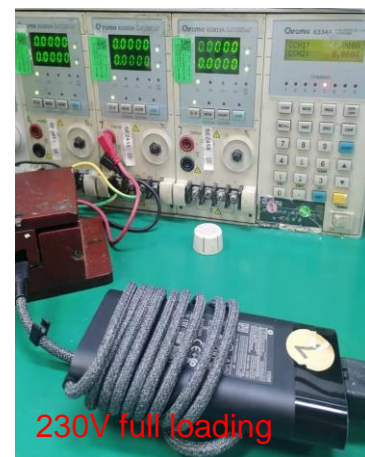
2. Power on test

檢查 adapter 外觀無異常,通電測試,230V full loading 無法工作.

The appearance of adapter is normal. Power on test confirms adapter failed to work on 230V full loading.

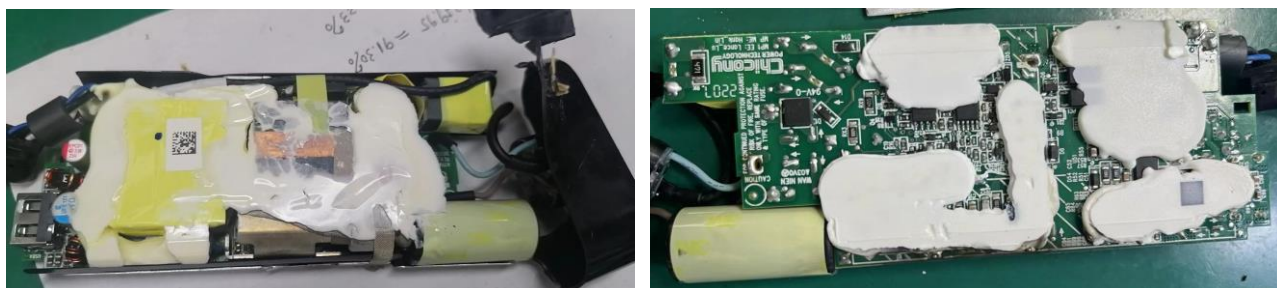
3. Failure analysis

3.1. 開殼檢查確認零件面及錫面.(如下圖).

Open the case to check the parts surface and tin surface.

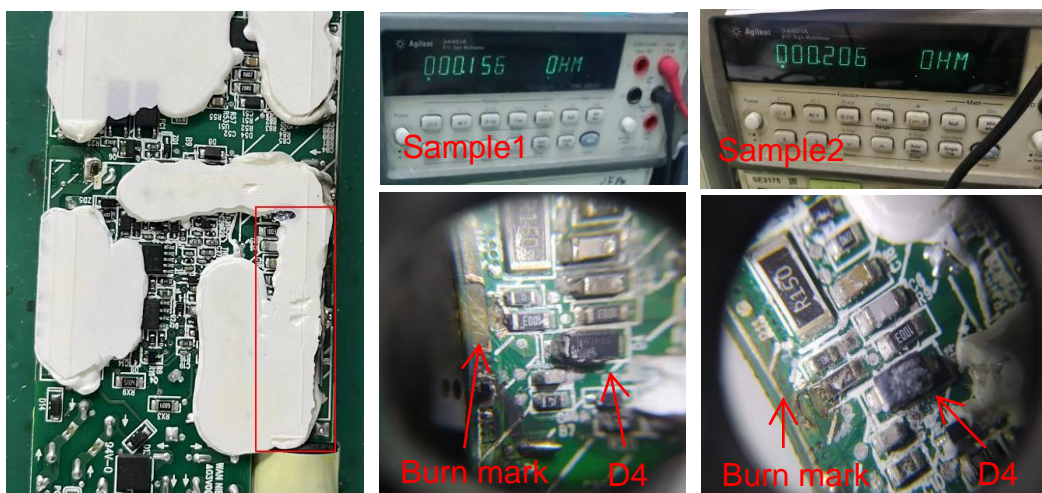
3.2. 清理錫面白膠,觀察到一次側 ground 銅箔燒毀痕跡.逐次量測錫面各個零件,發現 D4 fail(如下).

After cleaning the glue on the tin surface of the adapter, primary side ground copper foil has burn mark. PE measure each part of the tin surface one by one and found that D4 failed.

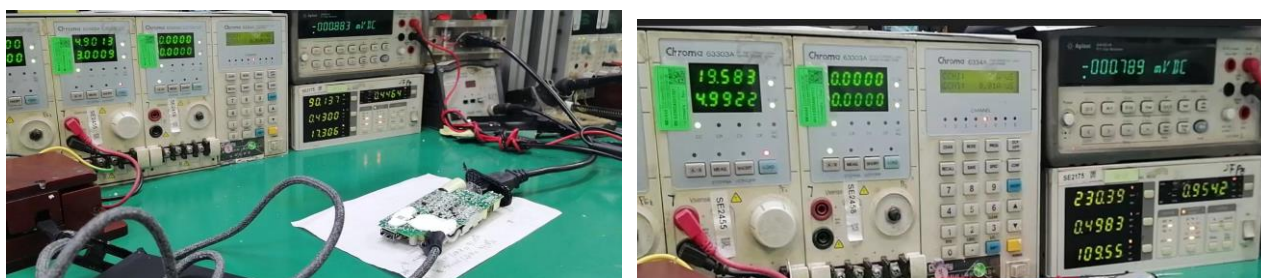
3.3. 更換 D4 零件,修復一次側 ground 銅箔.通電測試,輸出無異常.

Replace the adapter with a good D4 and repair the ground copper foil of primary side. The output of the adapter is normal.

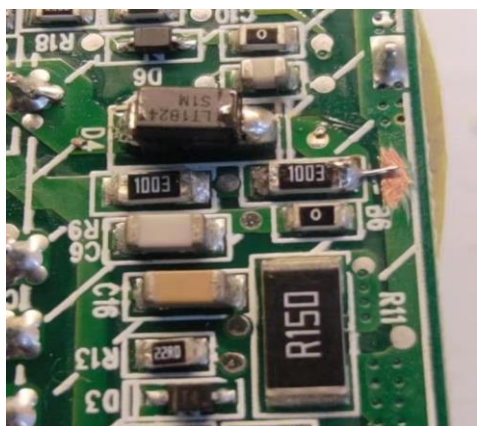
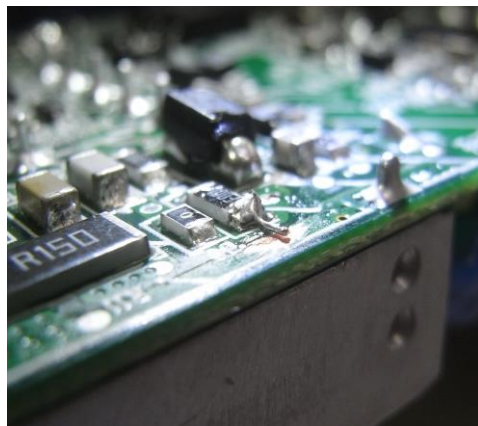
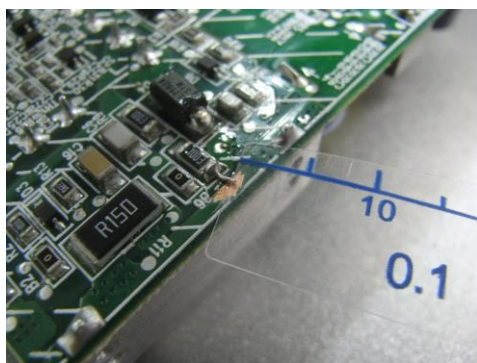
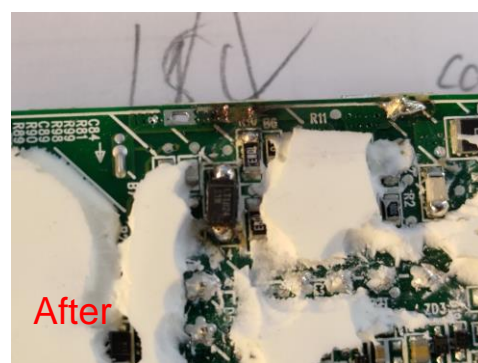
3.4.取產品進行模擬測試,將 R10 處(D4 負極)增加錫絲,使其到一次側 ground 銅箔距離 0.1mm.AC 輸入 220V(市電),觀察到 D4 fail.

Take the adapter for simulation test. Add tin wire to R10(D4 negative)to make the distance from it to the ground copper foil on the primary side is 0.1mm. AC input 220V, it is observed that the D4 fail.

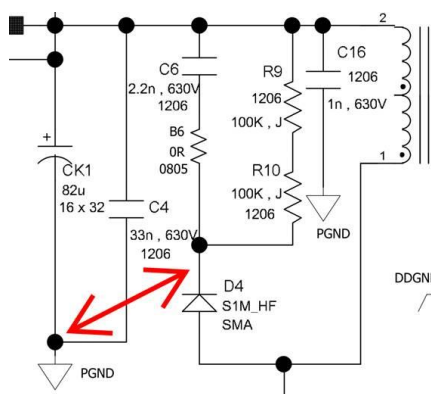
3.5.Arcing area 如下電路圖.Snubber diode R10 處銅箔(D4 負端)與一次側 GND 銅箔 0.4mm.

The arcing area is shown in the schematic below. The min clearance (mm) on this node to GND on current PCB is 0.4mm.

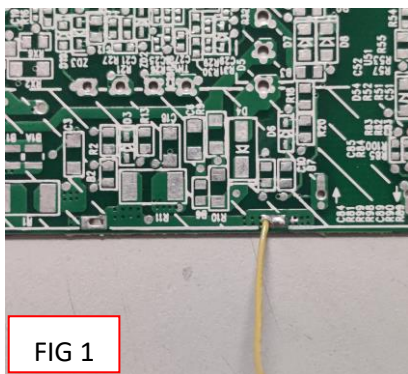
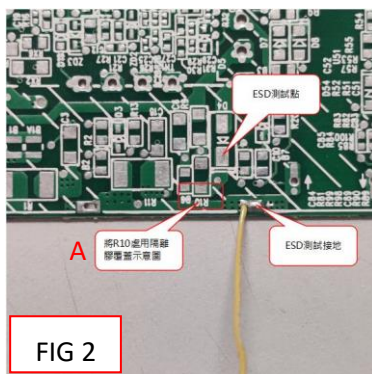
Test1: Without isolation glue.

Test result: ESD contact test at 4.2KV, arcing occurs at the area of the negative end copper foil of Snubber Diode D4 and the primary side GND copper foil.

Test2: Following test1. Cover the arcing area with isolation glue.(Refer to “A” in FIG 2)

Test result: ESD contact test at 5.5kV, arcing occurs at the same area.

Test3: Take a new PCB board. Cover the same area as Test2.

Test result: ESD contact test at 8KV, arcing occurs.

1. 驗證增加高壓絕緣膠來提升此兩 trace 的耐壓強度.

Verify that adding high voltage insulating glue improves the withstand voltage of the two traces.

Implement isolation glue immediately.
