Eight Discipline Report (8D Report)

To:	8D report No.:																								
From: Chicony Power Technology	RMA claim No.: N/A																								
CC :	Chicony Power P/N:																								
	Customer P/N:																								
Submit date: 2023/7/14	Product description: 65W PD																								
Receive date: 2023/7/24	Defect D/C or Lot No.:																								
Subject : 客戶 7/14 反應 sample 樣機測試殼溫 fail																									
D1.) 問題解決成員: Use Team Approach																									
主持者 (Team Leader) : Edward Ho 內部成員 (Internal Team Members): <div style="text-align: center;">RD: Will Wu</div> 外部成員 (External Team Member):																									
D2.) 問題說明: Problem Description:																									
(Note: Use who, what, when, where, why, how, how many to specify the Customer's problem.)																									
2023/7/14 客戶告知: 下面為 WM 機種殼溫測試數值，發現 Top 面 ΔT>40 度， Fail 請確認量測的熱點是否不是最 worst ， fail 的部分盡快釐清

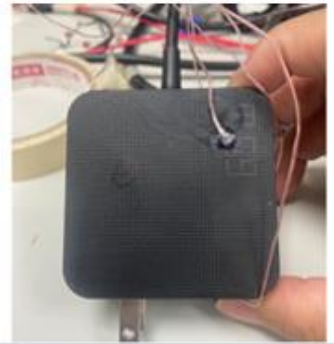
100V	ΔT	1. TOP	67.4	40.7	2. Right	63.3	36.6	3. Inlet	62.8	36.1	4. Output	62.3	35.6	5. Left	58.8	32.1	6. Bottom	65.1	38.4	Amb	26.7

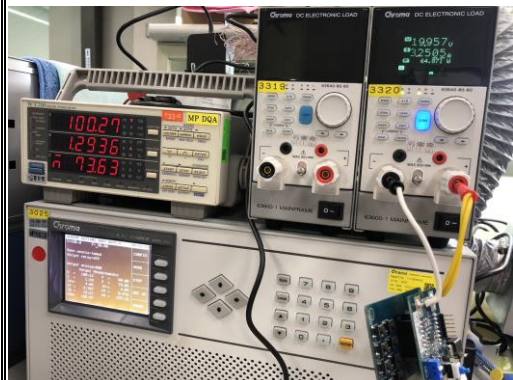
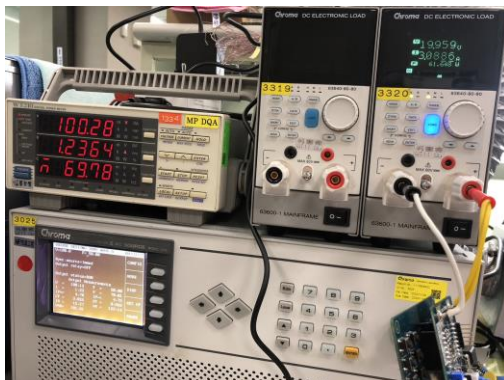
1. 樣機100%load、95%load效率測試，線端效率無異常。

100%load 效率: 88.1%

95%load 效率: 88.34%

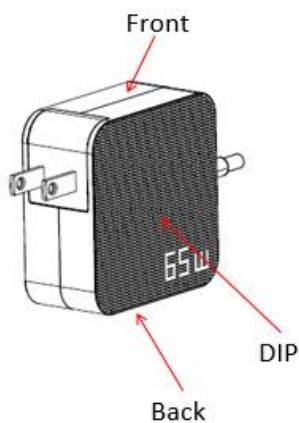
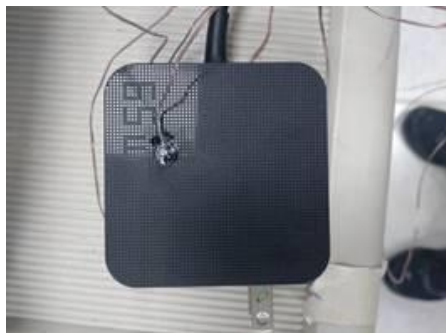
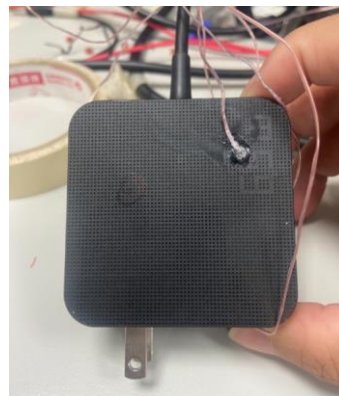
3. 殼溫測試結果，與客戶反應的狀況一致。

CPT 測試 fail 面 : SMD

客戶測試 fail 面 : Top

Location	Temp (°C)	ΔT(°C)
DIP	60.8	36.6
Front	52.2	28.0
AC	60.1	36.0
DC	61.8	37.7
Back	57.4	33.2
SMD	66.3	42.1
Ambient	24.2

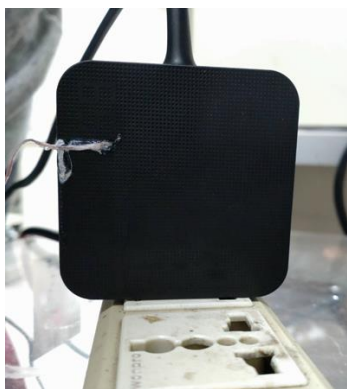
升溫線往水平方向架設

升溫線架設方式會影響殼溫的測試結果，差異約在 3.7 度左右。

依照結果推估原因，應該是升溫線的感測端垂直平貼熱源，又因熱空氣上升，導致升溫線偵測端受熱，所以偵測的溫度較高。

Original(線往Back side)		
Input Power	100V / 50Hz	
	69.66W	
Load	19.95V / 3.0872A	
	61.65W

Location	Temp (°C)	ΔT(°C)
SMD	60.3	35.3
Ambient	25.0

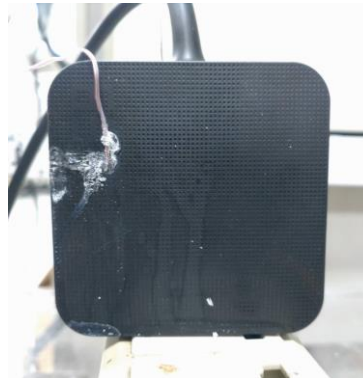
升溫線往垂直方向架設

另外固定升溫線點膠的膠量過多，也會造成升溫線偵測端產生積熱現象。

客戶(線往DC side)		
Input Power	100V / 50Hz	
	69.66W	
Load	19.95V / 3.0872A	
	61.65W

Location	Temp (°C)	ΔT(°C)
SMD	63.9	39.0
Ambient	24.9

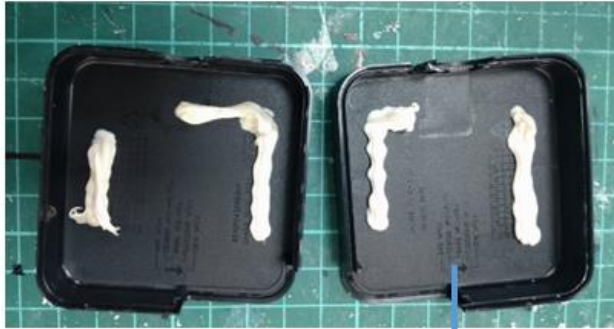
Original

Location	Temp (°C)	ΔT(°C)
DIP	60.8	35.3
SMD	67.6	42.1
Front	55.7	30.2
Back	63.7	38.2
AC	60.6	35.1
DC	60.8	35.2
Ambient	25.5

2. 解決對策：增加 Shielding 和 Case 之間點膠面積

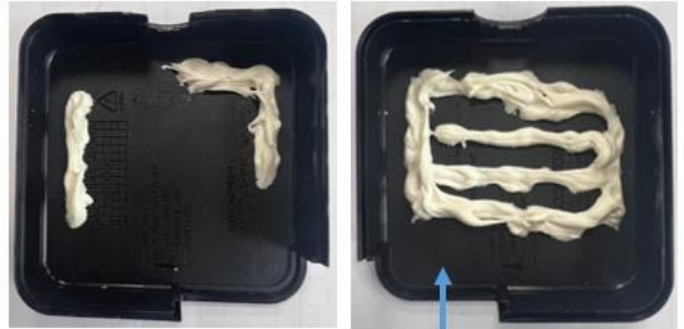
Improved

Only changed SMD side 點膠方式

Location	Temp (°C)	ΔT(°C)
DIP	57.7	32.9
SMD	59.3	34.5
Front	56.1	31.3
Back	59.7	34.9
AC	57.4	32.6
DC	62.1	37.3
Ambient	24.8

SMD Side 殼溫改善了7.6度

1. 增加 Shielding 和 Case 之間的點膠面積，並重新驗證殼溫，測試結果均符合客戶規格。
