## Eight Discipline Report (8D Report)

To: <b>Dell</b>	8D report No.: <b>xxxxxx</b>
From: : <b>Chicony Power Technology</b>	RMA claim No.: <b>N/A</b>
CC : Compal	Chicony Power P/N: <b>A100AP16P</b>
	Customer P/N: <b>GY21C</b>
Submit date: <b>2023/12/25</b>	Product description: <b>Dell Dark Star 100W</b>
Receive date: <b>2023/11/17</b>

**Subject : ESD Test No Output Power \*1pcs**

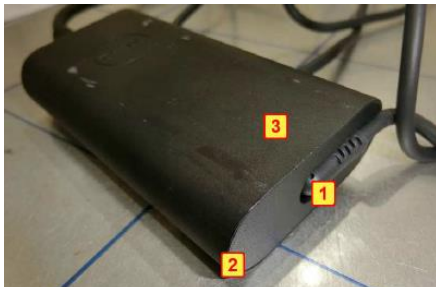
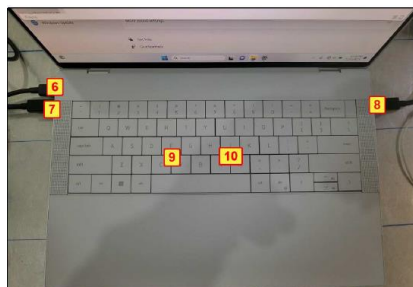
**Compal has feedback that Pista PVT validation with OB PD IC adapter air ESD test is fail at 8KV at point 3 & 6 (230VAC / 50Hz) with 100% failure rate**

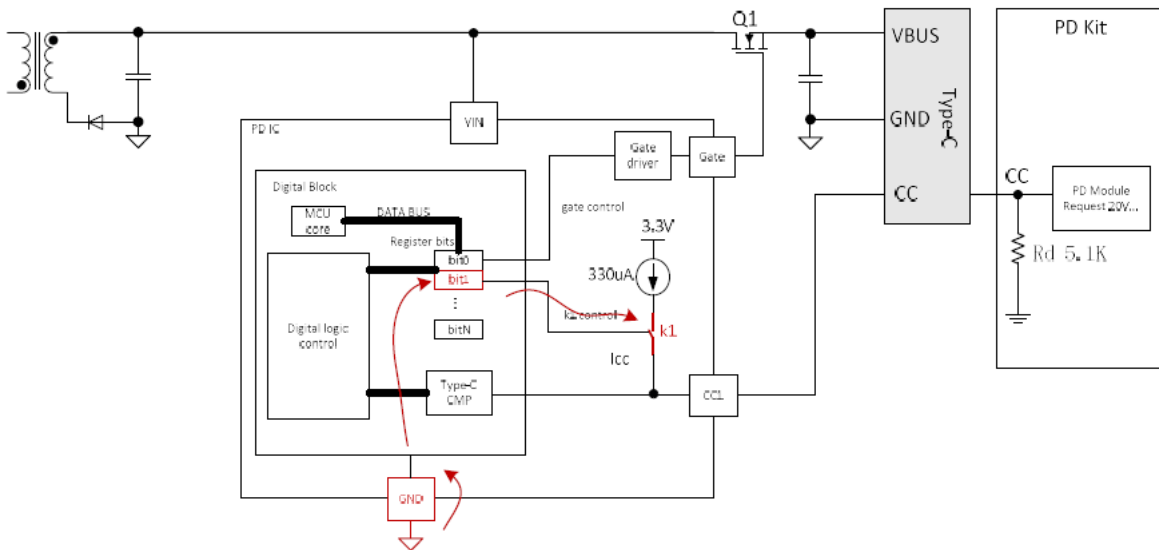
- **By tracking the PPID in our factory, this adapter passed all the test stations in the production line and no repair record.**
- **Reconfirm this adapter, it's latch of ESD test as same as customer's feedback.**
- **DC latch has been confirmed, but adapter cannot release latch by unplug the DC plug.**  
**(If it is primary side latch there is no sound heard and no 5V output voltage on blocking MOSFET, but it has been confirmed that both behavior observed thus it is not AC latch. )**
- **Since blocking MOS cannot be turned on, so the PD IC has abnormal**
- **The function related pin, VDD, VCC, CC, has been checked and there is only CC pin voltage is abnormal which is 0V.**
- **Through the IC circuit diagram, the CC pin voltage is controlled by bit1. The bit1 is abnormal checked by data log.**

The PD IC has been interfered by ESD energy through the ground loop during the test.

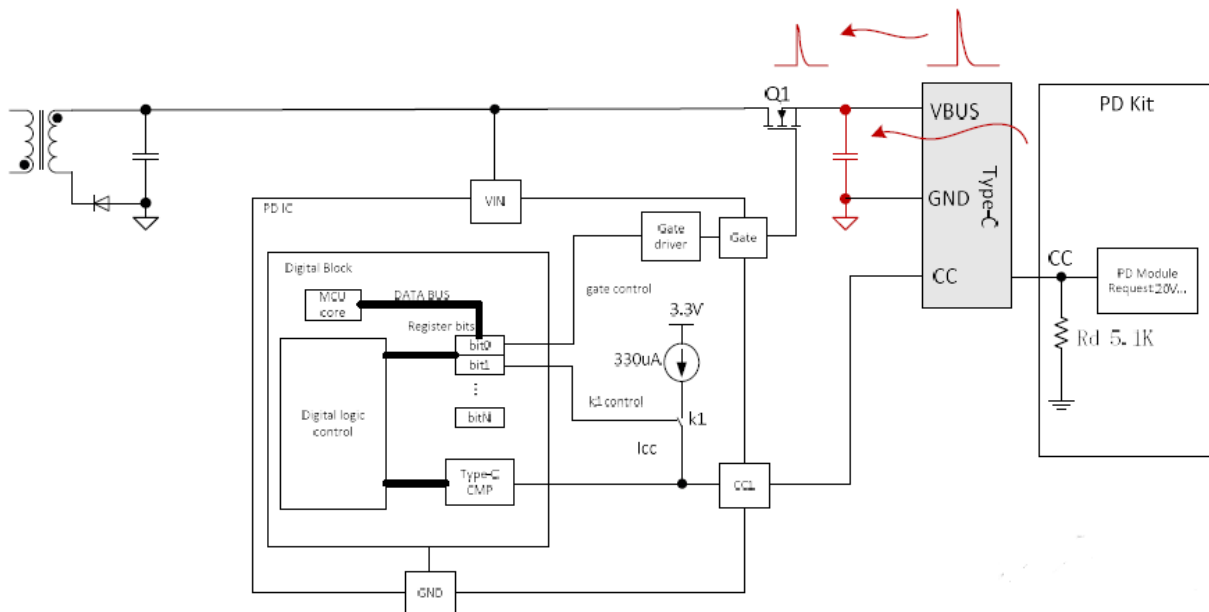
**Test ESD 16.5kV Pass**

**Increasing capacitance of C62 to 1uF to improve the capability of anti-interference.**
