Eight Discipline Report (8D Report)

To: Wistron	8D report No.: 20240301
From: : Chicony Power Technology	RMA claim No.: N/A
CC :	Chicony Power P/N: A090AP06P-DL01
	Customer P/N: H2FR2
Submit date: 2024/5/17	Product description: 90W Adapter
Receive date: 2024/3/19

Subject : noise issue * 2pcs

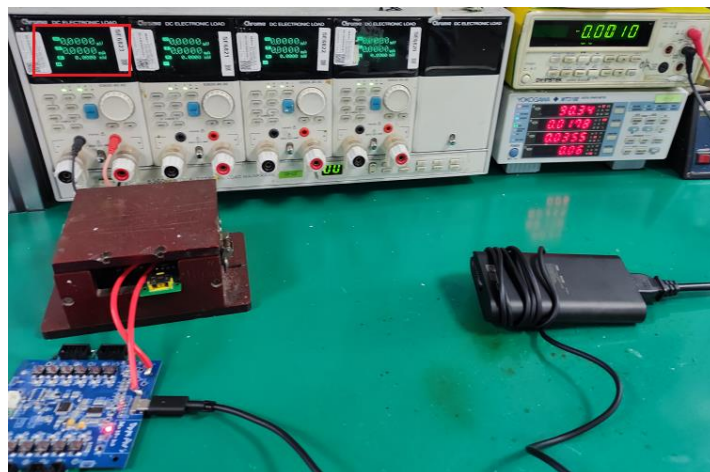
3. Turn on the adapter, all of them have no power that as same as customer feedback.(pic for reference)

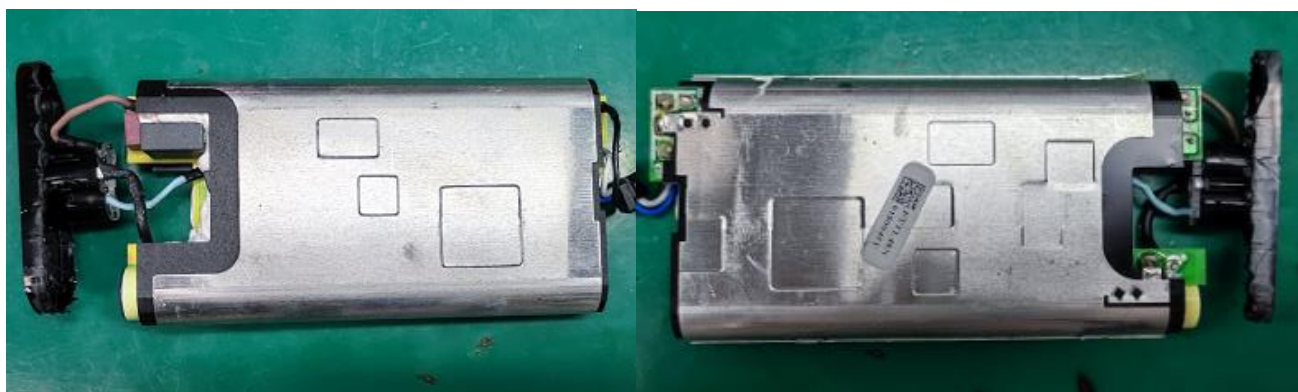
4. Open the case, also no abnormality was found.

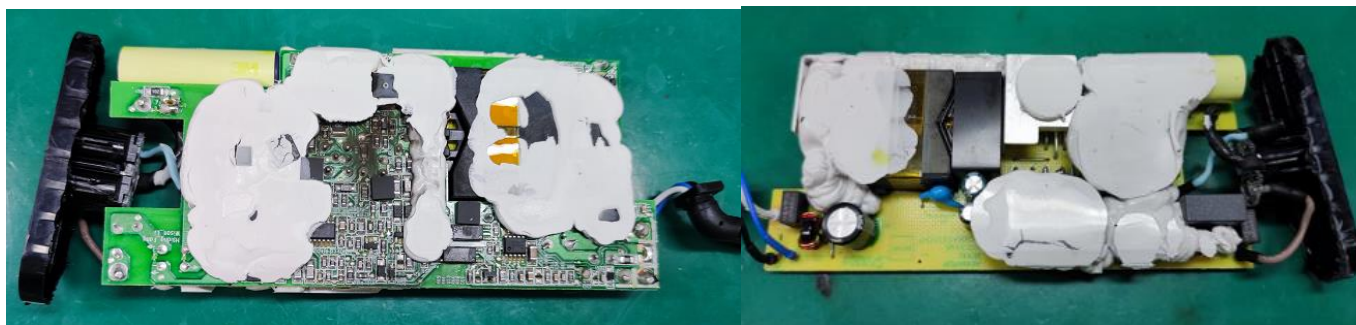
PPID:CN-0H2FR2-CH200-1BN-A0IK-X03

5. Remove the shielding then found the arc trace in below area.

PPID	Component loaction														
	Q2	U2	Q1	Q51	U52	BD1	R1A	R2A	R24	R07	R08	R02	D07	F1	L4
CN-0H2FR2-CH200-1BN-A0IP	short	short	short	short	short	short	open	open	open	open	open	open	open	open	OK
CN-0H2FR2-CH200-1BN-A0IK	short	short	OK	short	OK	OK	open	open	open	open	open	open	open	open	OK
CN-0H2FR2-CH200-1BN-00BL	short	short	OK	OK	OK	short	open	open	open	open	open	open	open	open	open

7. Repair the product by replacing good components then turn on the adapters , they can be power on normally.
 Burn in the samples for 24hours, they are still normal.

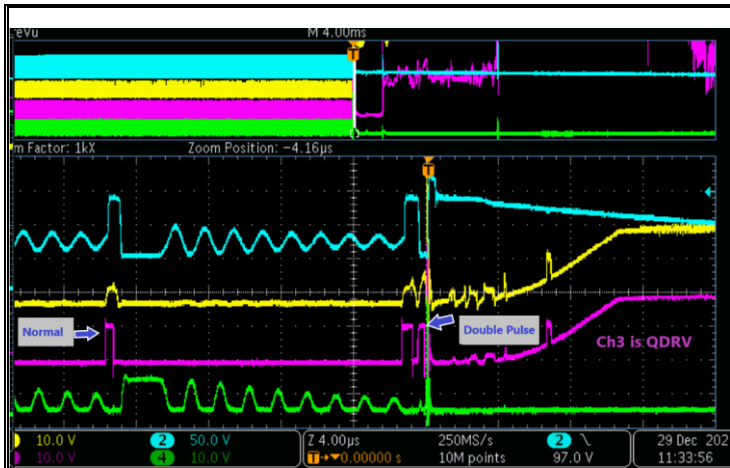
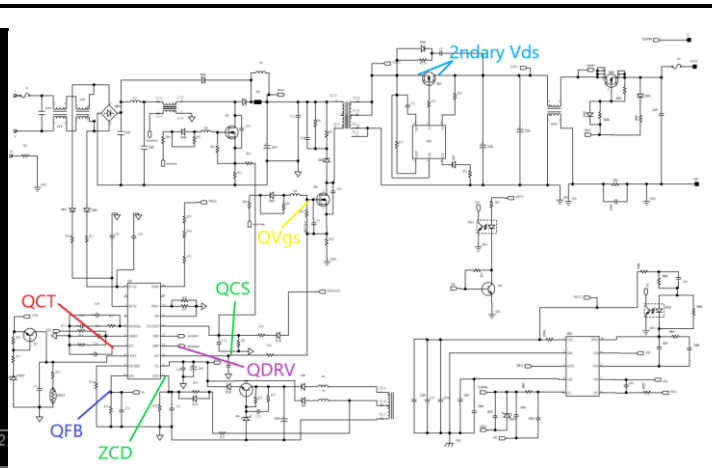
Ch1: QVgs Ch2: 2ndary Vds Ch4: QZCD

11. Measure the waveform when product damaged, double pulse of QDRV from PWM IC (U2) was observed.

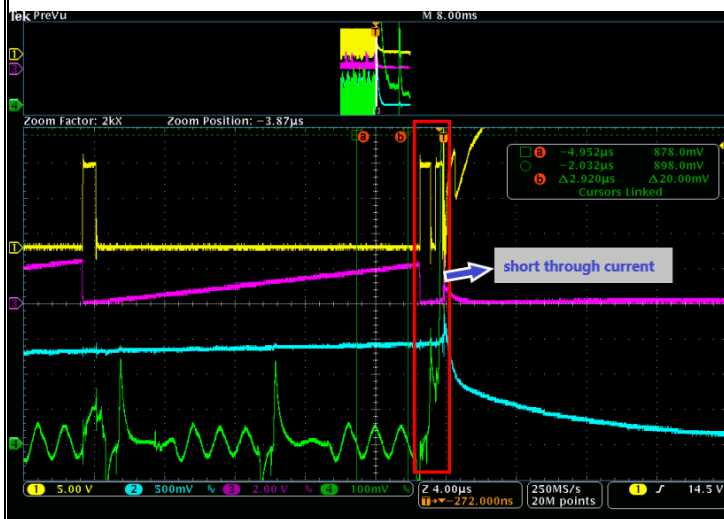
Ch1: QDRV Ch2: QFB Ch3: QCT Ch4: QCS

12. The double pulse bring a short through current that causes Q2 damaged.

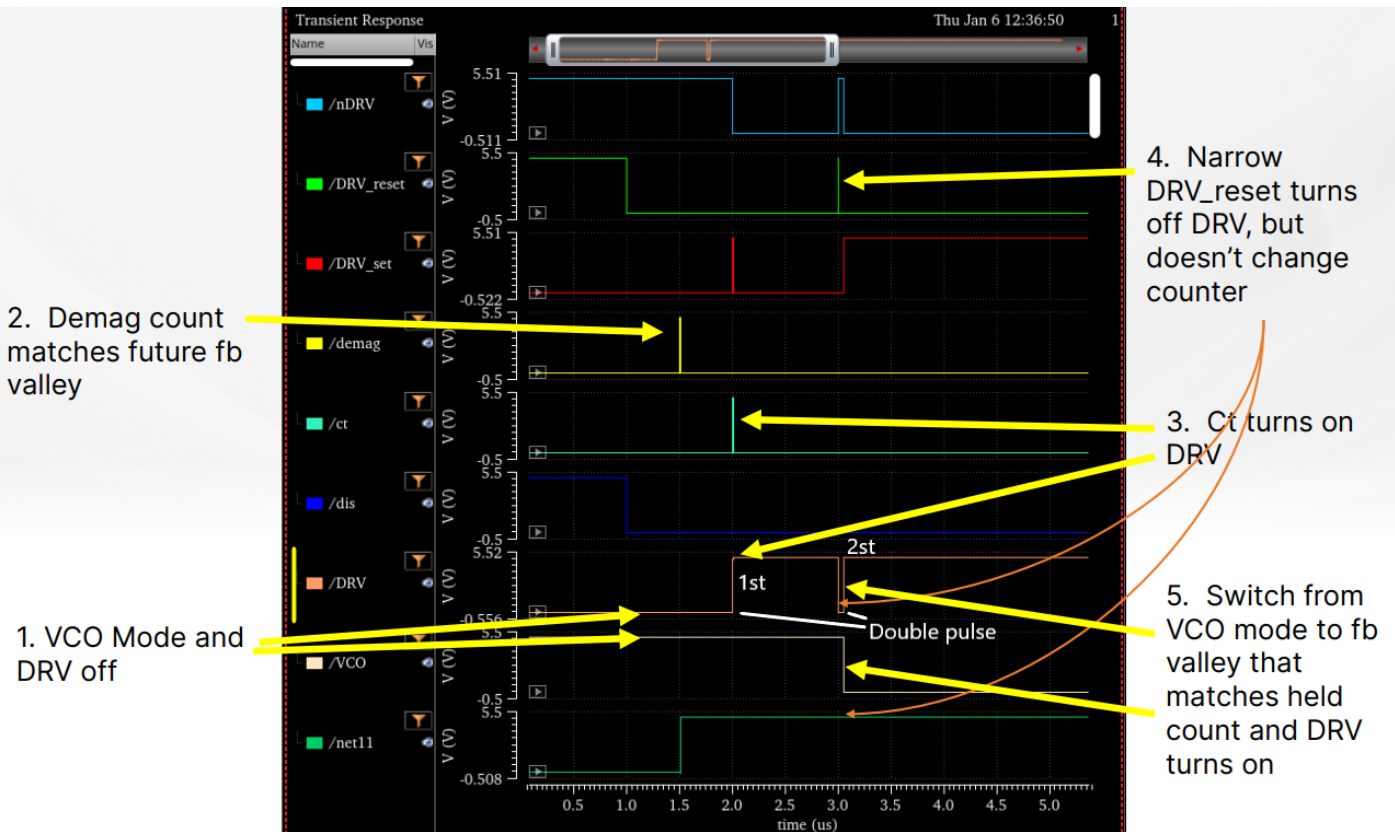
1. Send the defective IC to On-semi for further analysis and share the double gate waveform also. The designer found a blind duration (20ns~30ns) in counter and latch was observer after simulation

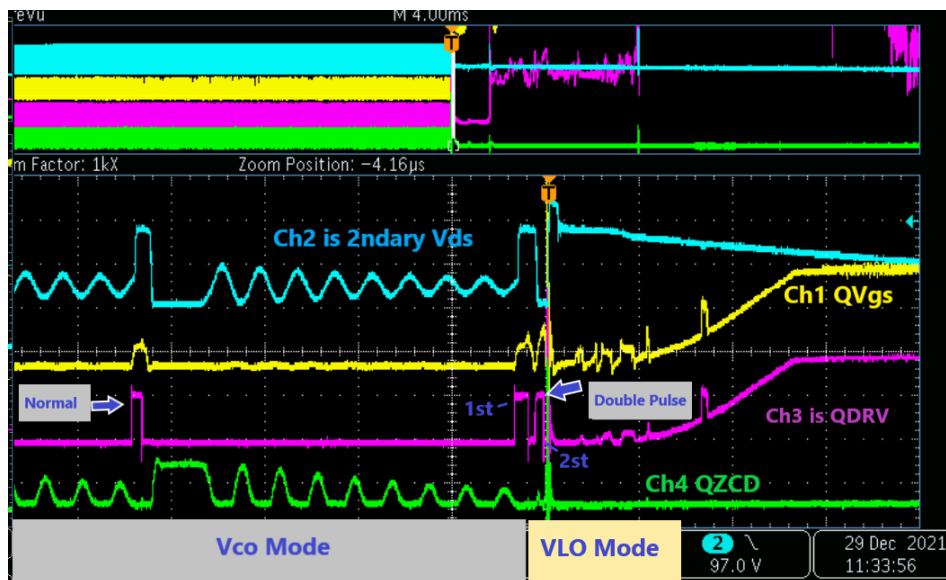
2.1 It is in VCO mode in the 1s DRV of this double QDRV.

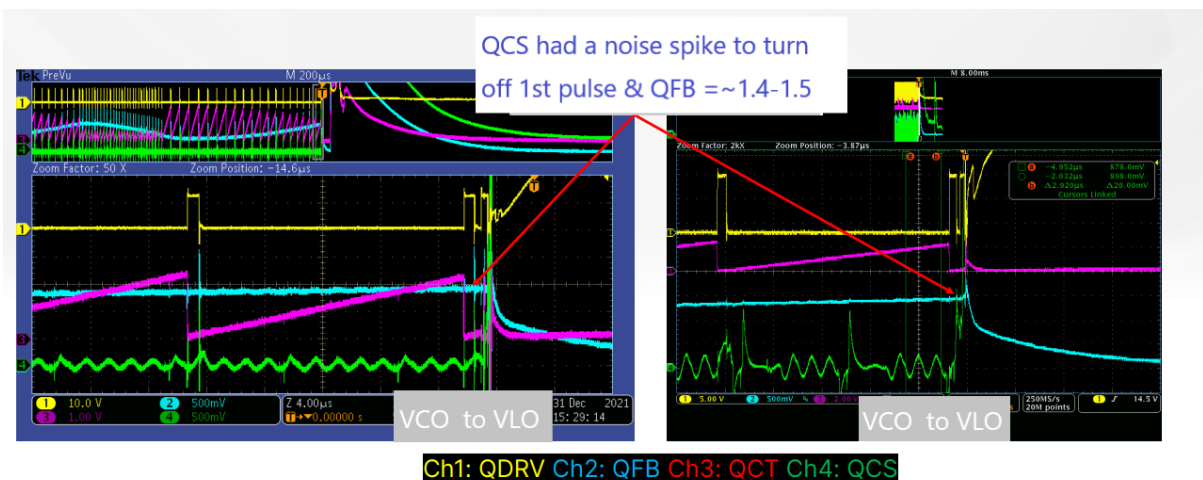
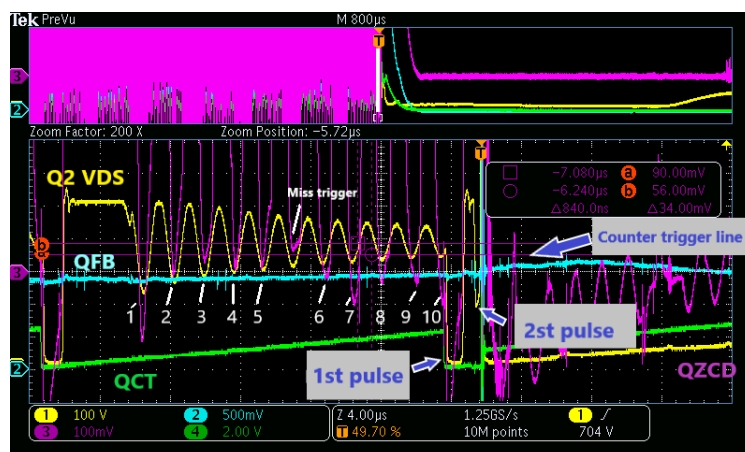
3. Compared fail waveform of Chicony, they all met above 4 criteria. (1. In VCO mode at 1st pulse. 2. Qcs had a noise (20ns-30ns) to turn off QDRV. 3. The counted number is 10. 4. The FB is 1.4-1.5V)

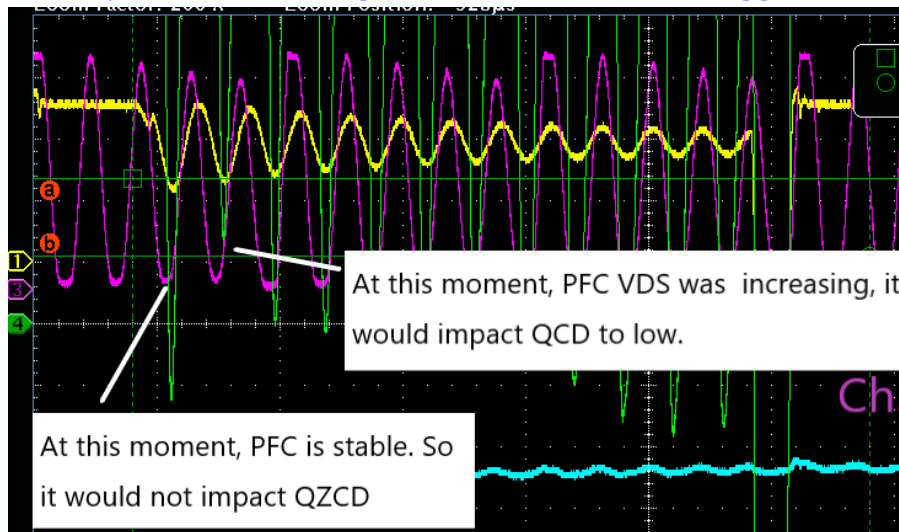
4. The miss triggered analysis: PFC VDS ring would cause ZCD miss triggered.

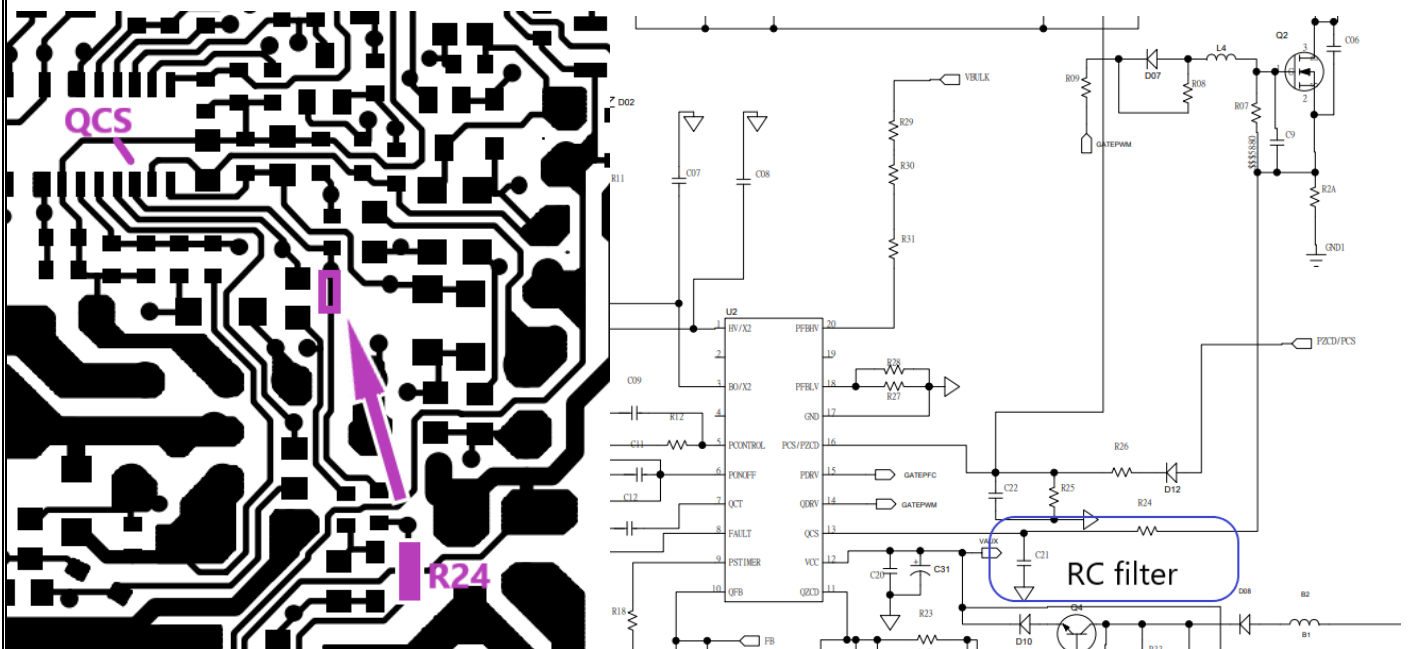
- ✓ Improved RC filter loop to improve noise coupling of QCS
- CPT reworked 20pcs finished goods by replacing R24 as below layout drawing and do burn in 48 hours with dynamic load. All sample are pass the burn in test.

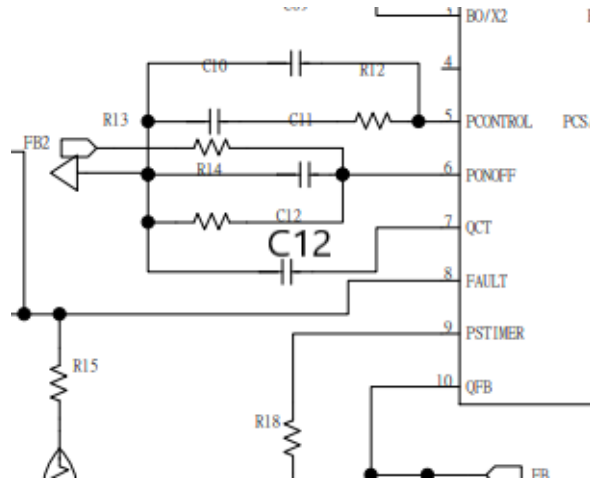
- CPT reworked 20pcs finished goods by replacing C12 from 150pF to 197pF (150pF + 47pF). To increase chance of counter at 10 and do burn in 48 hours test with dynamic load. All samples are damaged within 24hours.

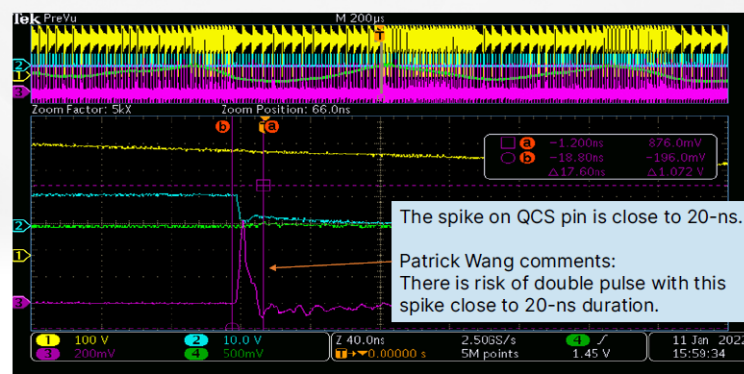
Chicony 90W PD – QCS spike

- ✓ **Waveform comparison between E5 PD 90W and E5 Non-PD 90W model, the waveform of non-PD model is cleaner than PD model that's why E4 90W can pass the test.**
