Eight Discipline Report (8D Report)

To:	8D report No.: 202206101
From: : Chicony Power Technology	RMA claim No.: N/A
CC :	Chicony Power P/N: A180A062P-AX01-X3
	Customer P/N: A20-180P1A
Submit date: 2022/6/10	Product description: 180W Adapter
Receive date: 2022/6/5	Defect D/C or Lot No.:
Subject : 客戶反饋系統驗證 ESD 測試時, PSU no power 共 3pcs	
D1.) 問題解決成員:Use Team Approach	
主持者 (Team Leader) : Cf Liu 內部成員 (Internal Team Members): <div style="text-align: center; margin-top: 10px;"> CQS: Jack Wang QE: Kitty Zhang MFG: Xiaohui Du PE: Yong Liu Sales: Justin Yu RD: Jacky Hsu </div> 外部成員 (External Team Member):	
D2.)問題說明:Problem Description:	
(Note: Use who, what, when, where, why, how, how many to specify the Customer's problem.) 2022/6/5 CPT has received 3pc no power PSU from Customer for analysis. 問題描述: 客戶測試 ESD 3pcs fail sample , 測試過程中出現聲響就沒輸出了, 測試條件 air +10KV ,次數 > 50 下 S/N:0A001-00265100141200039(D/C:2141) Version :A03 0A001-00265200124235848(D/C:2124) Version :A02 0A001-00265200124222244(D/C:2124) Version :A02

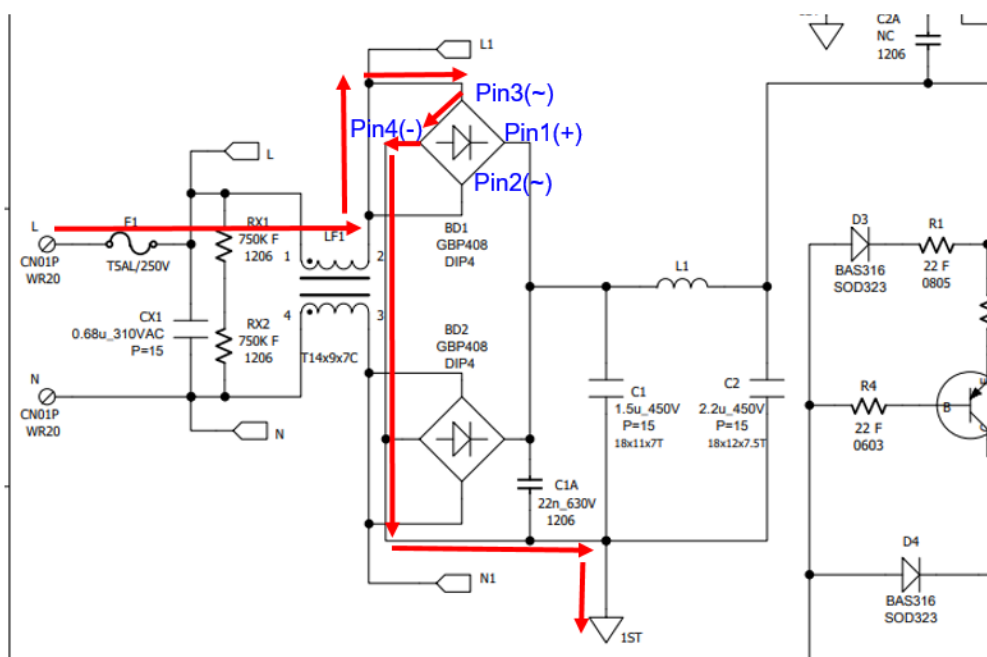
Schematic analysis

因為 BD1 Pin3(~) & 4(-) short, 導致 F1 OPEN, 造成 PSU 無電壓輸出

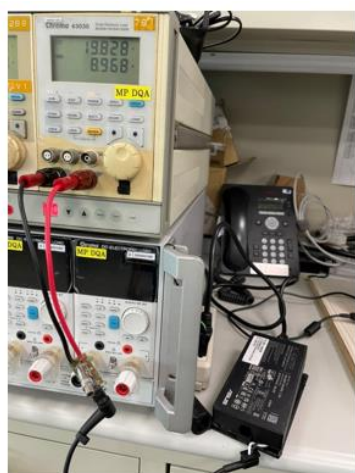
0A001-00265200124235848

更換 BD1 & Fuse 後，Full Load 開機正常
