## Eight Discipline Report (8D Report)

To: <b>Customer</b>	8D report No.:
From: : <b>Chicony Power Technology</b>	RMA claim No.:
CC :	Chicony Power P/N: <b>A035R004L</b>
	Customer P/N:
Submit date: <b>2014/09/04</b>	Product description: <b>Adapter 35W</b>
Receive date: <b>2014/09/01</b>	Defect D/C or Lot No.: <b>140628</b>
<b>Subject : Drop test fail 3pcs units(5 , 6, 7) , 由於 PCB &amp; T1 及 CASE 未固定好, 造成有元件損毀, 因此 Drop test 後發生有異音、failed hipot、輸出無法正常切換的問題。</b>

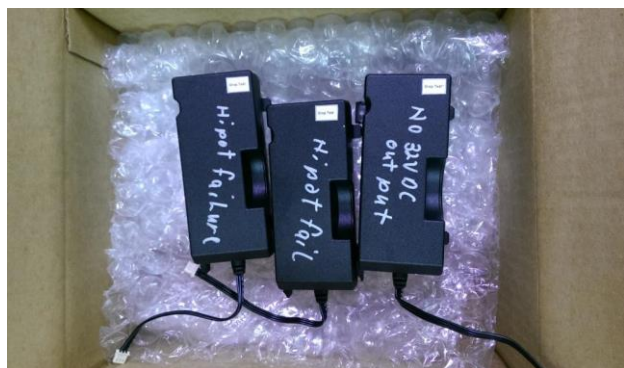
- 140628003BC7 - Rattle noted after Front/Right drop and failed hipot after drop.
- 140628003CC7 - Rattle noted and output voltage fluctuates after all drops and failed hipot after drop.
- 140628003DC7 - Movement noted prior to drops; output is 12V, cannot switch to 32V after drop.

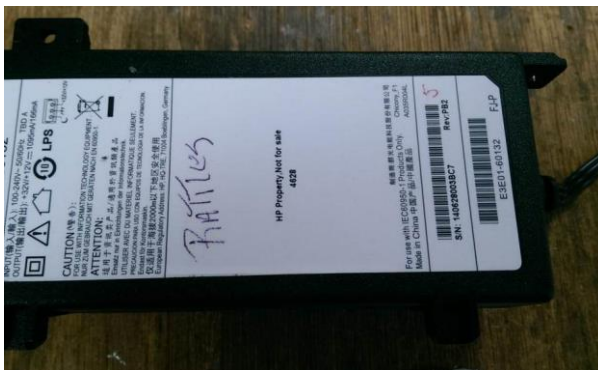
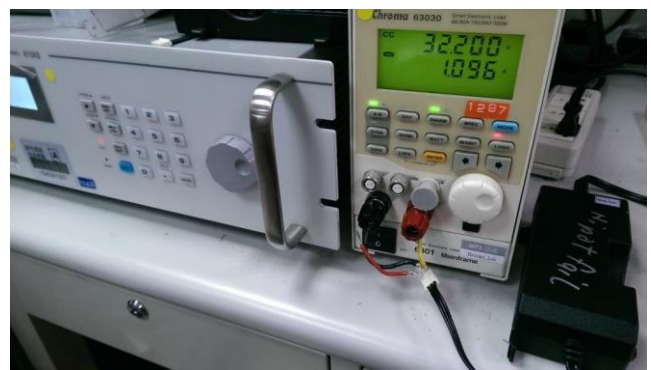
#### 1. S/N:140628003BC7

We checked the Hi-pot test and the result is fail. The output voltage regulation is passed.

The return unit has rattling sound.

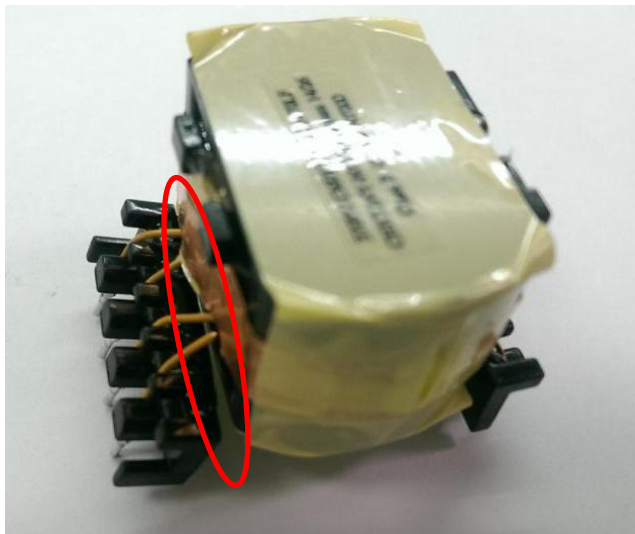
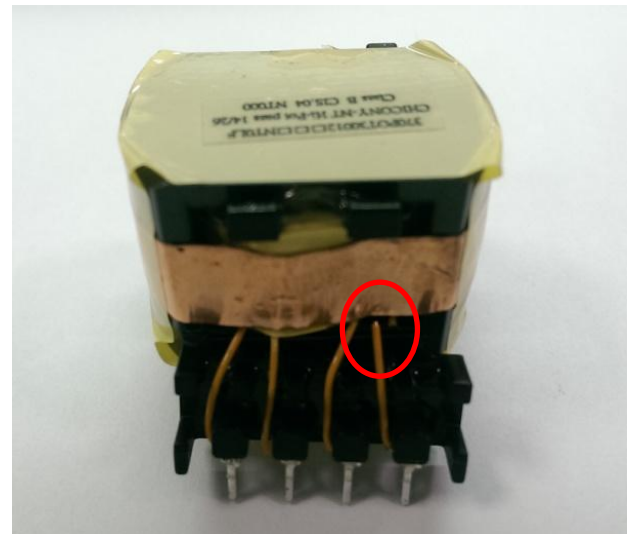
After open the case, we observed the transformer bobbin was broken and the secondary winding (N4) of transformer had snapped. The copper shield (S1) is soldered to pin 1 and pin 1 is connected in primary side ground. The copper shield (S1) is pasted on the core so the transformer core was defined primary side then if the triple wire of secondary snapped, it will cause arc due to the insulation of triple wire was broken (insulation is insufficient). We found the root cause of hi-pot was an arc between copper and the secondary winding of transformer during the hi-pot test. The secondary windings (N3 and N4) are connected in parallel thus there is still output even if one winding is broken.

1. Add gray glue between the primary of transformer and CK2. Amount of glue is 2g

2. Add gray glue between secondary bobbin of transformer and PCB for fixing the transformer. Amount of glue respectively: 1g.

4. Add epoxy rubber between bobbin and core of transformer to avoid transformer bobbin broken.

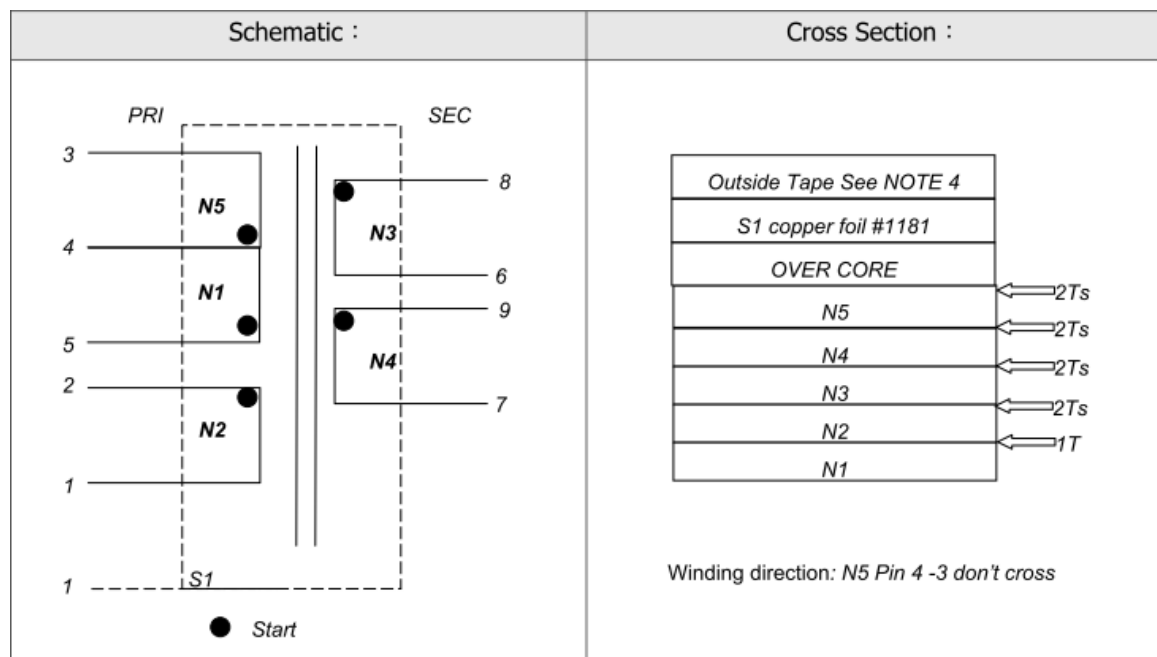
The transformer schematic as below:

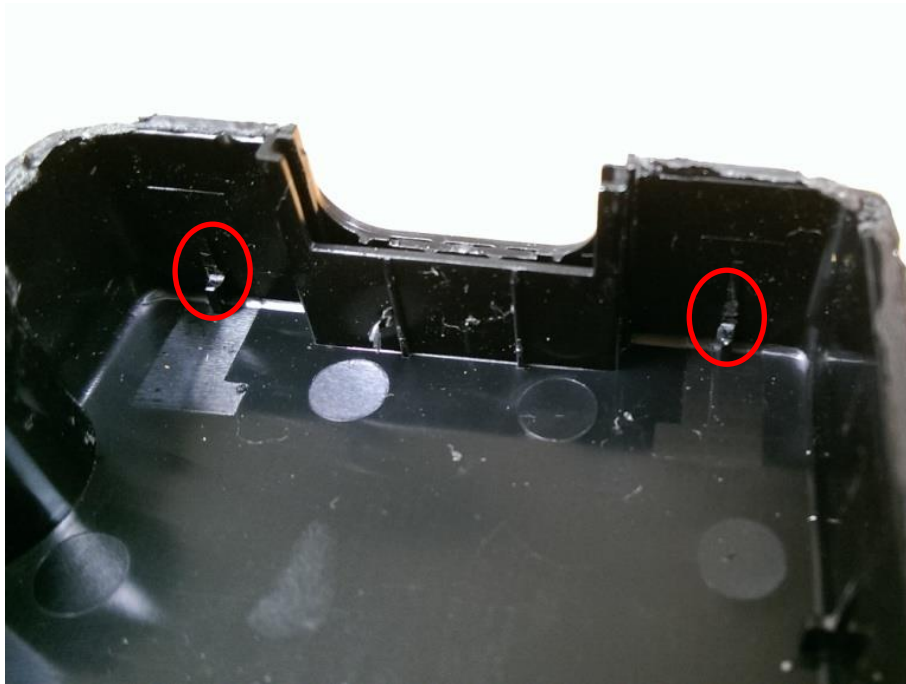
The slot to hold the PCB are cracked on the chassis, and the PCB cannot be fixed in the case. It's the reason why the unit is rattled.

3. Add gray glue between PCB and case to avoid the rattle sound. Amount of glue respectively: 1g.

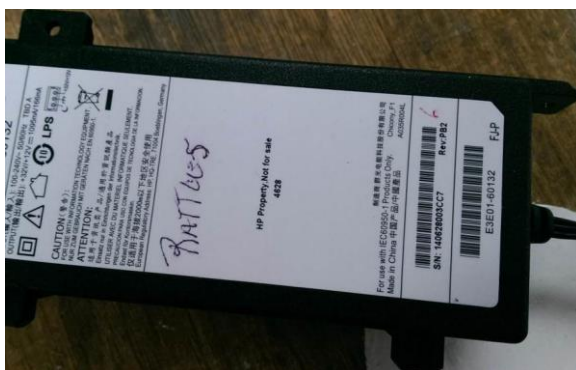
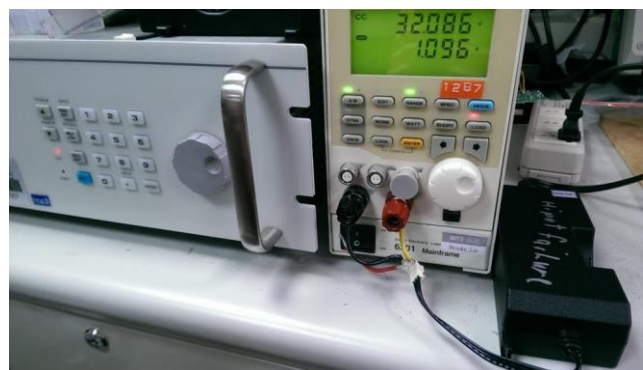
## 2. S/N:140628003CC7

We checked the Hi-pot test and the result is fail. The output voltage regulation is passed.  
The return unit has rattling sound.

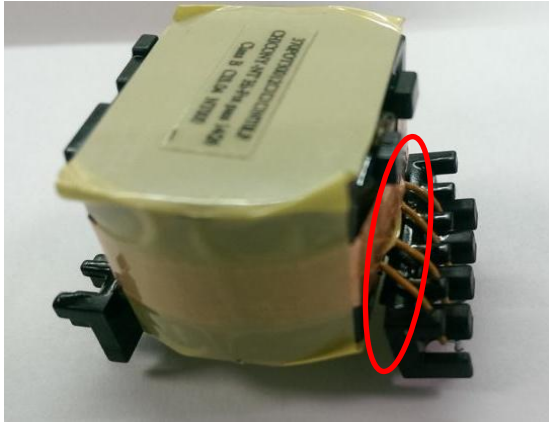
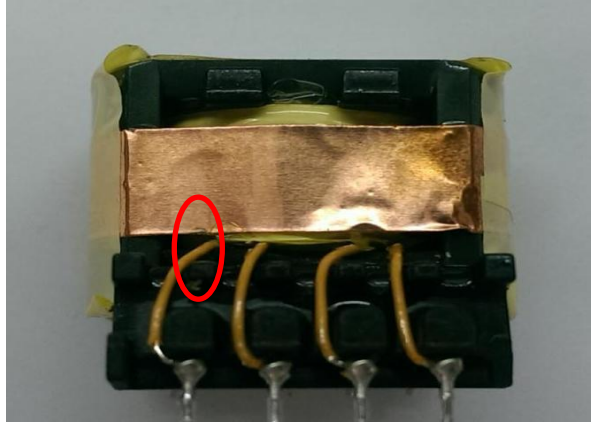
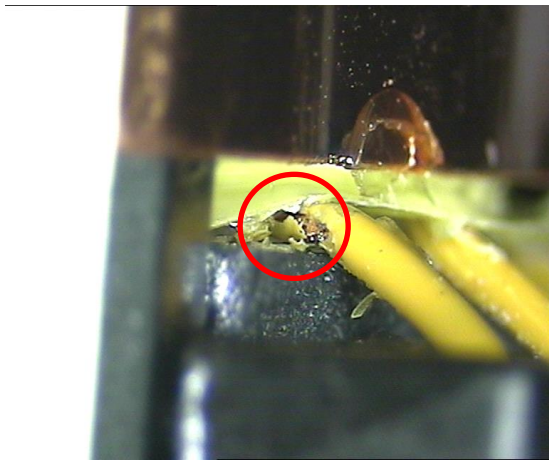
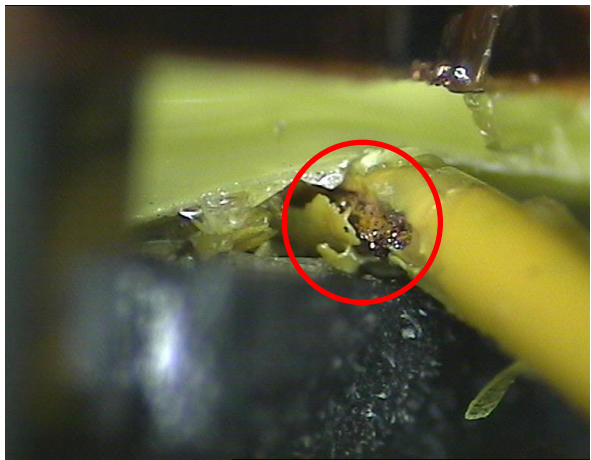
After open the case, we observed the transformer bobbin was broken and triple wire winding (N3) was breakage. The copper shield (S1) is soldered to pin 1 and pin 1 is connected in primary side ground. The copper shield (S1) is pasted on the core so the transformer core was defined primary side then if the triple wire of secondary was breakage, it will cause arc due to the insulation of triple wire was broken (insulation is insufficient). We found the root cause of hi-pot was an arc between copper and the secondary winding of transformer during the hi-pot test.

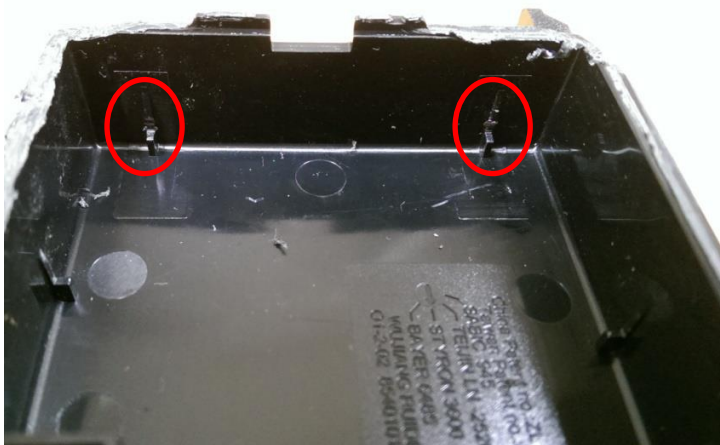
The slot to hold the PCB are cracked on the chassis, and the PCB cannot be fixed in the case. It's the reason why the unit is rattled.

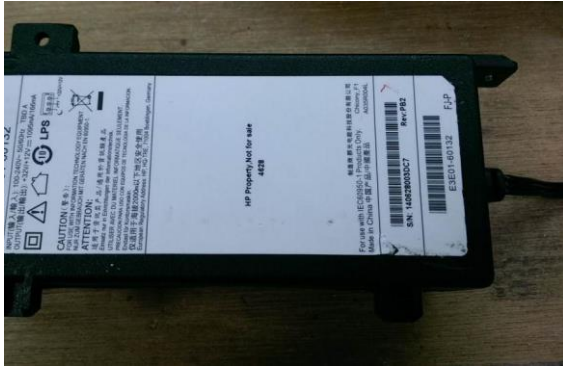
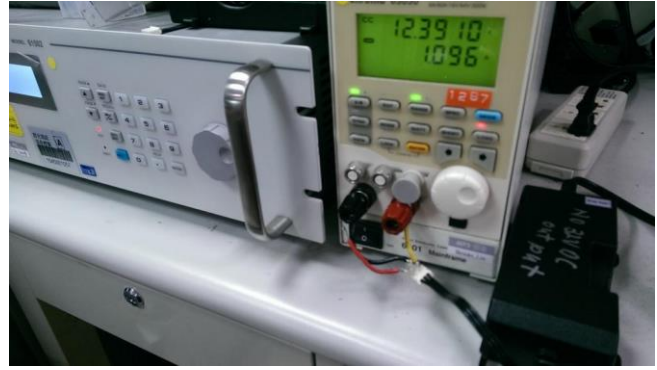
### 3. S/N:140628003DC7

We checked the Hi-pot test and the result is passed. The output voltage was 12V only.

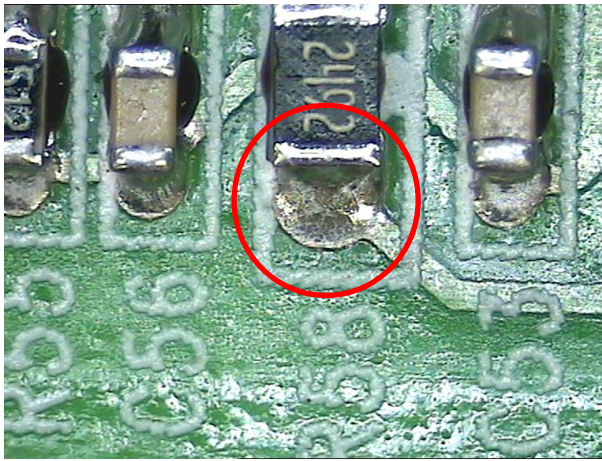
Before re-welded

After open the case, we observed the transformer bobbin was broken and the R58 may has cold soldering after drop test. The output voltage was normal 32V after we re-welded the R58.

5. Definition MOI for soldering inspection
