Eight Discipline Report (8D Report)

| To: Customer | 8D report No.: CPD0507 |
| Submit date: 2013/5/17 | Product description: 15W adapter |
| Subject : No power*2pcs (poor manual soldering caused the pins of the connector to fail). | |

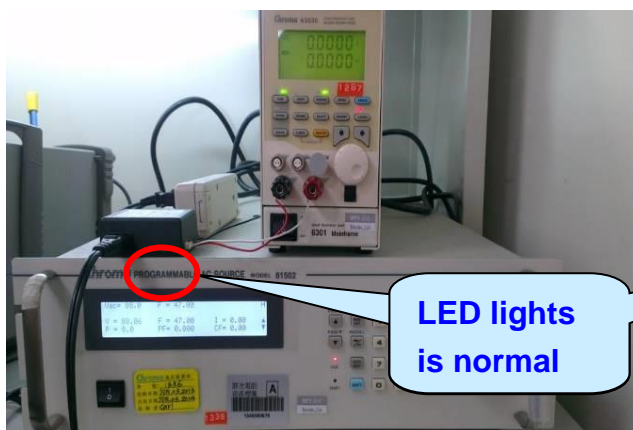
1. CPT checks the output voltage at full load and no load. The test result was no output voltage, but the LED lights normally.

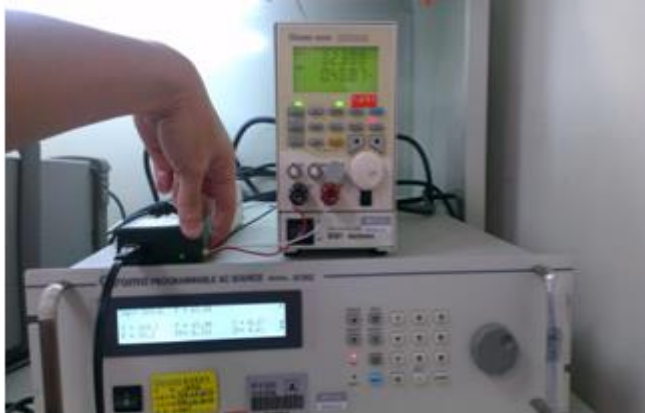
269V/Full load

2. We touched the output connector and the output voltage is normal at full load and no load:

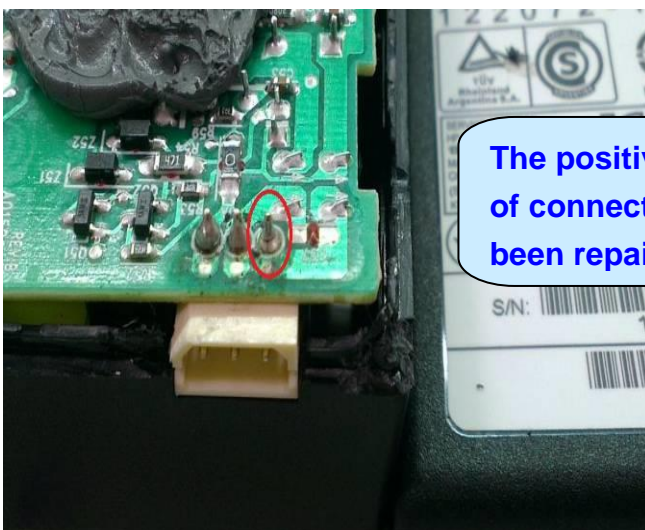
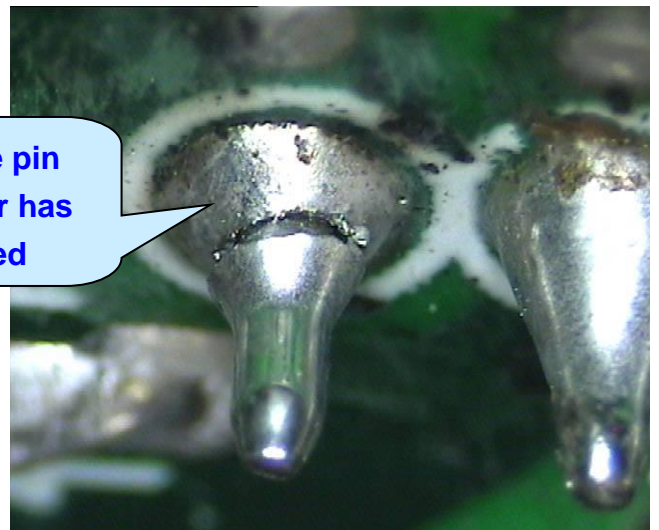
3. Open case & Visual inspection found the positive pin of connector has been repaired.

The positive pin
of connector has
been repaired

From above analysis and tracking by our production records know that these two units are repaired due to case issue. We should change the cases for these two products when open case the connector is damaged, so we also change the connector and do soldering manually. Poor manual soldering caused the pin of connector soldering fail.

1. **Quarterly Soldering training and exam to the operator in Touch Up” station to enhance the capability of the operator.**

2. **We plan to use a fixture when soldering the connector, in order to fix the connector well when repair.**

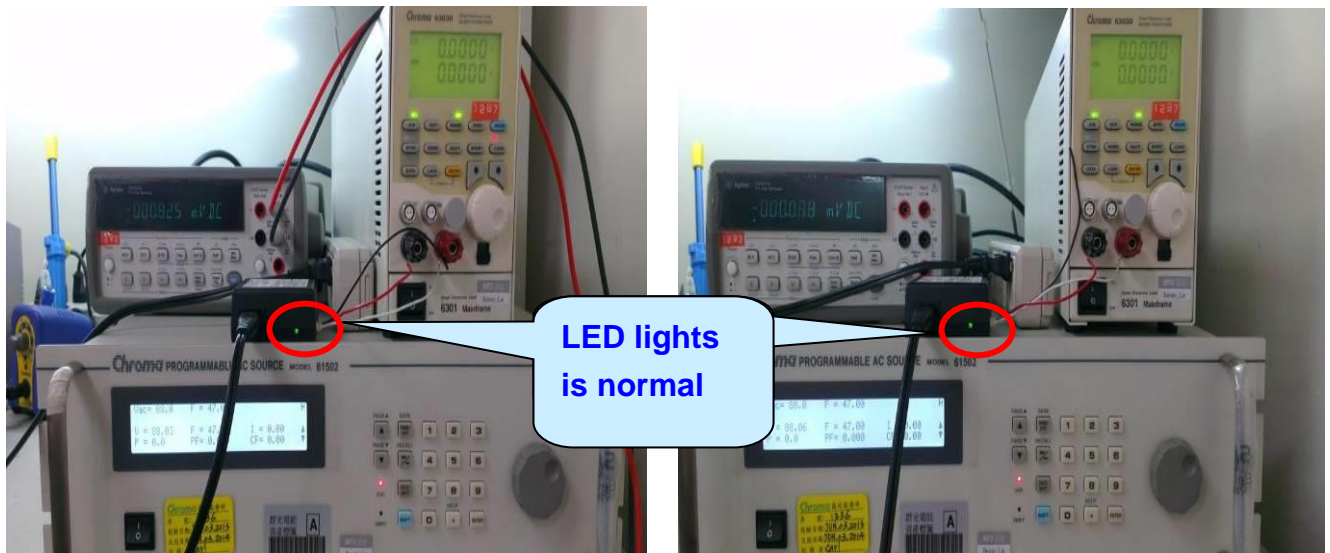
1. CPT checks the output voltage at full load and no load. The test result was no output voltage, but the LED lights normally.

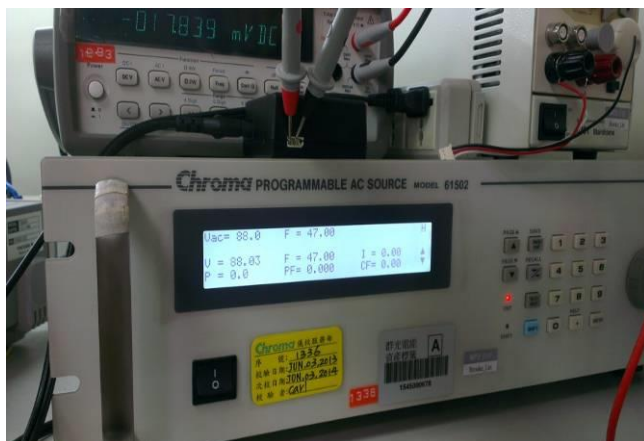
88 V

2. We measured the positive pin and the negative pin of connector that it is no output voltage.

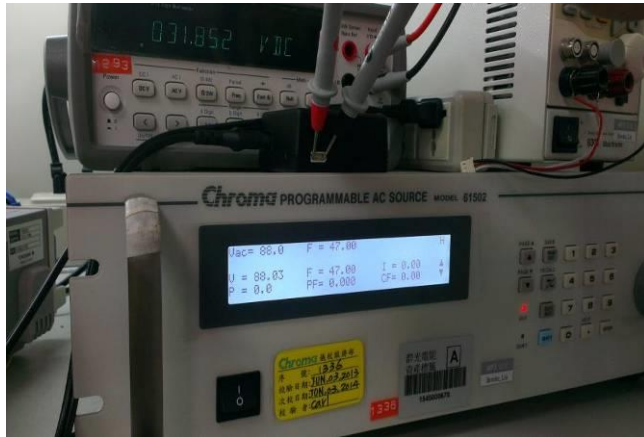
88V

3. Then checked the positive pin and the control pin of connector that the output voltage has 31.85V.

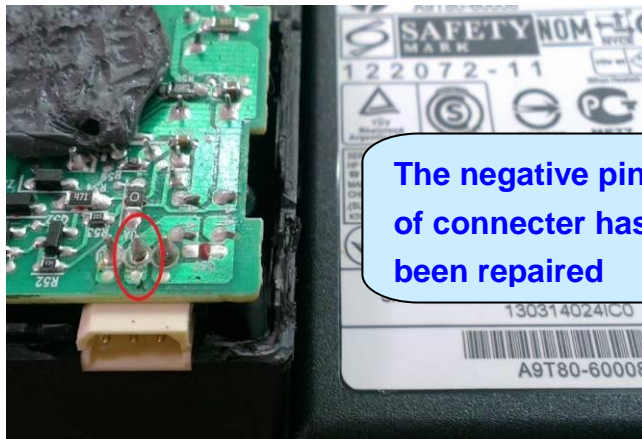
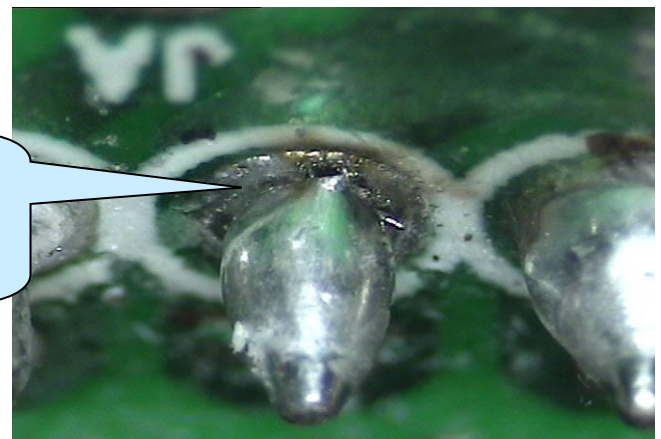
4. Open case & Visual inspection found the negative pin of connector has been repaired.

The negative pin of connector has been repaired
