Durability of rammed earth walls exposed for 20 years to natural weathering

Q.B. Bui^{a,b}, J.C. Morel^{a,b,*}, B.V. Venkatarama Reddy^c, W. Ghayad^{a,b}

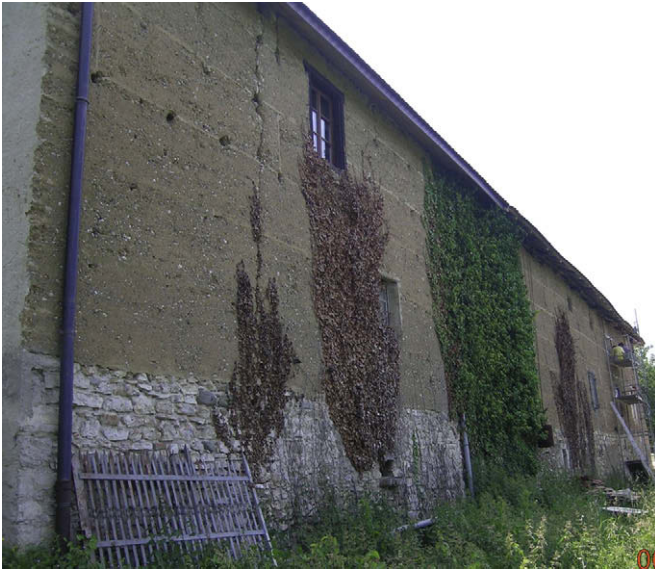
Fig. 1. 150 years old rammed earth house in the South East of France.

The erosion measurement of the unstabilised rammed earth in this “in-situ test” confirms the durability of traditional unstabilised rammed earth walls which have undergone more than 100 years of weathering (the old house in Fig. 1 is an example.)

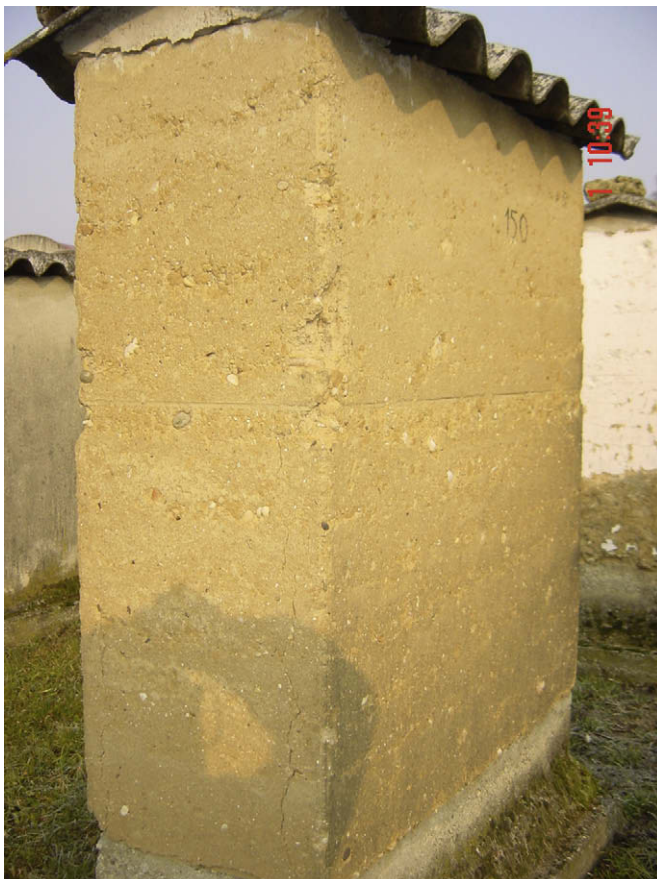
4.1. SMRE reference wall no. 15 (Fig. 6)

This is the rammed earth wall stabilised with 5% by dry weight of hydraulic lime. After 20 years, there are no significant changes in rammed earth quality except for some minor vertical cracks at the wall edges which have occurred during construction when the formwork was removed. This type of crack can be prevented by proper construction detailing.

Fig. 6. Reference wall no. 15 made with SMRE (stabilised rammed earth).

The stabilised rammed earth wall no. 15 has not eroded much in general (2 mm erosion on average) and the erosion between the upper and lower parts is not very different.

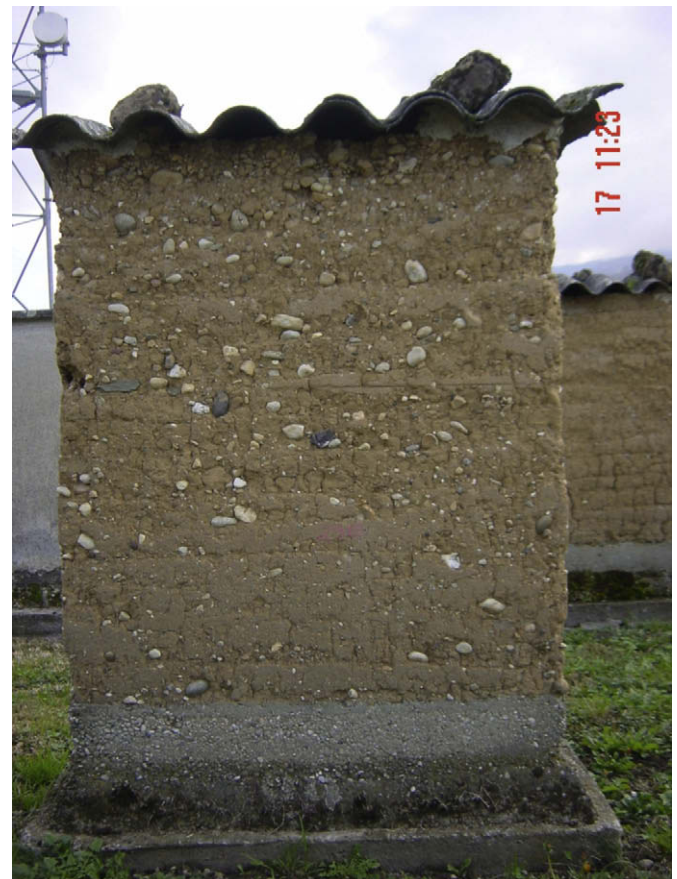
4.2. MRE reference wall no. 29 (Fig. 7)

This is the unstabilised rammed earth wall made with the mix soil (MRE). On this wall, half of the southern side is left without any protection as a reference (right half on Fig. 7) and half of the northern side is protected with impregnation (as indicated in Fig. 4). Wall 29 is relatively eroded when compared with wall 15, especially the top two-thirds of the wall portion.

Fig. 7. Unstabilised reference wall no. 29 made with MRE (unstabilised rammed earth), facing West.

The unstabilised rammed earth wall no. 29 (FRE) presents an aspect rather difficult to understand: the top and middle parts of the wall (i.e. the upper two-thirds) have eroded more, while the lower part of the wall has not eroded as much. This may be attributed to construction defects in the walls such as non-uniform compaction across the height. Moreover, the top portion of the walls is protected by the small roof covering on top, yet shows more erosion. It should be noted that wall no. 29 has one half with no protective layer and that the other half is painted by impregnation. It is possible that the painted part has obscured its behaviour by encouraging water retention [14].

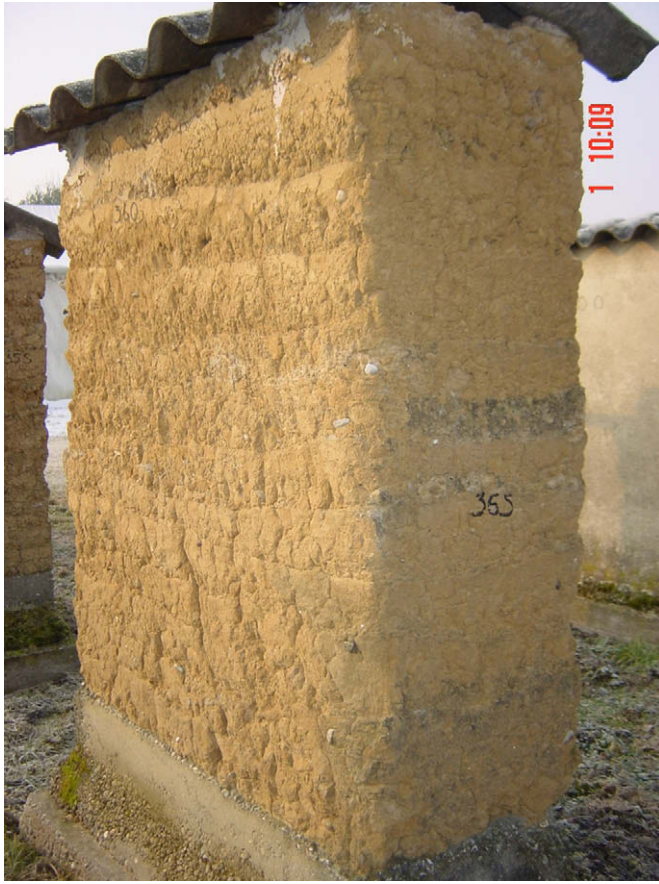
4.3. FRE reference wall no. 36 (Fig. 8)

This is the unstabilised rammed earth wall made with fine soil (FRE). The multiple cracks on the rammed earth surface appeared the day after installing the wall due to considerable shrinkage (as discussed earlier), but they are located only on the wall surface.

Fig. 8. Reference wall no. 36 made with FRE (unstabilised rammed earth).

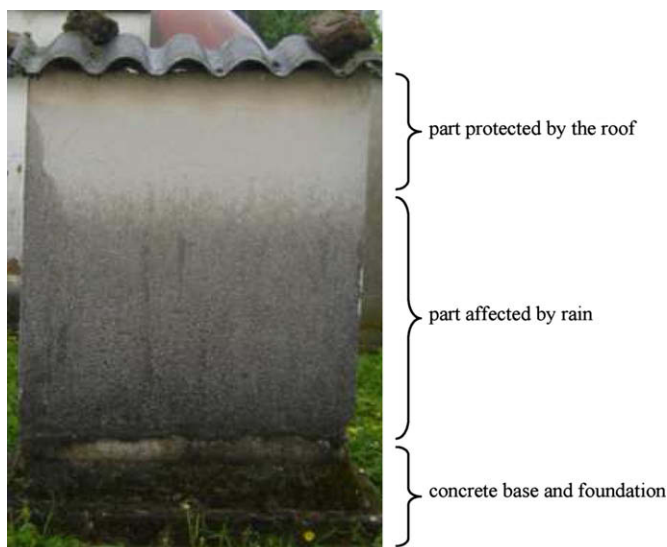
For most of the walls we observe that the upper part is less eroded because it is protected by the roof. Fig. 12 present an example of the roof role. In rain, the roof protects only the head and a part at the top of the wall. From Fig. 13, we measure that only about 20% (218 mm) of wall height is well protected by the roof. The eroded area covers 2890 mm² at the top and 6213 mm² at the lower part in the case of wall no. 36 and 2196 mm² at the top and 2446 mm² at the lower part in the case of wall 15. However, this is not true for wall no. 29, and the reasons are discussed later.

Fig. 12. The photo shows the wall no. 23 in the rain. The roof protects only the head and a part at the top of the wall against the rain.

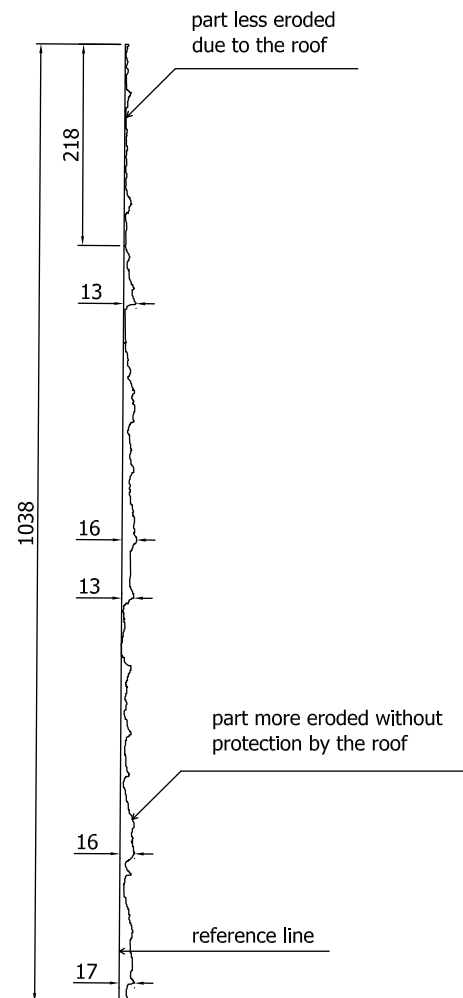
and compaction energy under the rammer during the compaction. Therefore, the lower part of each compacted layer is more eroded (Fig. 13). This heterogeneity causes variations in eroded volumes across the height of each compacted layer. Because of this heterogeneity, horizontal profiles cannot be used to estimate the eroded material of a wall. Only vertical profiles will be used because they pass through the entire height of the wall. With the vertical profiles, the heterogeneities due to the different zones (well protected by the roof or not) and the diversity of density in each compacted layer can be avoided to obtain the representative depth of erosion.

The top portion of the unstabilised rammed earth wall no. 36 (MRE) is well protected by the roof and shows very little erosion compared to the unprotected part (Fig. 13).

Fig. 13. Difference of erosion between upper and lower parts of wall 36 presented on a vertical profile.
