MPW 2 Silicon Bring Up Status

SWT Frame Location	SLOT	PROJECT	ID	Git Repo
B1	7	yiFive	20007	Link

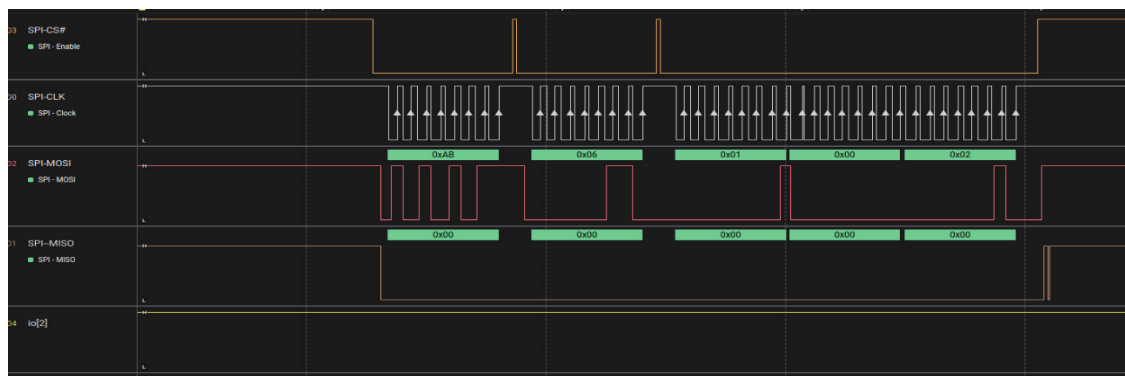
Baby Step-2: Remove the User Reset and check SPI init request at externa SPI Interface

Logic analyzed capture at User Flash I/f (GPIO 35:30] shows that SPI IP has initiated the flash memory initialization sequence and this matches with expected simulation waveform.

1. User Power hook-up to SPI core is good.
2. Clock to SPI clre is good.
3. SPI reset removal working through wishbone i/f.
