MSP430F2132 Device Erratasheet

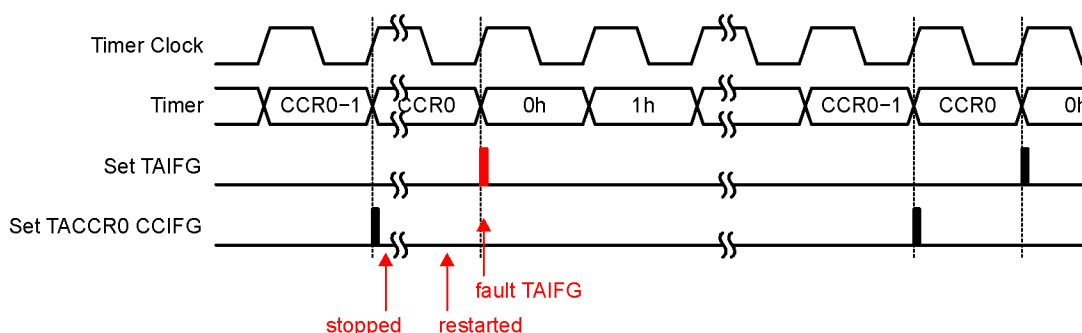
TA21 *TIMER_A Module*

Function TAIFG Flag is erroneously set after Timer A restarts in Up Mode

Description In Up Mode, the TAIFG flag should only be set when the timer counts from TACCR0 to zero. However, if the Timer A is stopped at TAR = TACCR0, then cleared (TAR=0) by setting the TACLR bit, and finally restarted in Up Mode, the next rising edge of the TACLK will erroneously set the TAIFG flag.

Workaround None.
