Report

Clive House

Internal Reference ID: PRONE455DN

The Survey/Specific Defects Inspection

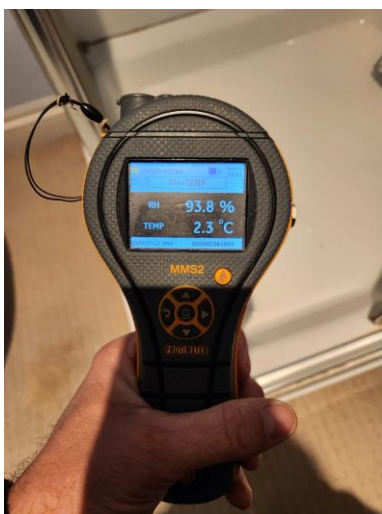
High humidity

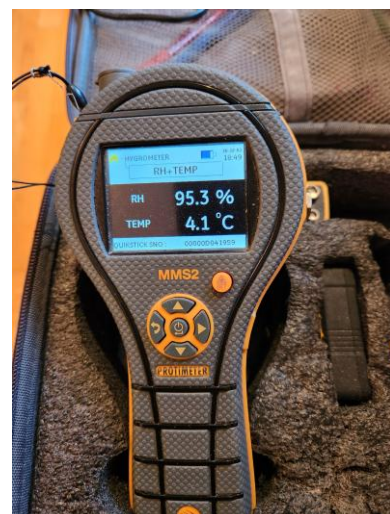
High humidity

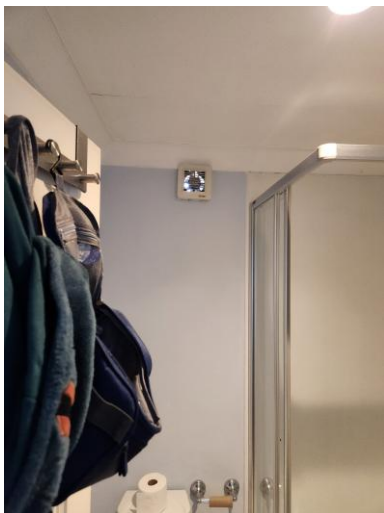
- Leaks from the ensuite. Plumber to inspect and repair. Main bathroom has caused staining to the ceiling below.
- Lack of ventilation and air movement with the property have caused elevated humidity levels within the building.
- It is our opinion that the current extraction and ventilation at the property does not provide sufficient ventilation

Current extraction

- Supply & install of 1 loft mounted Dryair PIV **heated** unit(s) to the following area(s):
 - Loft area and diffusor to hallway ceiling
- Supply & install of 5 Humidistat trickle and boost fan(s) to the following area(s):
 - Upgrade the existing extractors at the property
- Supply and installation of any necessary electrical fittings/ducting/trunking/grilles required for the installation of Fans/PIVs/Vents (if applicable).
- Supply of labour and materials to treat and kill black mould (Any area treated for mould may require you to redecorate).

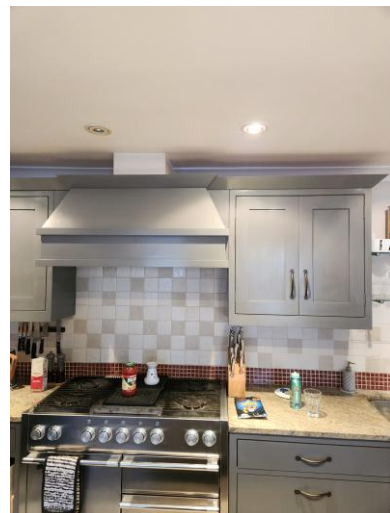
Current extraction

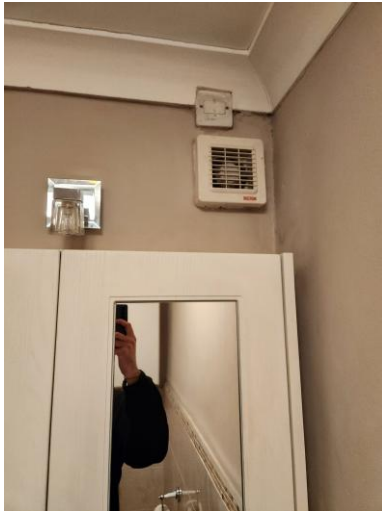
Current extraction

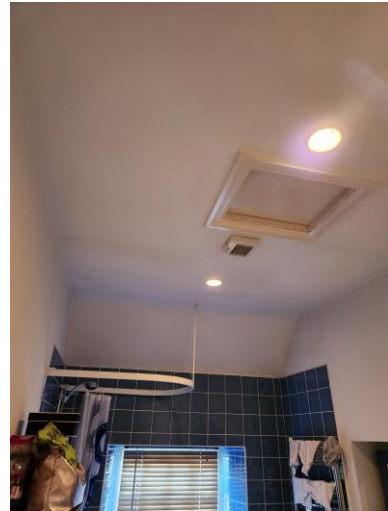
Current extraction

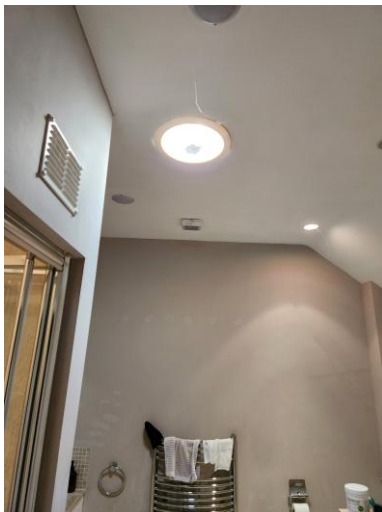
Current extraction

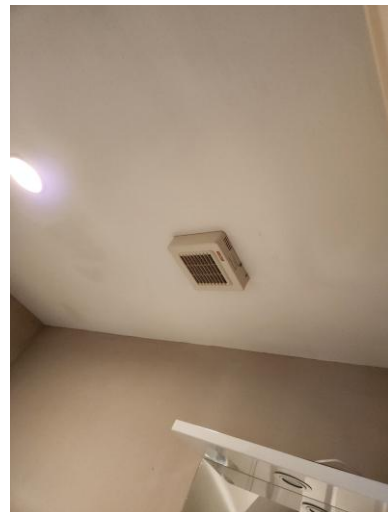
Current extraction
