Report

Keli Martin
57 Stothard Street
Jarrow
Tyne & Wear
NE32 3AN
Internal Reference ID: MAR57NE323AN

The property is a: Mid terrace ground floor flat
The property is constructed of : Brick slate
The property was built approximately : 1900s

Wet Rot Survey

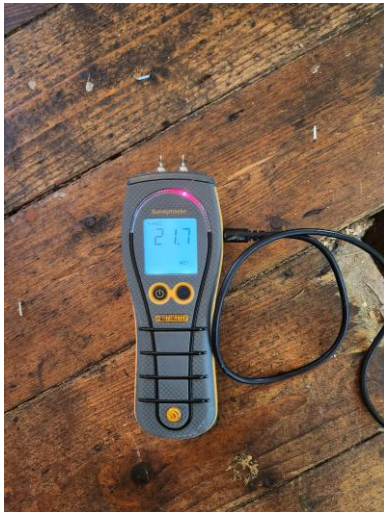
Moisture reading taken from the timbers was recorded as: 21 %.

High moisture

- An attack of wood rotting fungi, this was identified as wet rot
- Rotting timbers were also suffering from an infestation of woodboring weevil (*Pentarthrum Huttoni*)
- A high W/W moisture level to the floor timbers, this was due to a lack of ventilation to the sub floor voids

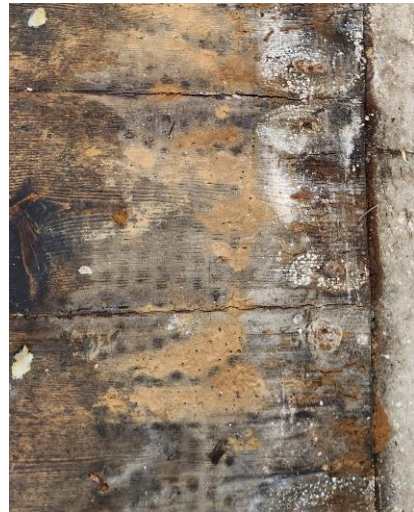
Rot and woodboring insects

We have quoted to carry out a guaranteed solution to resolve the issue fully this will come with a 25 year guarantee. The floor is bouncing, and I was able to push a screw driver through the joist ends, both rot and woodboring insects were noted. I would advise to carry these works out rather than trying to patch sections of the floor up, this has already been done in areas of the floor and would only be a short term fix. Apply liquid membrane to the concrete hearth as this was damp. Install wayrock sheet flooring to the living room.

- Timber replacement and treatment for wood rot and woodboring insects, as per the schedule specified below.

- Open up affected area.
- Cut out affected timbers as per SOP.
- Treat all remaining timber cut ends as per SOP.
- Treat all masonry as per SOP.
- Clean out and sterilise joist wall socket holes as per SOP.
- Treat all surfaces of new timbers with dual purpose application.
- Treat and endwrap joists as per SOP.
- Install and fix new timbers as per SOP.
- Bag up and remove debris to safe external area.
- Clean and tidy site.
