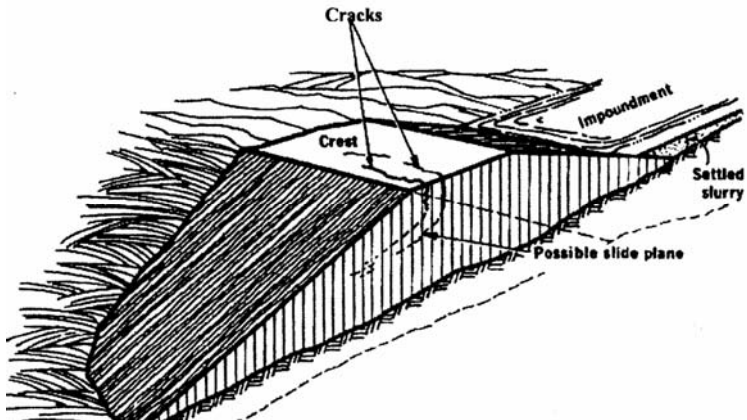
Figure 5: Cracks on Embankment Crest
