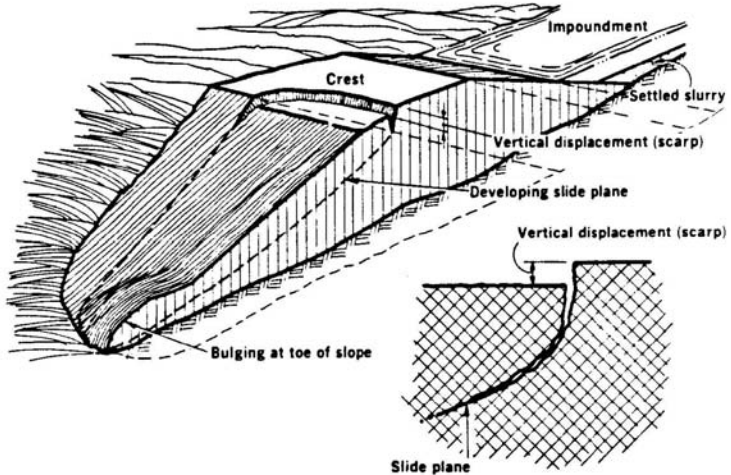
Figure 4: Surface sloughing of material on embankment.
