Railway Accident Investigation Unit

INVESTIGATION REPORT

**Rock fall at Plunkett Station, Waterford,
31st December 2013**

RAIU Report No: R2014 – 006

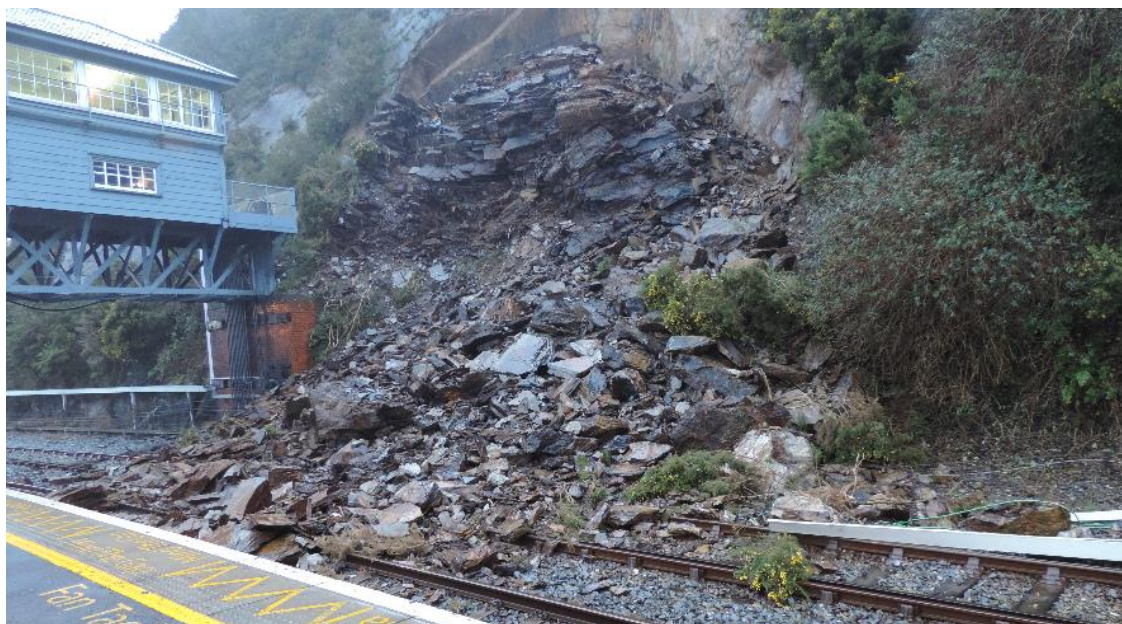
Figure 2 – Rock fall adjacent to the Signal Cabin at Plunkett Station

- 2 When the Signaller went out onto the steps of the Signal Cabin to investigate, he saw that a large portion of the *rock face* running adjacent to the station had collapsed onto the two tracks which run under the Signal Cabin and through Plunkett Station, see Figure 2.

- 21 The rock fall resulted in minor damage to the track and the footings for Signal Cabin. However, there was considerable damage to the signalling system, in particular, the disabling of the signalling connected to the Signal Cabin which resulted in a number of points and signals being rendered inoperable.

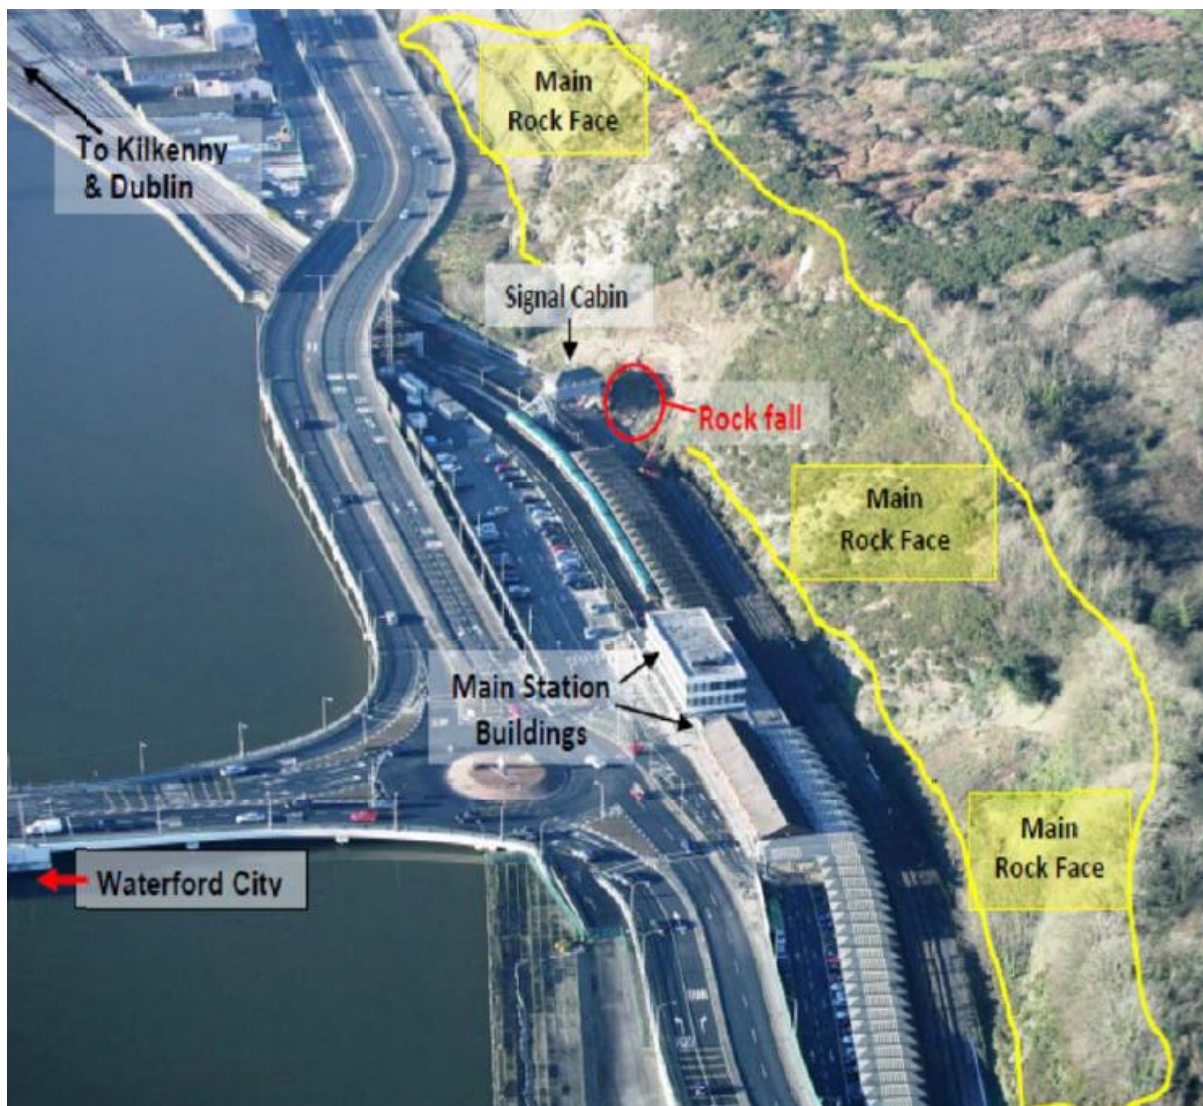
Figure 4 – Aerial view of the rock face and location of the rock fall

- 32 The length of the rock face is approximately 375 m and runs the entire length of Plunkett Station. The rock fall occurred within the proximity of Plunkett Station, adjacent to the Signal Cabin, see Figure 4.

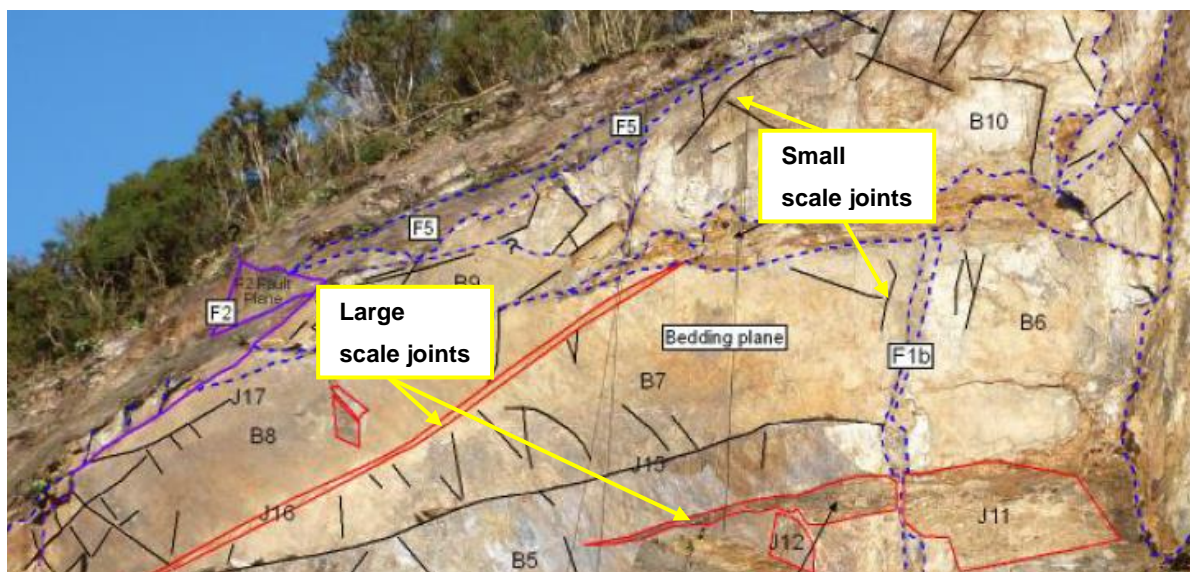
Figure 5 – Joints at incident site

- Small scale joints which are closely to medium spaced² (60 – 600 millimetres (mm)) which are limited in lateral extent, inclined to either the east or the west, and are abundant at the site, see black lines in Figure 5;

- Larger scale mega joints which are medium to widely spaced (200 – 2000 mm) which are more laterally extensive, see red lines in Figure 5.

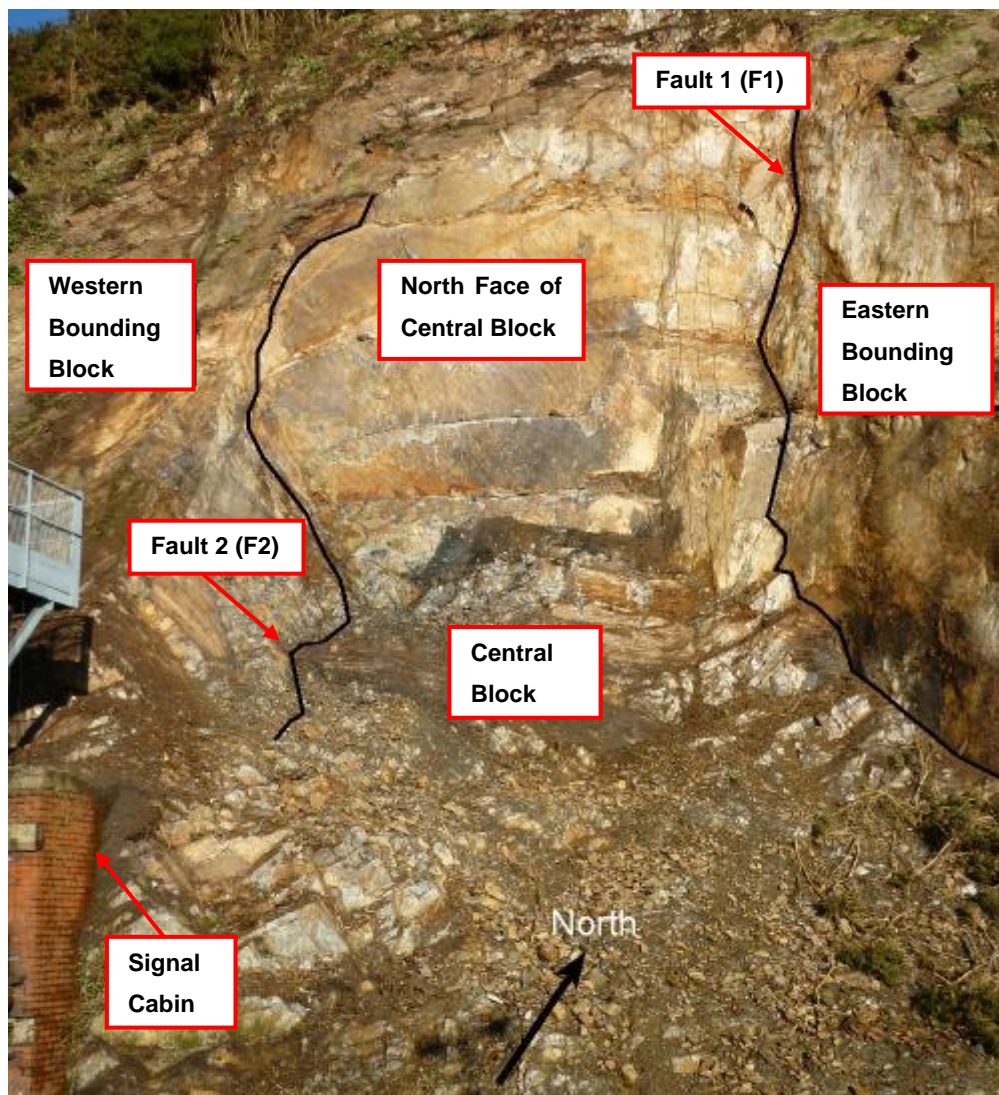
Figure 6 – Rock face after the debris was removed

- F1 – Located on the eastern side of the Central Block (area of rock fall), see Figure 6. F1 is inclined at approximately 82° to the west-southwest with the *fault zone* showing relatively intense weathering probably due to groundwater migration;
- Fault 2 – Located on the western side of the Central Block, see Figure 6. F2 consists of a 1 metre (m) wide fault zone containing a number of internal fault elements, suggesting a history of multi-event *tectonic movements*.

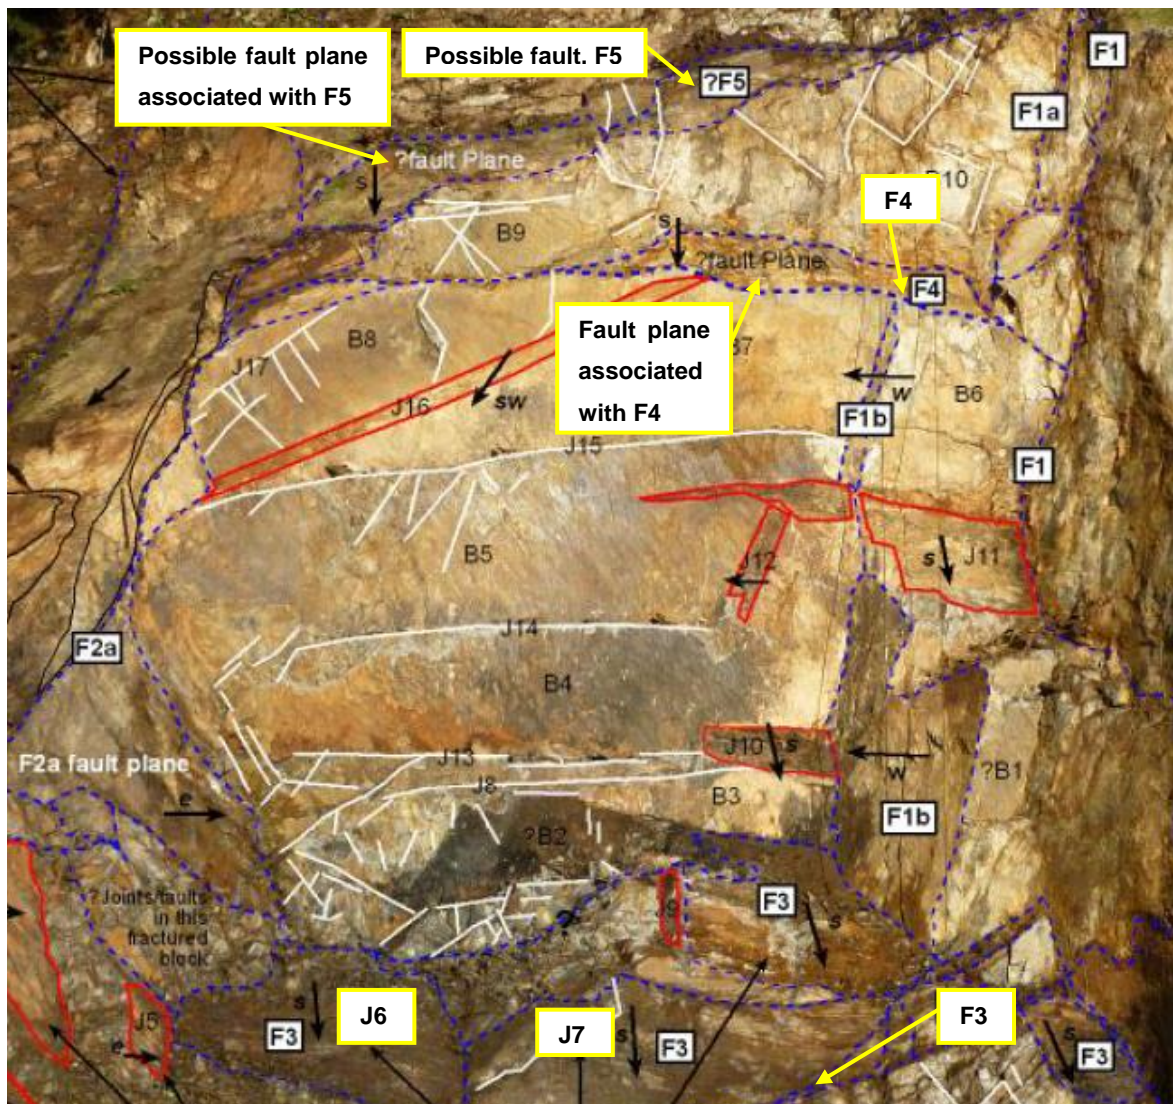
Figure 7 – Joints and faults around the Central Block

- F3 – Spans the Central Block, consisting of a number of interconnected *fractures*, linking F1 and F2. Joint 6 (J6) and Joint 7 (J7) may be joints or maybe part of F3. Irrespective of whether they are joints or faults, they are major planes of weakness which facilitated the collapse by providing a surface on which the rock mass was able to slide southwards;
- F4 – Southward inclined fault zone in the northern part of the Central Block, see Figure 7, which is also an important surface of weakness due to its direction of inclination;
- F5 – Southward inclined fault zone, which may be a fault, located at the top of the Central Block north face, see Figure 7.

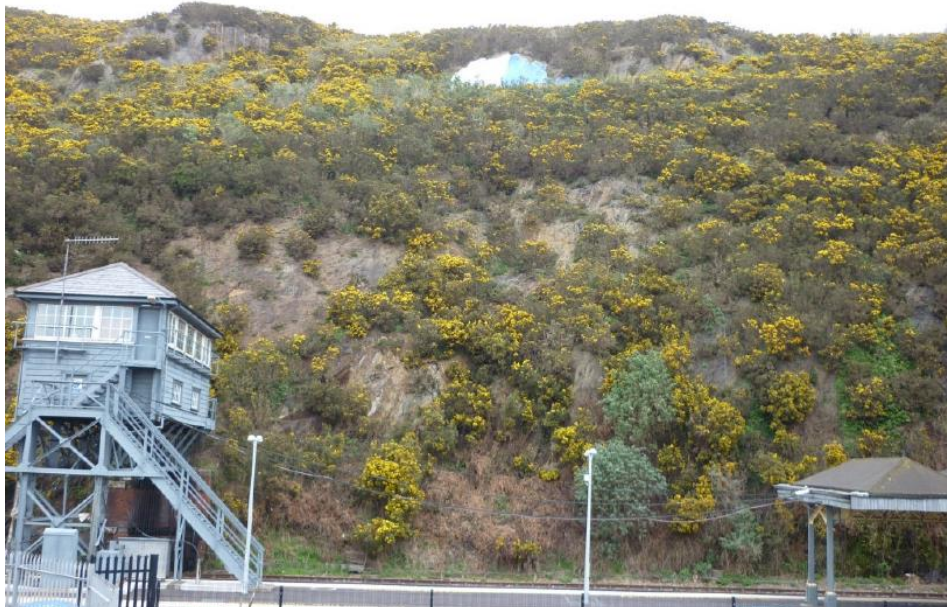
Figure 11 – Photograph taken in 2012, in the location of the 2013 rock fall

56 The most recent GEI carried out on the rock face at Plunkett Station was on the 2nd March 2012, the rock face was broken up into three different GEIs to accommodate for the long nature of the rock face and the inspections were carried out from the track. The GEI included a photograph of the rock face, taken on the day of the GEI, see Figure 11.

57 The Inspection Card noted “loose rocks” in three locations, and allocated a Design Rating of 2, a Condition Rating of 3 (Poor) and a Deterioration Rating of 3 (Discernible deterioration).

59 The Condition Ratings of 3 and 4, differ greatly in terms of inspection frequency, i.e. from one in every five years to annually, respectively (paragraph 48). As part of the RAIU investigation, this Condition Rating was queried with the Technical Manager CCE, where he stated in correspondence with the RAIU on the 24th September 2014 that “while the condition of the asset was rated as Condition Rating 3, along with many thousands of other assets throughout the network, this is simply representative of the aged and legacy infrastructure which we manage”. This is generally as a result of the fact that a number of structures on the IÉ network are in excess of 100 years old, including earthworks.

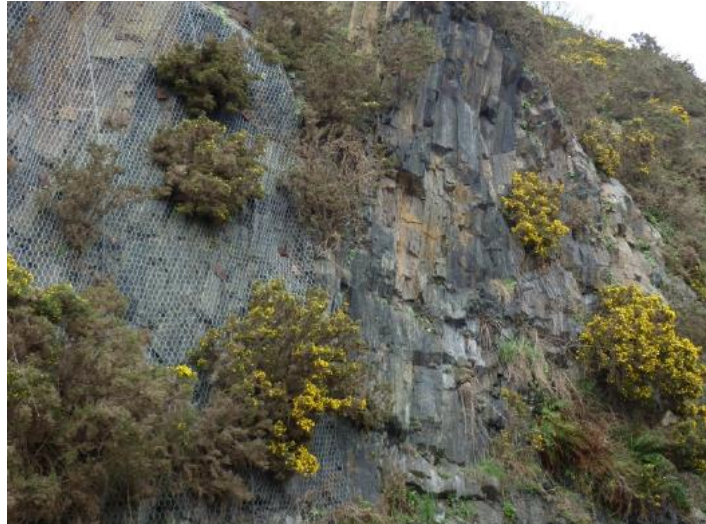
Figure 12 – Rock netting present in 2012 GEI

62 The Inspection Card also noted that the continuation of the rock netting was required, but not urgent; and suggested the possible consideration of a catch fence when the “siding” was removed. The rock netting was present at other locations on the rock face, see Figure 12 for an example of the rock netting. It should be noted that the Consultant’s Report confirmed that the continuation of rock netting was not urgent.

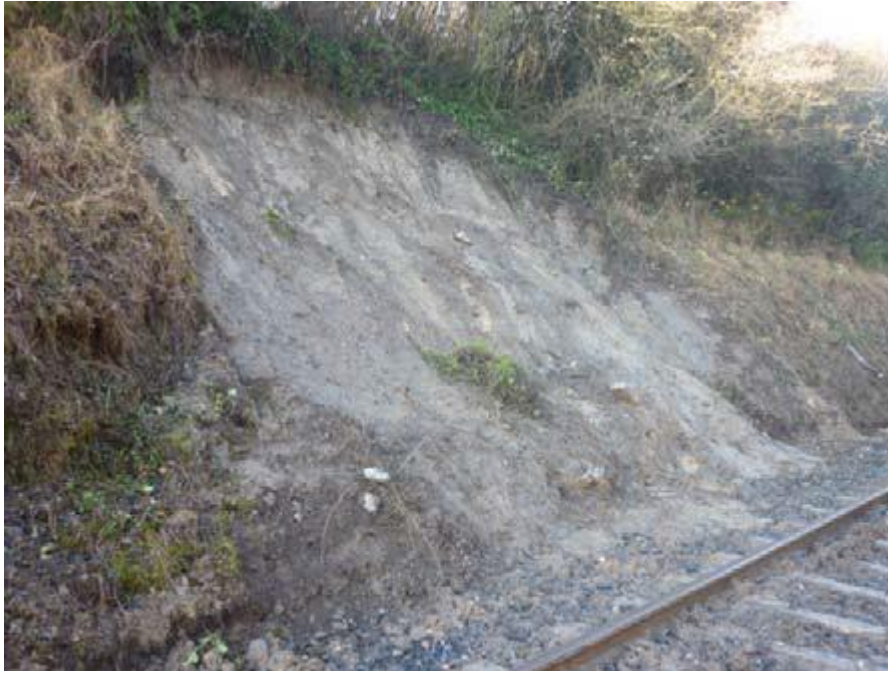
Figure 15 – Landslide between Ballyhale and Lavis

108 At approximately 06:40 hrs on the 31st December 2013, the 06:05 hrs passenger service from Waterford to Heuston struck a landslip just north of Legan Level Crossing (XW113) at the 38 ¼ MP, between Ballyhale and Lavison. The first three coaches of the train sustained damage to the undercarriage and the train came to a stop with the rear coach over the bulk of the debris, see Figure 15. There were eight passengers onboard and there were no injuries reported.

109 An internal IÉ investigation report into the incident found that the immediate cause of the landslide was due to the saturation of the cutting material following heavy rainfall over the days preceding the 31st December 2013; the rainfall for the month of December was above average. Causal to the incident was the saturation of the embankment due to higher levels of water within the field and insufficient drainage at the crest of the slope, which allowed water to infiltrate the steep cutting slope, causing the top layer of the cutting material to slip down the bank, see Figure 16. Underlying to the incident was the difficulty in observing changes in water levels and drainage in adjacent land during routine track patrolling and GEIs.

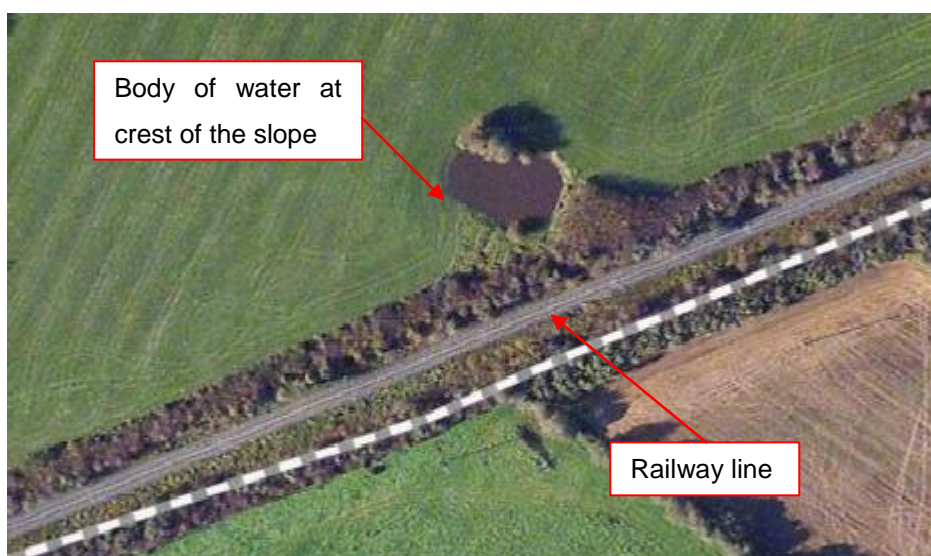
Figure 16 – Aerial photograph water at crest of the cutting slope

110 The internal investigation report found that the inspections were carried out to the required frequencies as set out in CCE-TMS-361 and CCE-STR-STD-2100. However, the investigation report noted that the labelling of the assets on the Inspection Card was not as set out in CCE-STR-STD-2100, in that the Structures Inspector identified the incorrect asset.

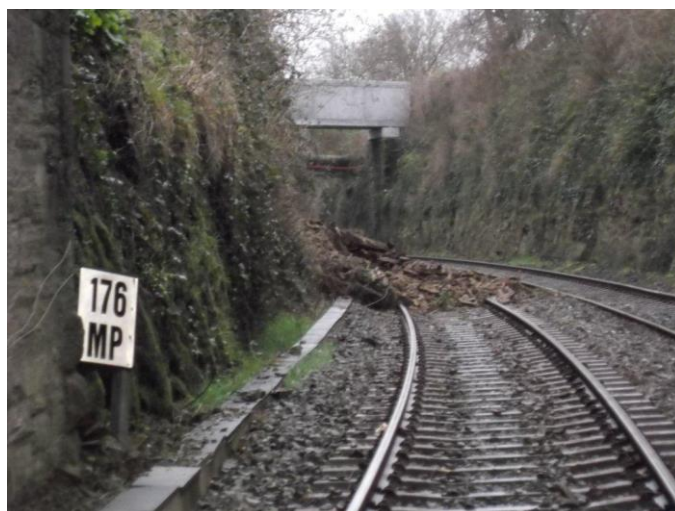
Figure 17 – Landslide at 176 MP

112 At approximately 22:40 hrs on the 7th March 2014, a rock fall, consisting of approximately thirty tonnes of debris, occurred on the cutting near the 176 MP between Rushbrooke and Cobh Stations. The rock fall occurred on the side of the down line (towards Cobh). The line was under *possession* (with no passenger services) at the time of the incident, to facilitate the renewal of an *overbridge*. Staff who were working at the overbridge heard the rock fall and went to investigate and found that the down line was blocked as a result of rock fall debris, see Figure 17.

113 An internal Technical Investigation Remit was commissioned by IÉ and published on the 14th March 2014; it found that the ingress of water passing through the mudstone/shale rock, and the general weathering of the rock reduced the integrity of the rock to a state where the rock became unstable; resulting in the rock collapsing due to its reduced ability to support itself, causing the failure of the bond between two layers of rock along a 60 degree plain. The remit found that the constant flow of water through the cutting was contributory to the incident occurring.
