**STATE COMMISSION ON RAILWAY ACCIDENT INVESTIGATION**  
**Ministry of the Interior and Administration**

**REPORT No. PKBWK 04/2023**

**on the investigation of a railway accident**  
**that occurred on 12 December 2022 at 02:35 hrs on the Kozięglowy – Poznań Piątkowo**  
**route,**  
**track no. 2, km 11.788 of railway line no. 395 Zieliniec – Kiekrz,**  
**a Category C level crossing**  
**area of the infrastructure manager PKP PLK S.A. Railway Line Plant in Poznań**

**WARSAW, 11 December 2023**

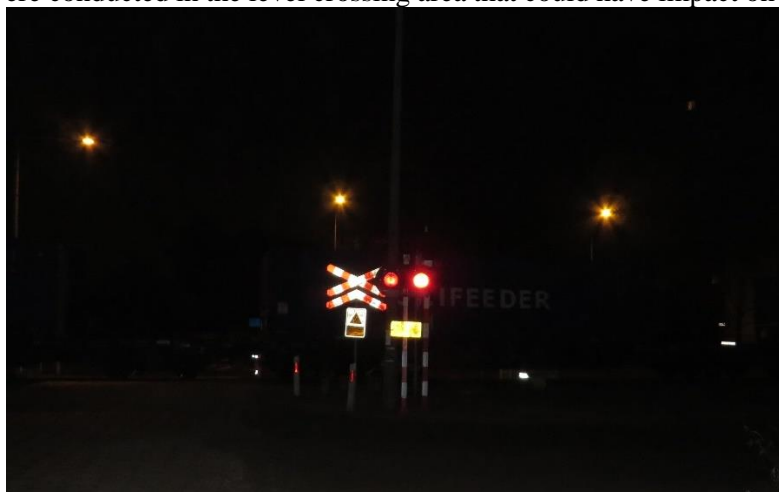
The signals had the board hung on them that read "Signalling out of order" (Polish: *Sygnalizacja uszkodzona*), without the B-20 "STOP" sign (Photograph 2).

Photograph 2 – A view of level crossing signalling immediately after the accident (source: the railway commission).

- 2) In the event of a malfunction of automatic crossing system devices which cause the Osp-1 signal to be displayed by level crossing warning signal lights for one track of a given level crossing, infrastructure managers shall cause that the Osp-1 signal is displayed for all tracks within the level crossing concerned.

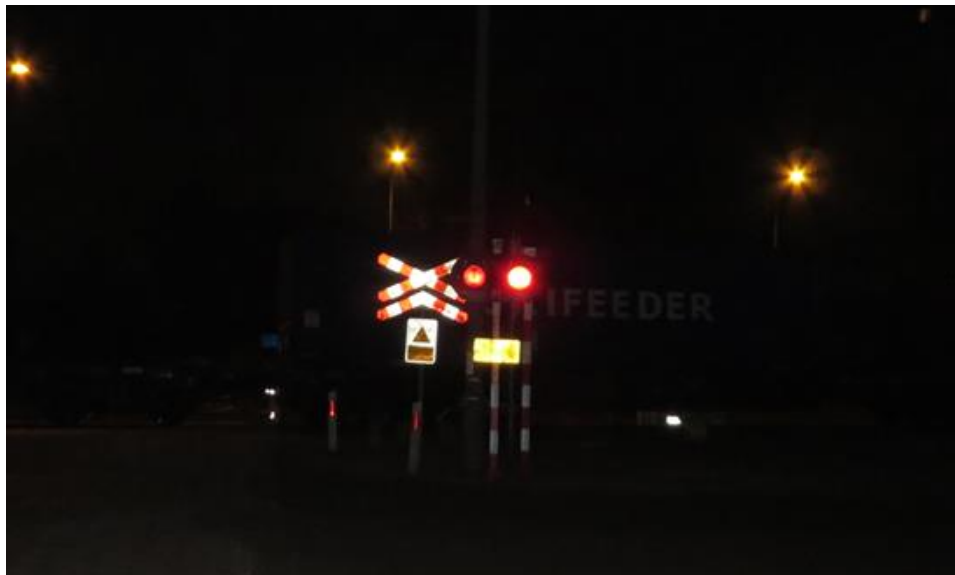
Due to the malfunction of the Automatic Crossing System (SSP), boards reading "Signalling out of order" were put on the signals. In the event of unserviceability of SSP devices, the infrastructure manager is required to mark the level crossing concerned with the sign B-20 "STOP". The sign was not there at the moment of the accident (Photograph 3).

Photograph 3 – Signage of the level crossing immediately after the accident (footage provided by the railway commission)

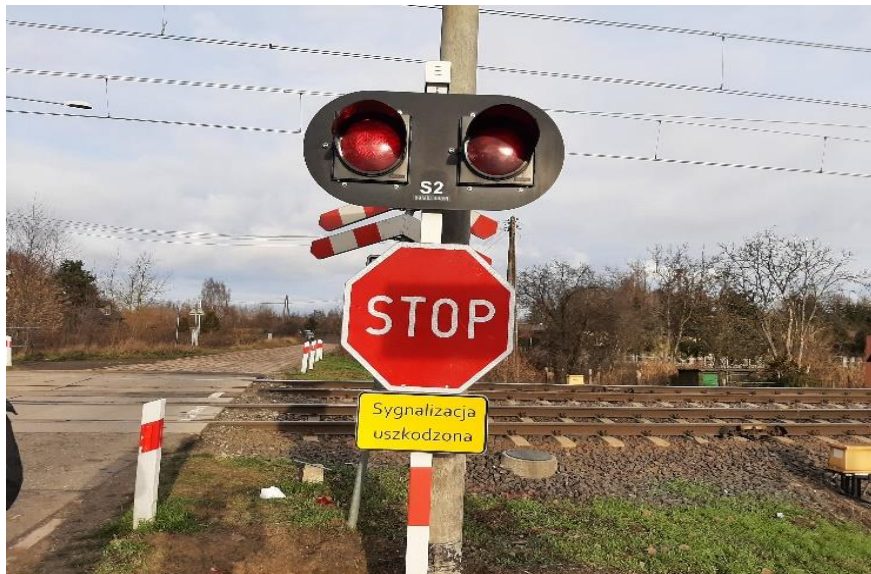
According As it transpires from interviews with employees of the infrastructure manager, the B-20 „STOP” sign placed after the malfunction occurred on 11 December 2022 had been stolen. Based on an analysis of the investigation material gathered and photographic documentation made immediately after the accident, the Investigation Team was unable to state clearly whether the level crossing had been marked with a B-20 "STOP" sign following the malfunction. Following the receipt of the theft report, the police communicated on 22 December 2022 that no request for punishment had been brought to court as no perpetrator(s) had been found. In accordance with applicable regulations, a Category C level crossing should be marked with *inter alia* sign G-4 "St. Andrew's Cross". The railway manager did place such a sign, but its positioning does not ensure good visibility for road users, for it is obscured by a roadside signal S2 of the Automatic Crossing System (Photograph 4).

The sign B-20 "STOP" was placed in the morning of 12 December 2022.

**Photograph 4 – Signage of the level crossing after the arrival of PKBWK representatives**

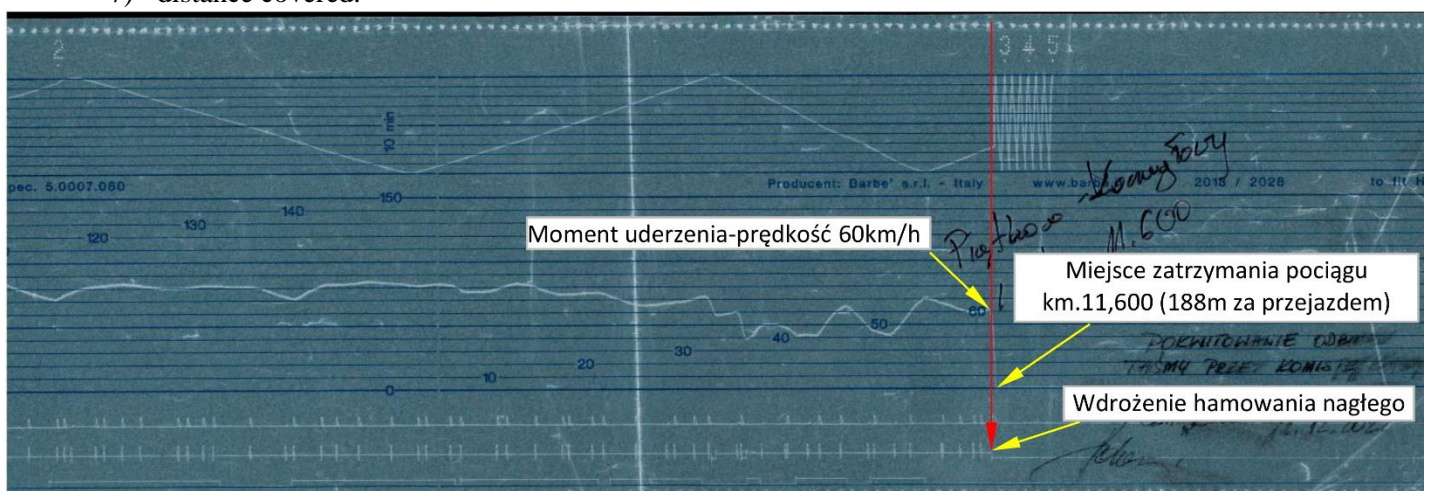
Photograph 5 – A scan of the speedometer tape with the performance characteristics of train no. 872000

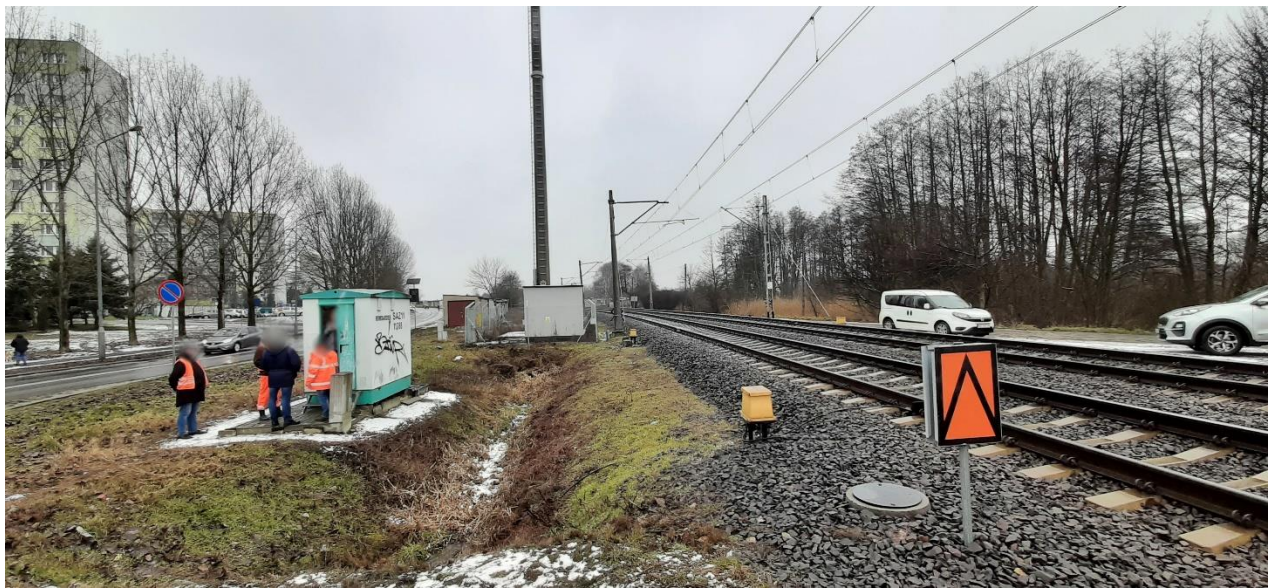
The level crossing at Nad Różanym Potokiem street is located behind an elevation relative to Stróżyńskiego street. The approach to the crossing from Stróżyńskiego street is inclined by 4.195% along the length of 17.5 metres. At the point of measurement of the visibility triangle from 5 metres, looking to the left (from the direction of a moving car), there is a container with a GSM-R mast. The structure obscures visibility of trains incoming from the left for drivers of road vehicles. The structure also obstructs visibility for drivers of trains during observation of the approach leading to the level crossing. Photographs 6 and 7 show visibility from the road onto track no. 2 from 5 metres, and from track no. 2 onto the approach and level crossing at km 11.788 from around 80 metres before the level crossing.

Photograph 6 – A view of track no. 2 from the road from the distance of 5 metres from the outermost rail

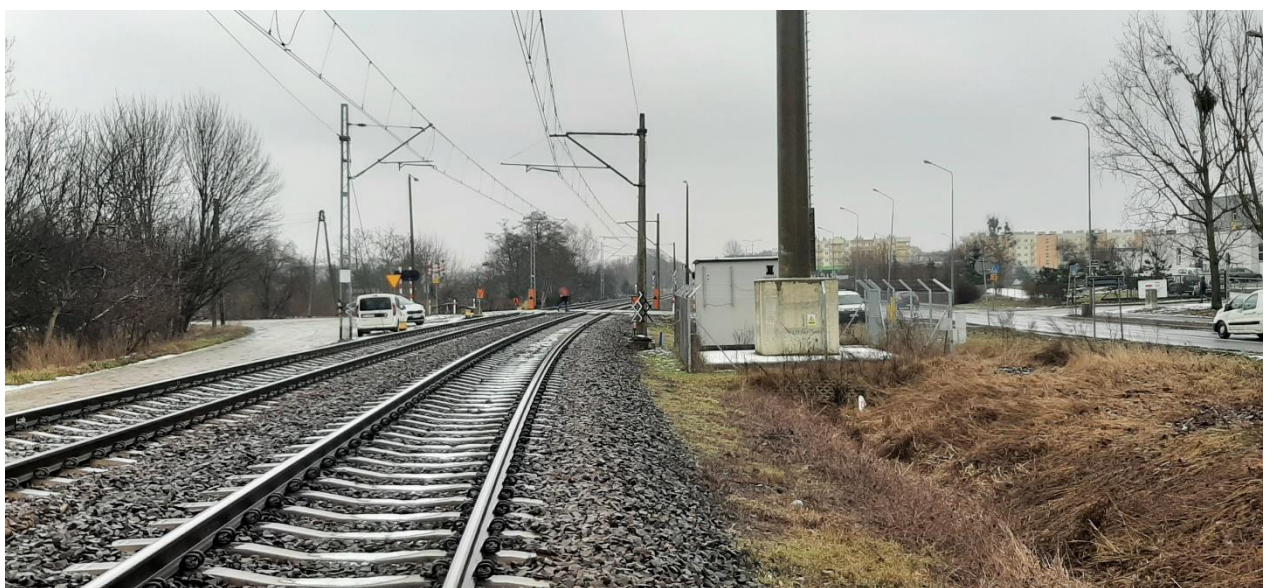
Photograph 7 – A view from track no. 2 on the access road and the level crossing at km.11.788 from the distance of around 80 metres

Erecting the GSM-R container and mast within the visibility triangle at 5 m significantly reduced visibility for road users, making it more difficult to notice a train incoming on track no. 2, and also leaves the train driver with very little reaction time if he notices any irregularities in the behaviour of road vehicle drivers. A road vehicle that stopped before the level crossing is practically invisible for the train driver from the distance of around 80 metres before the level crossing. In accordance with the provisions of Paragraph 15, Part B, Annex 3 to the Regulation of the Minister of Infrastructure and Development of 20 October 2015 on the technical conditions to be met by crossings of railway lines and sidings with roads, and on their positioning (Journal of Laws of 2015, items 1744, as amended), *"Within the boundaries of visibility triangles, no objects that reduce visibility shall be placed, in particular construction works, trees, shrubs and other high-growing plants, advertisements, elements of acoustic protection"*. The erection of the construction works in the 5 m visibility triangle started in 2019. PKP PLK S.A. is the investor. Photograph 8 shows boards placed on the object.

- 6) Infrastructure manager PKP PLK S.A. shall take effective actions to synchronise time in the electronic time system which it operates.
- 7) Authorised infrastructure managers shall include in their hazard records hazards related to any structures erected within the visibility triangle. In each case, they shall conduct a risk analysis at the stage of designing structures close to level crossings, taking into account the local conditions of a given level crossing.

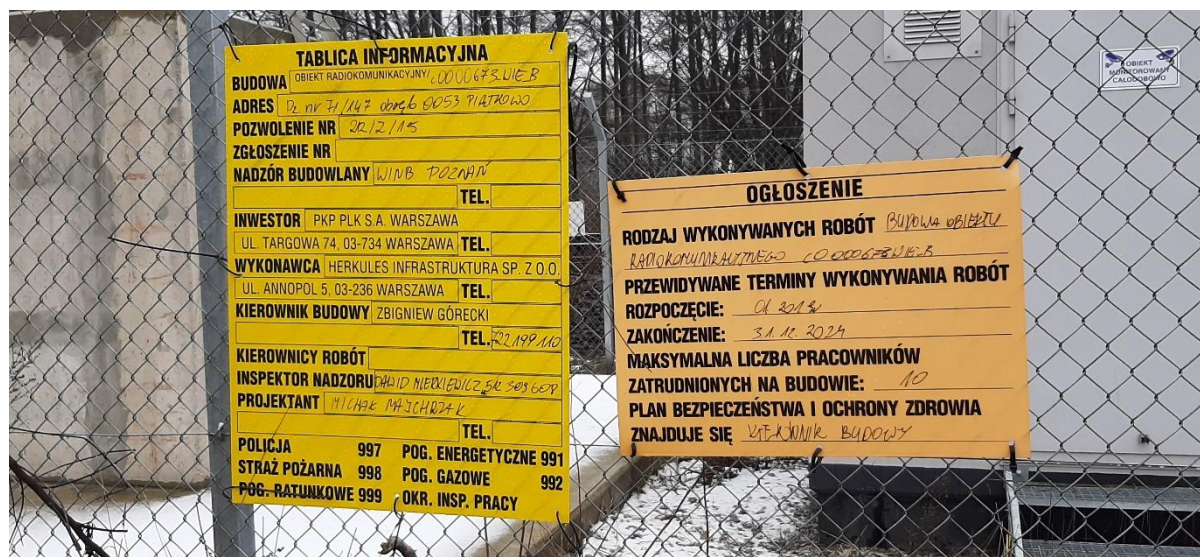
Photograph 8 – Boards placed on the fence of the construction work
