STATE COMMISSION ON RAILWAY ACCIDENT INVESTIGATION
Ministry of the Interior and Administration

REPORT No. PKBWK 02/2024

on the investigation of a railway accident
that occurred on 7 February 2023 at 02:00 hrs
at the Wrocław Brochów station,
km 1.701 of track no. 1N of railway line no. 349 Św. Katarzyna – Wrocław Kuźniki
the area of the rail infrastructure manager PKP PLK S.A. Railway Line Plant in Wrocław

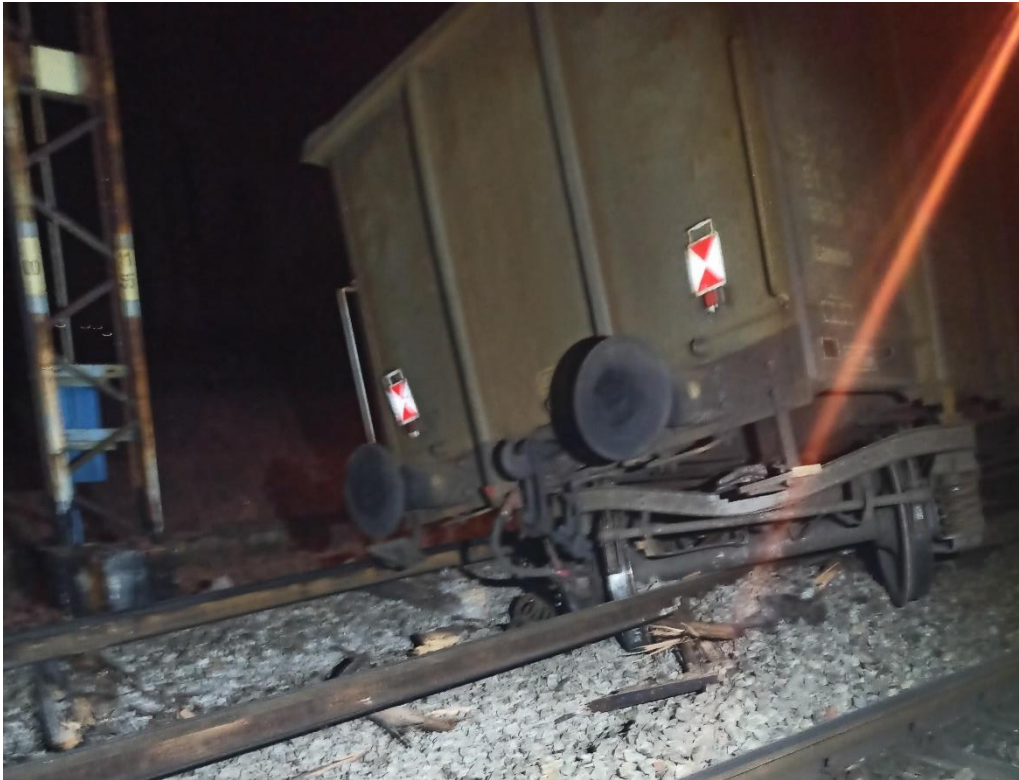
Photograph 1 - A view of the derailed wagon (source: materials provided by the railway commission)

Visual examination of the damaged wheelsets of wagon no. 33 51 5839 055-9 confirmed damage to the wheels and axle boxes qualifying them for scrapping.

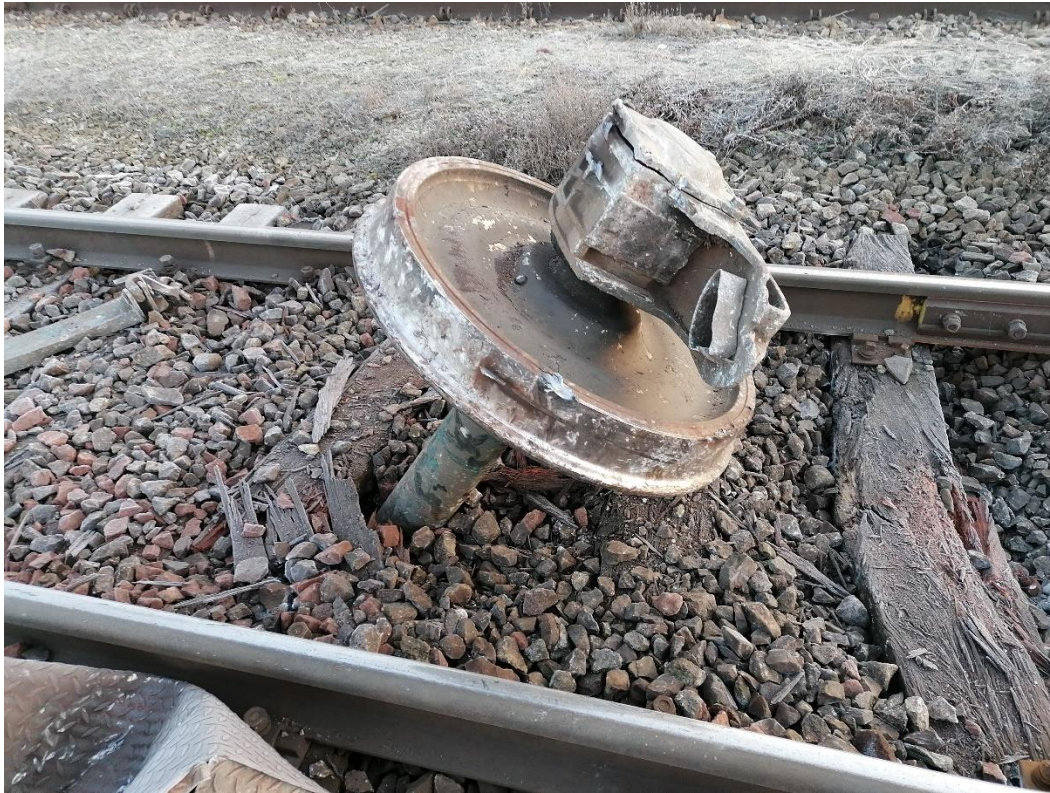
Photograph 2 - A view of one part of the broken axle (source: materials provided by the railway commission)

5. *Metallographic tests of the surface of axle breakage in the area of the crack revealed existence of corrosion; furthermore, the tests revealed clear traces of a tool bit after rough machining of the radius of transition of the wheel seat to the axle centre section. The wagon driving dynamics coupled with the existing tensions became the source of a fatigue crack in the axle. The direction of propagation of fatigue lines visible*

on the axle breakage also confirms the starting point of the axle crack.

In summary, it was established that the crack in the axle started probably during the period of intensive operation after the repair carried in 2020, with the roughly machined and corroded surface of the transition of the wheel seat to the axle centre section becoming the place of the crack that propagated during subsequent operation of the wagon. The propagation of the fatigue crack caused the strength of the axle cross-section to deteriorate up to the critical moment where the sudden crack visible in the axle breakage occurred.

1. Entities in charge of maintenance (ECMs) of freight wagons shall strengthen supervision of the process of repairs of wheelsets during replacement of wheels and P4 and P5 maintenance.

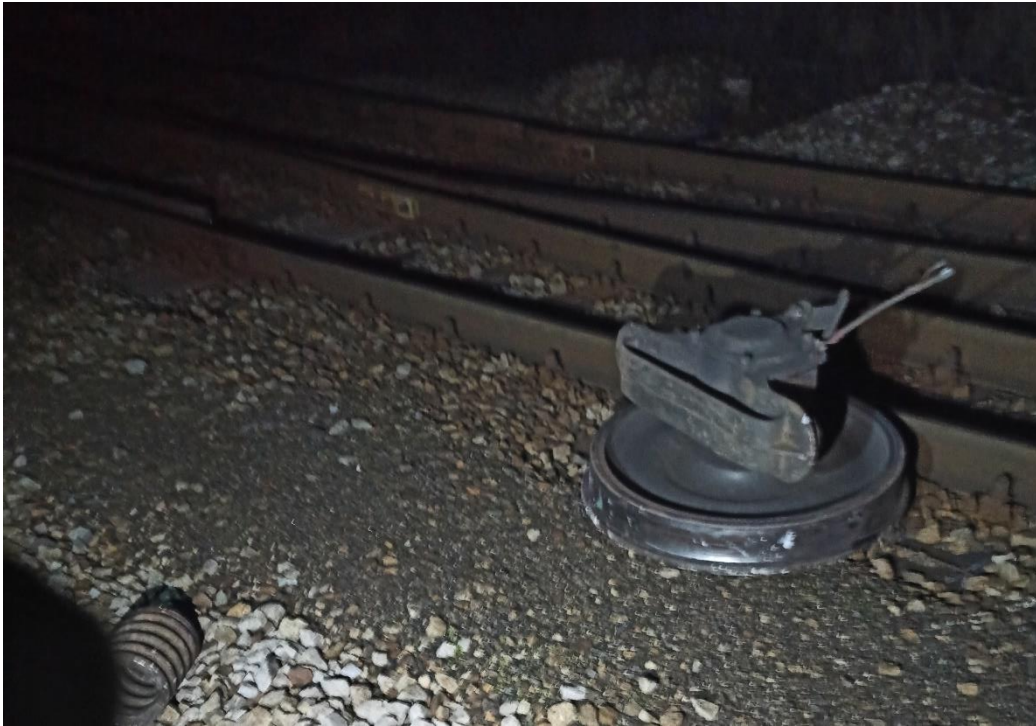
Photograph 3 - A view of the other part of the broken axle (source: materials provided by the railway commission)

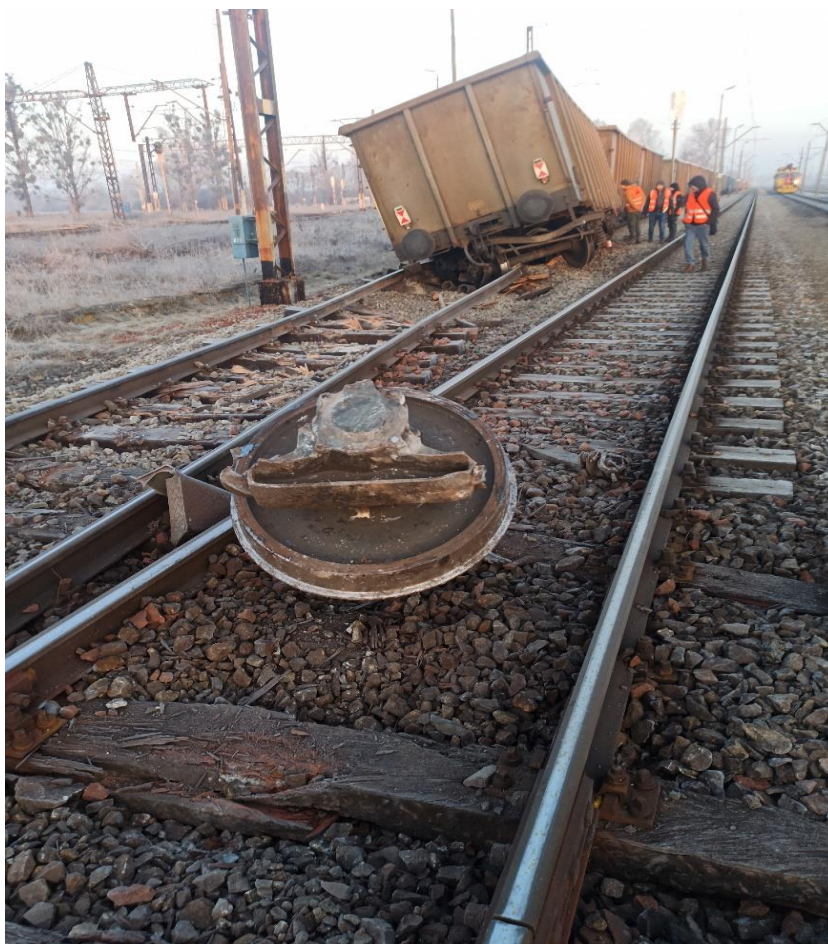
Photograph 4 - A general view of the occurrence site (source: materials provided by the railway commission)

Damage to the rail infrastructure included damage to turnouts no. 501, 502, 503 and 506 on tracks no. 1N and 3N, and turnout segments with turnout bearers, sleepers and other elements of track infrastructure such as elements of turnout heating.

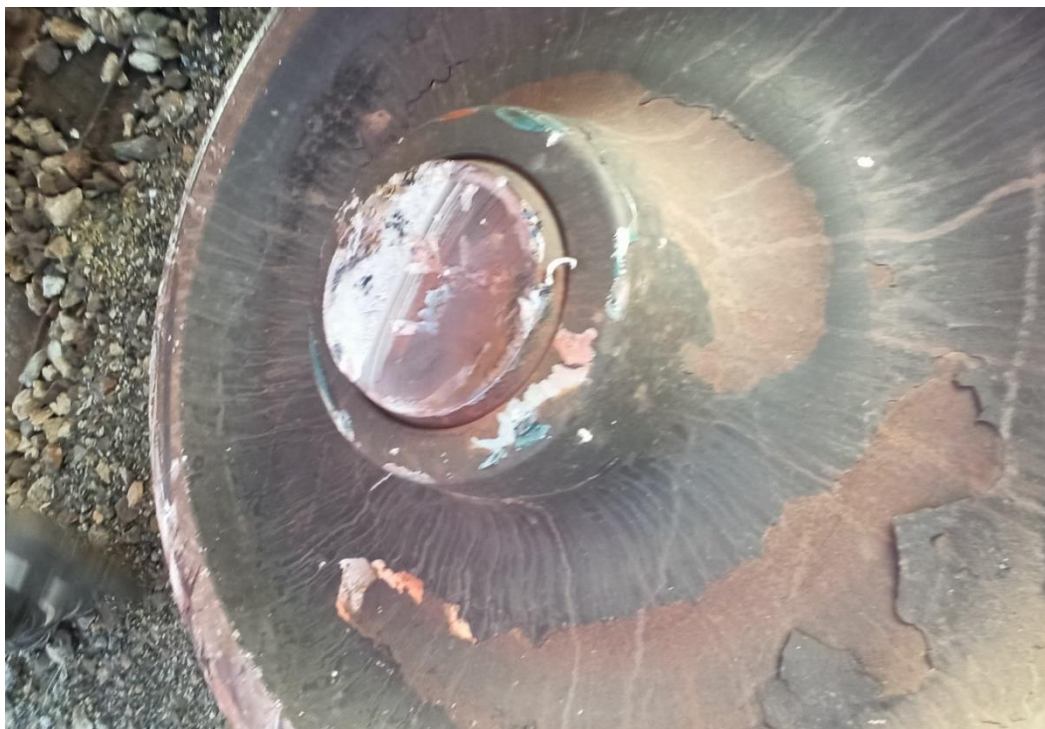
Photograph 5 - A view of the broken axle (material provided by the railway commission)

– first wheelset no. 345211 – broken axle

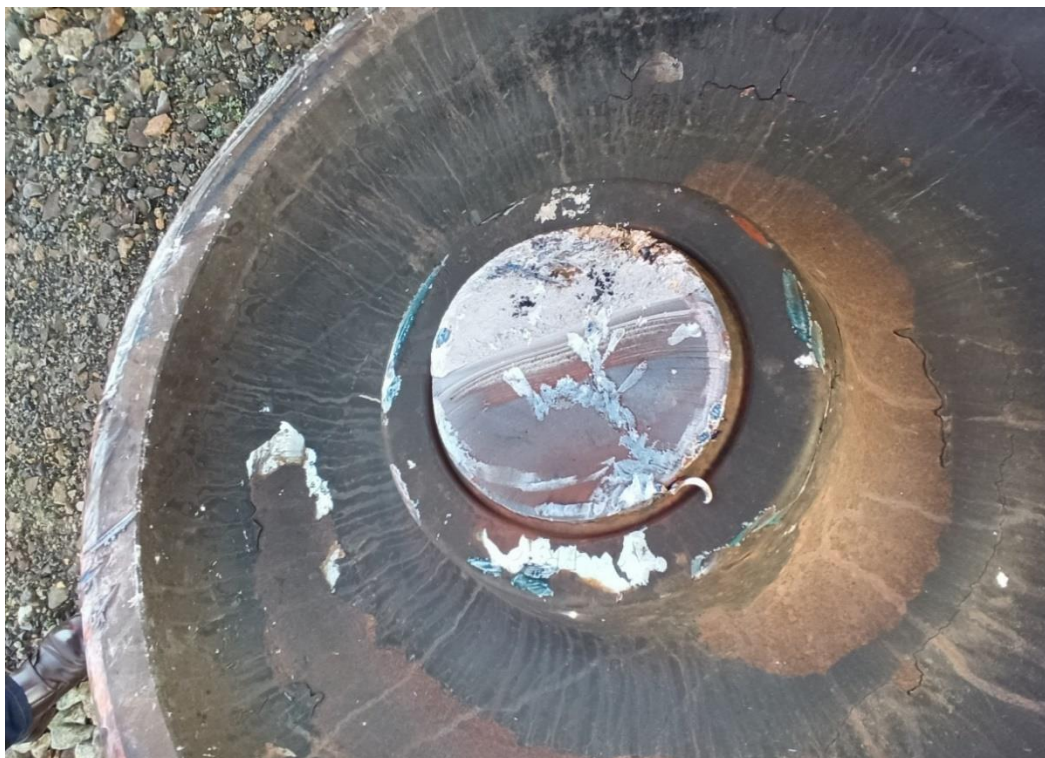
Photograph 6 - A view of the broken axle (material provided by the railway commission)

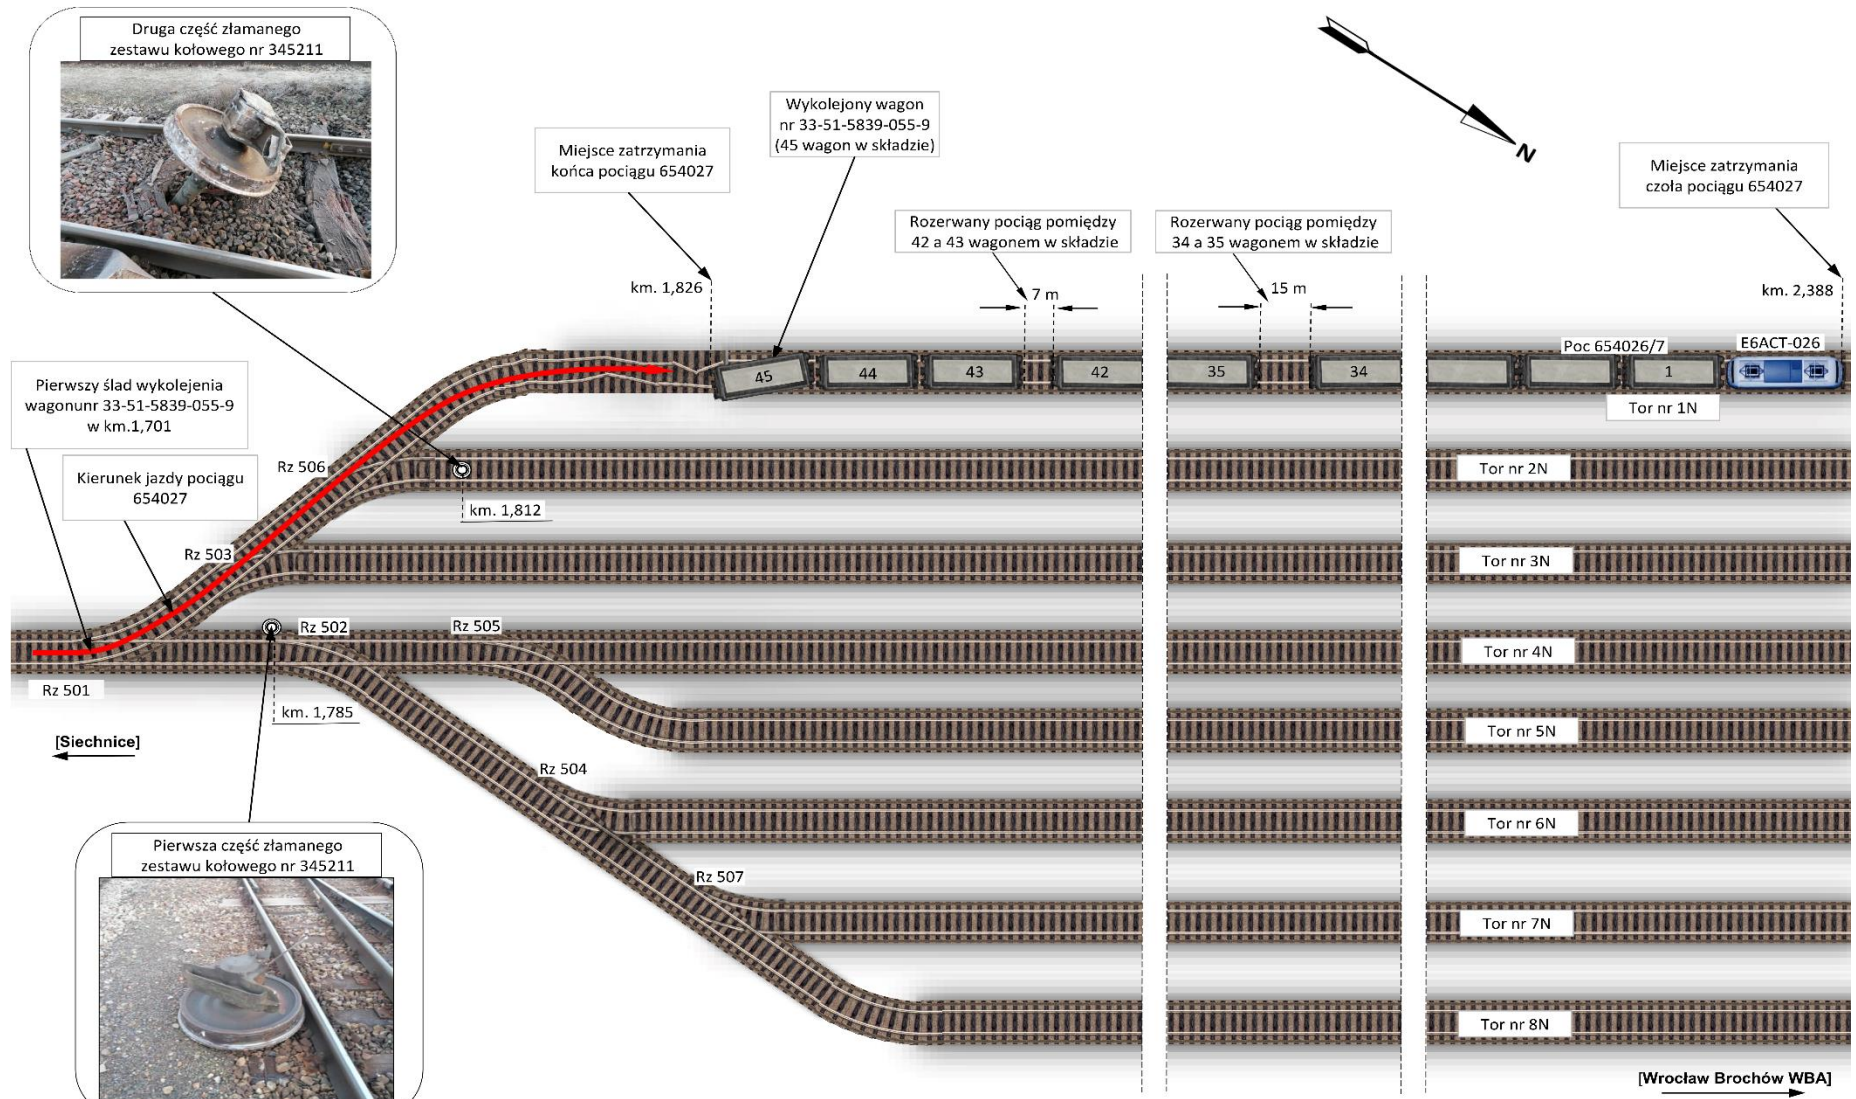
Figure 1 - A drawing of the accident (author: PKBWK)

As a result of the derailing, the train set was broken apart between the 34th and 35th wagon, and between the 42nd and 43rd wagon, counting from the train head.

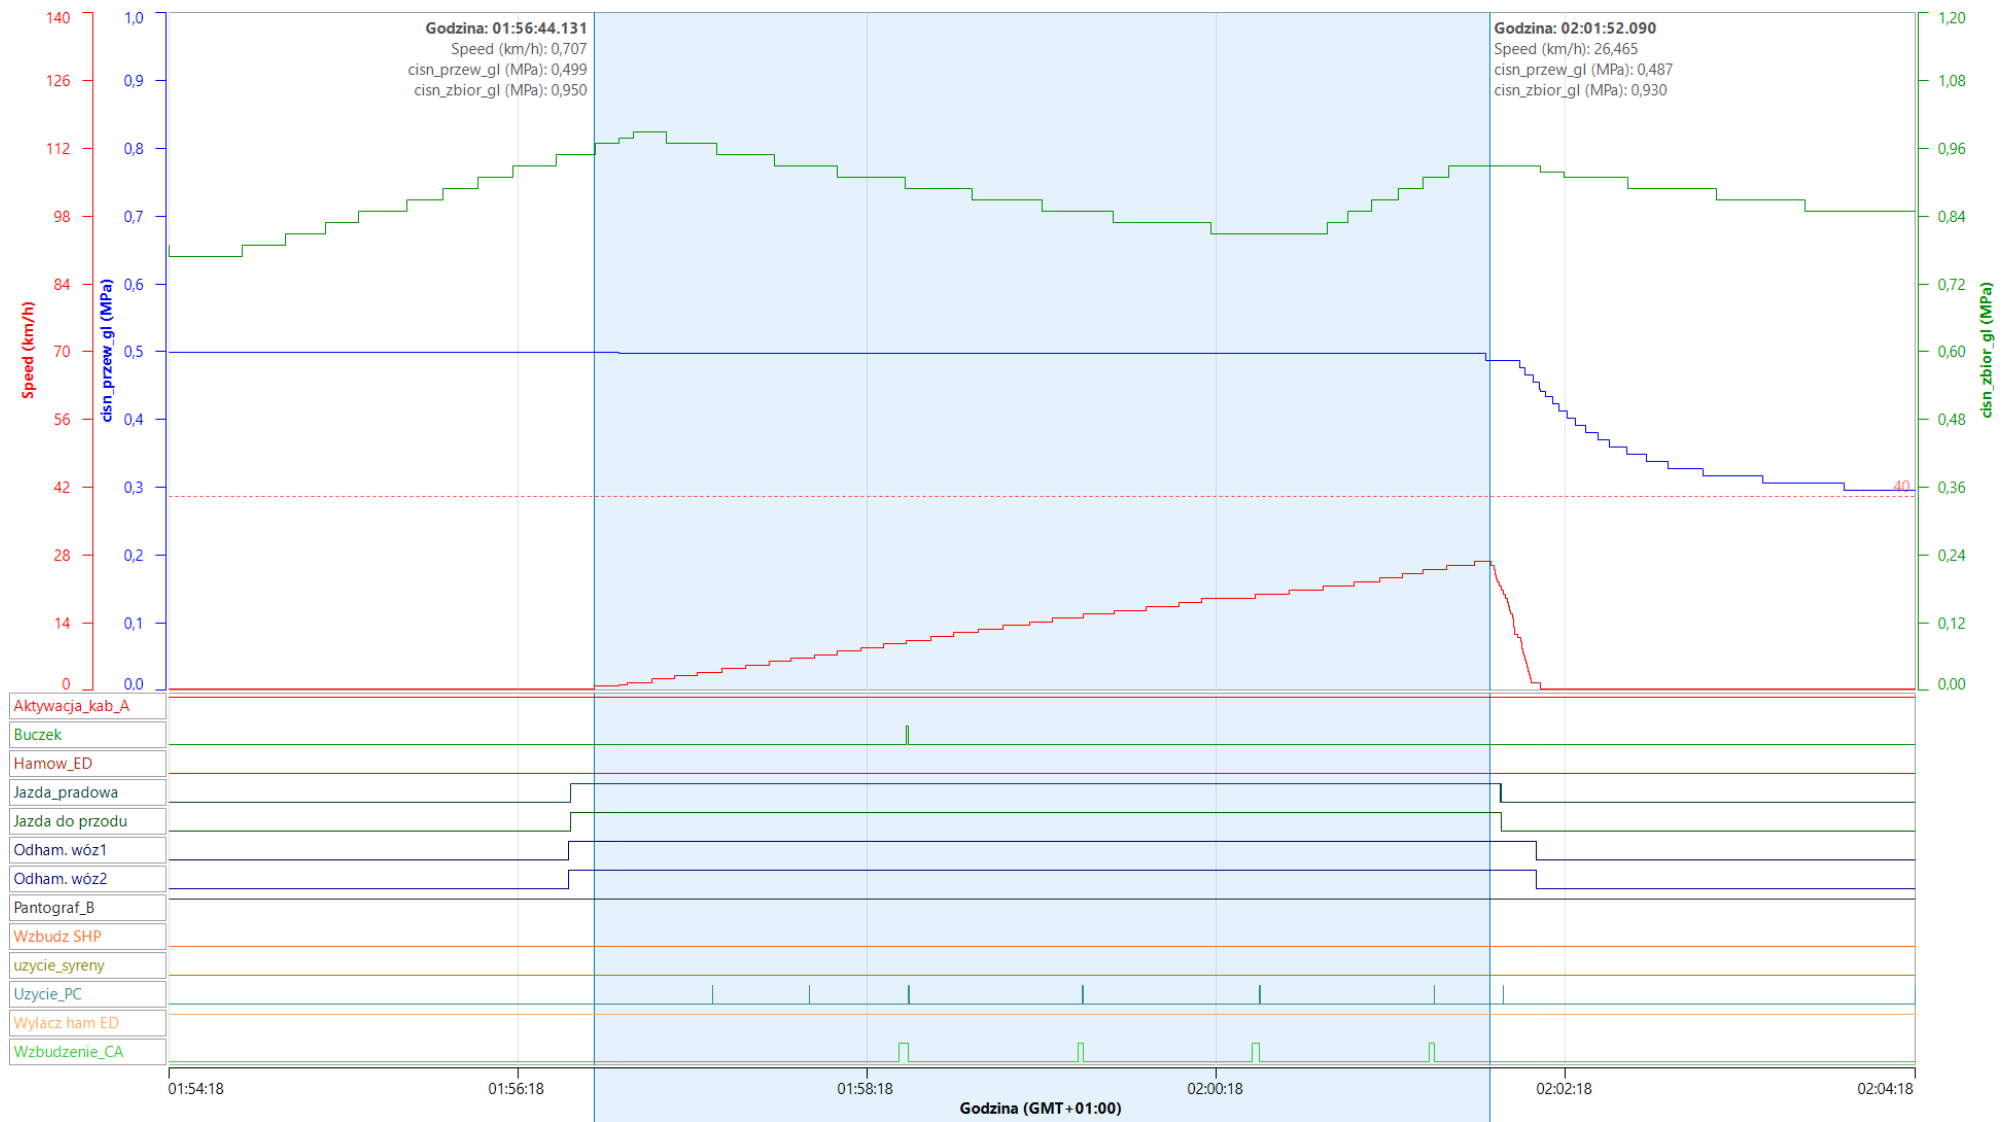
Figure 2 - A chart showing the driving parameters of the E6ACTad-026 locomotive in the function of time (developed by PKBWK)

Analysed were the driving parameters of train no. 654027 recorded on 7 February 2023 between 01:56:44 hrs and 02:02:09 hrs;

- 01:56:44 hrs - start of the train from the entrance semaphore to the Wrocław Brochów station; an increase in the speed to 26.46 km/h and a sudden decrease in the speed accompanied by activation of emergency braking
- 02:02:09 hrs - the train stops after covering 1,241 metres from the start time.
