STATE COMMISSION ON RAILWAY ACCIDENT INVESTIGATION
Ministry of the Interior and Administration

REPORT No. PKBWK 01/2024

**on the investigation of a railway accident
that occurred on 19 January 2023 at 18:37 hrs
on the Szczecin Podjuchy – Szczecin Port Centralny SPA route,
km 349.520 of track no. 1, railway line no. 273 Wrocław Główny – Szczecin Główny,
the area of infrastructure manager PKP PLK S.A. Railway Line Plant in Szczecin**

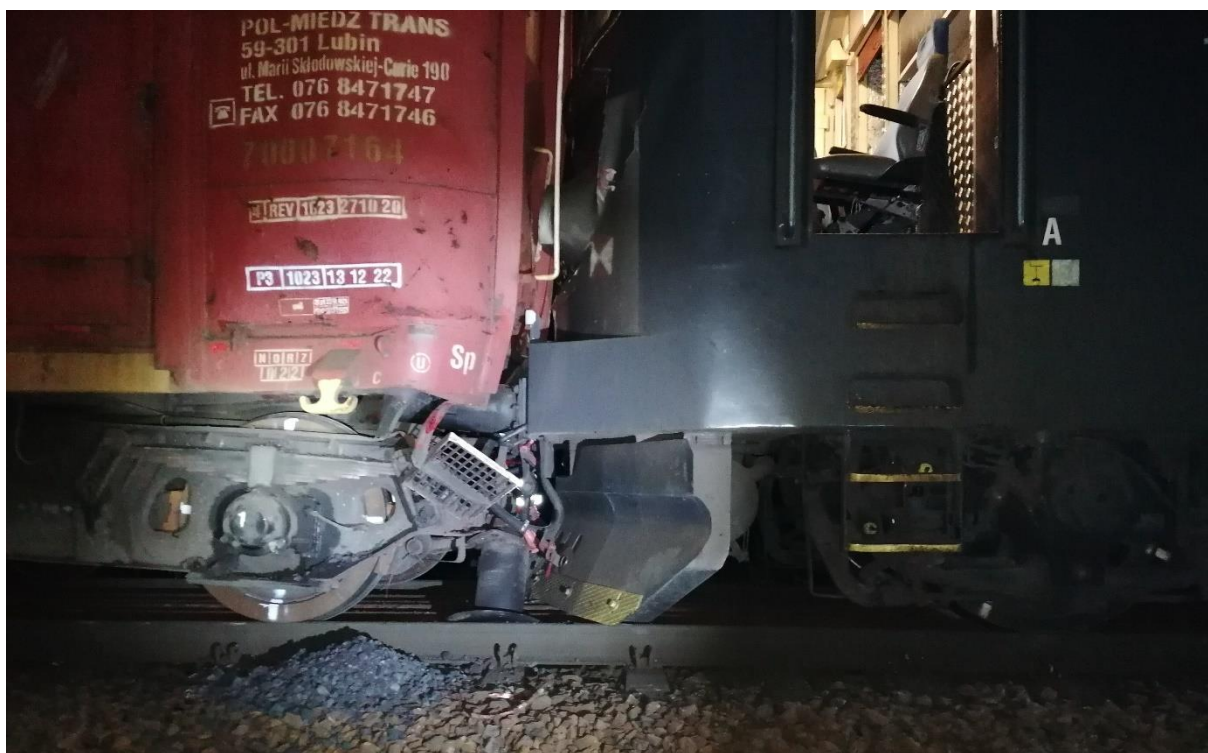
Photograph 2. A view of the effects of the occurrence (source: the railway commission)

As a result of train LTE 785009 running into the last wagon of train TME 684013, the E182 055-4 locomotive was damaged. Damaged were *inter alia* the head wall of Cabin A (the central part at the headlights was indented to the inside of the vehicle), both buffer devices, the draw device, the skin of the front beam, bogie pivots and steps on the head of the cabin together with their mounting.

The damage to the Eamos 84 51 5944 675 4 wagon of train TME 684013 included both buffer devices (the left buffer was knocked into the wagon), the solebar, the end sill, the draw device. Furthermore, there was damage to the lower part of the head wall and a section of the left side wall connected directly with the head wall. Additionally, the shunting step and its mounting were damaged.

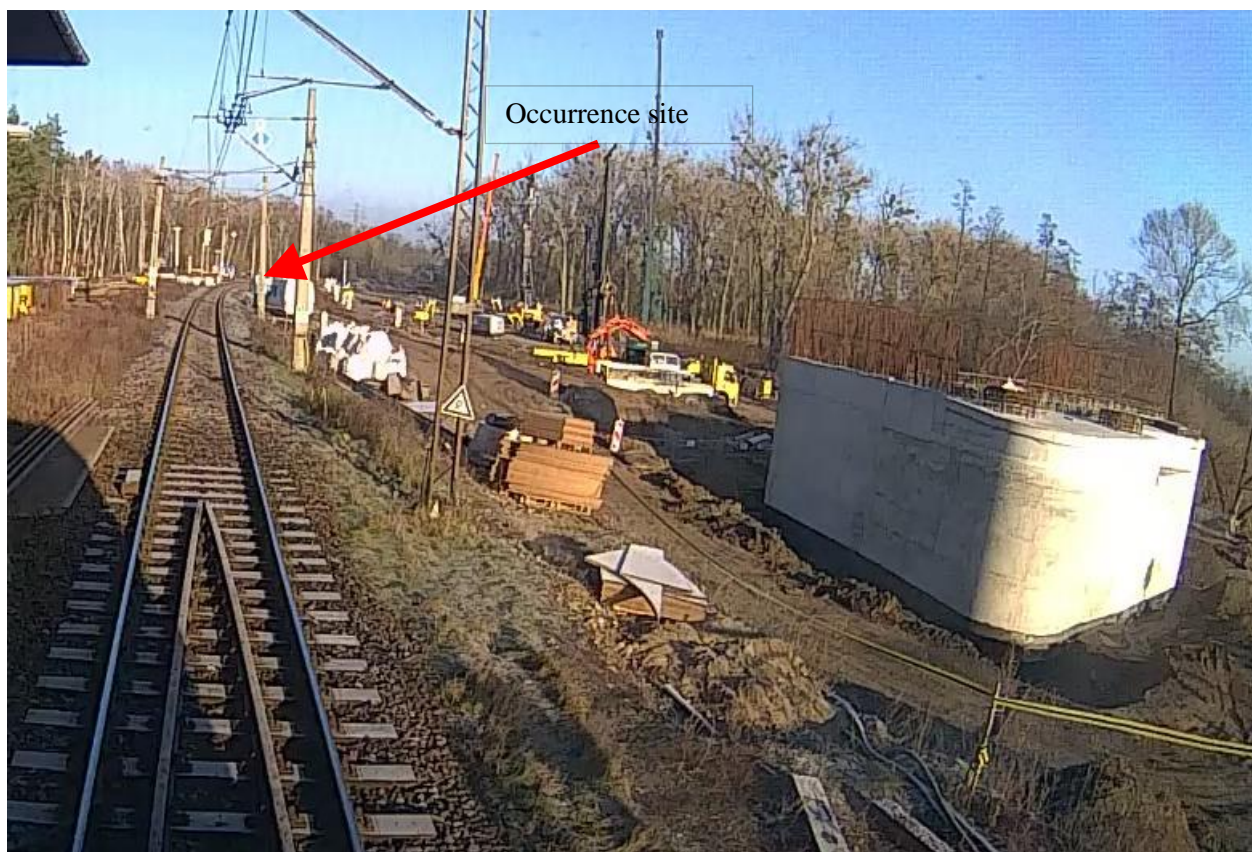
Near the plain track, to its left, there is a woodland, and to the right there were works in progress as part of the project "*Conversion of bridges to ensure minimum clearance*" on the railway bridge at km 349.140 of railway line no. 273 (Szczecin Podjuchy). The scope of the works included *inter alia* construction of a new railway bridge over the Regalica River and conversion of the infrastructure at the Szczecin Podjuchy station and on the Szczecin Podjuchy – Szczecin Port Centralny SPA route.

Photograph 3. A general view of the route and the site of the occurrence as seen from the driver cabin in daylight on 19 January 2023. Visible is the construction site whose illumination at nighttime hindered observation of the route by the driver of the rail vehicle (materials of the railway commission).

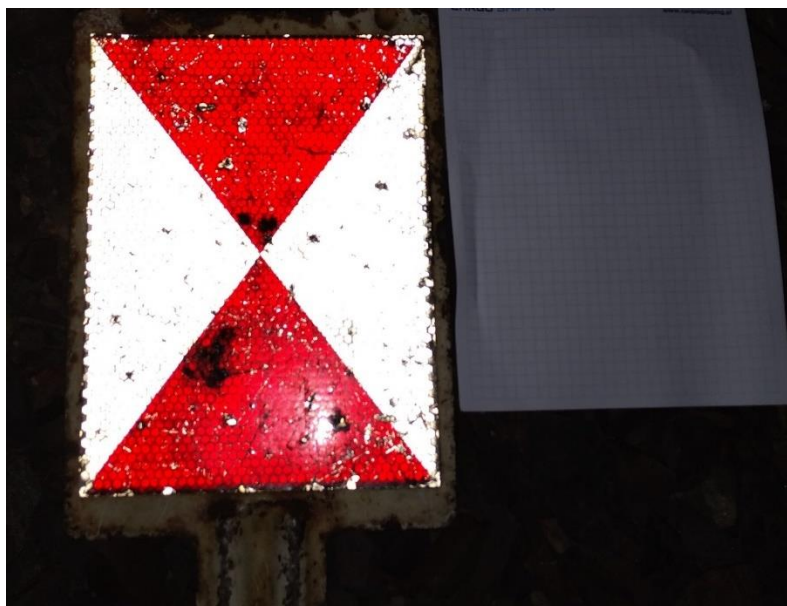
The last wagon of train TME 674013 had train end signals used on German railways, as shown in Photograph 4.

Photograph 4. The train end signal used on train TME 684013 (next to it is a non-reflective sheet of white paper for comparison)

The investigation Team considered that restricted ability to monitor the route on the part of the driver of the CTL Logistics E182-055 locomotive was a contributing factor due to the curve of the track and illumination of the construction site adjacent to the plain track which caused dazzling after clearing the bridge and reduced visibility of reflective signals of the end of the rain on the track. The train end signals used are shown in Photograph 4.

The Pc-5 train end signal disks affixed to the last wagon of train TME 674013 did not meet the requirements laid down in "Technical requirements for indicators and signal disks Ie-102".

- 6) In order to ensure good visibility of the return reflection from Pc 5 signal disks (day) on curves, the railway carriers shall implement the obligation to use Pc 5 signal disks "Marking of the end of a train or another rail vehicle" in accordance with the technical requirements laid down in Part II of Instruction Ie-102 "Technical requirements for indicators and signal discs" on freight trains operating on railway lines managed by PKP Polskie Linie Kolejowe S.A.

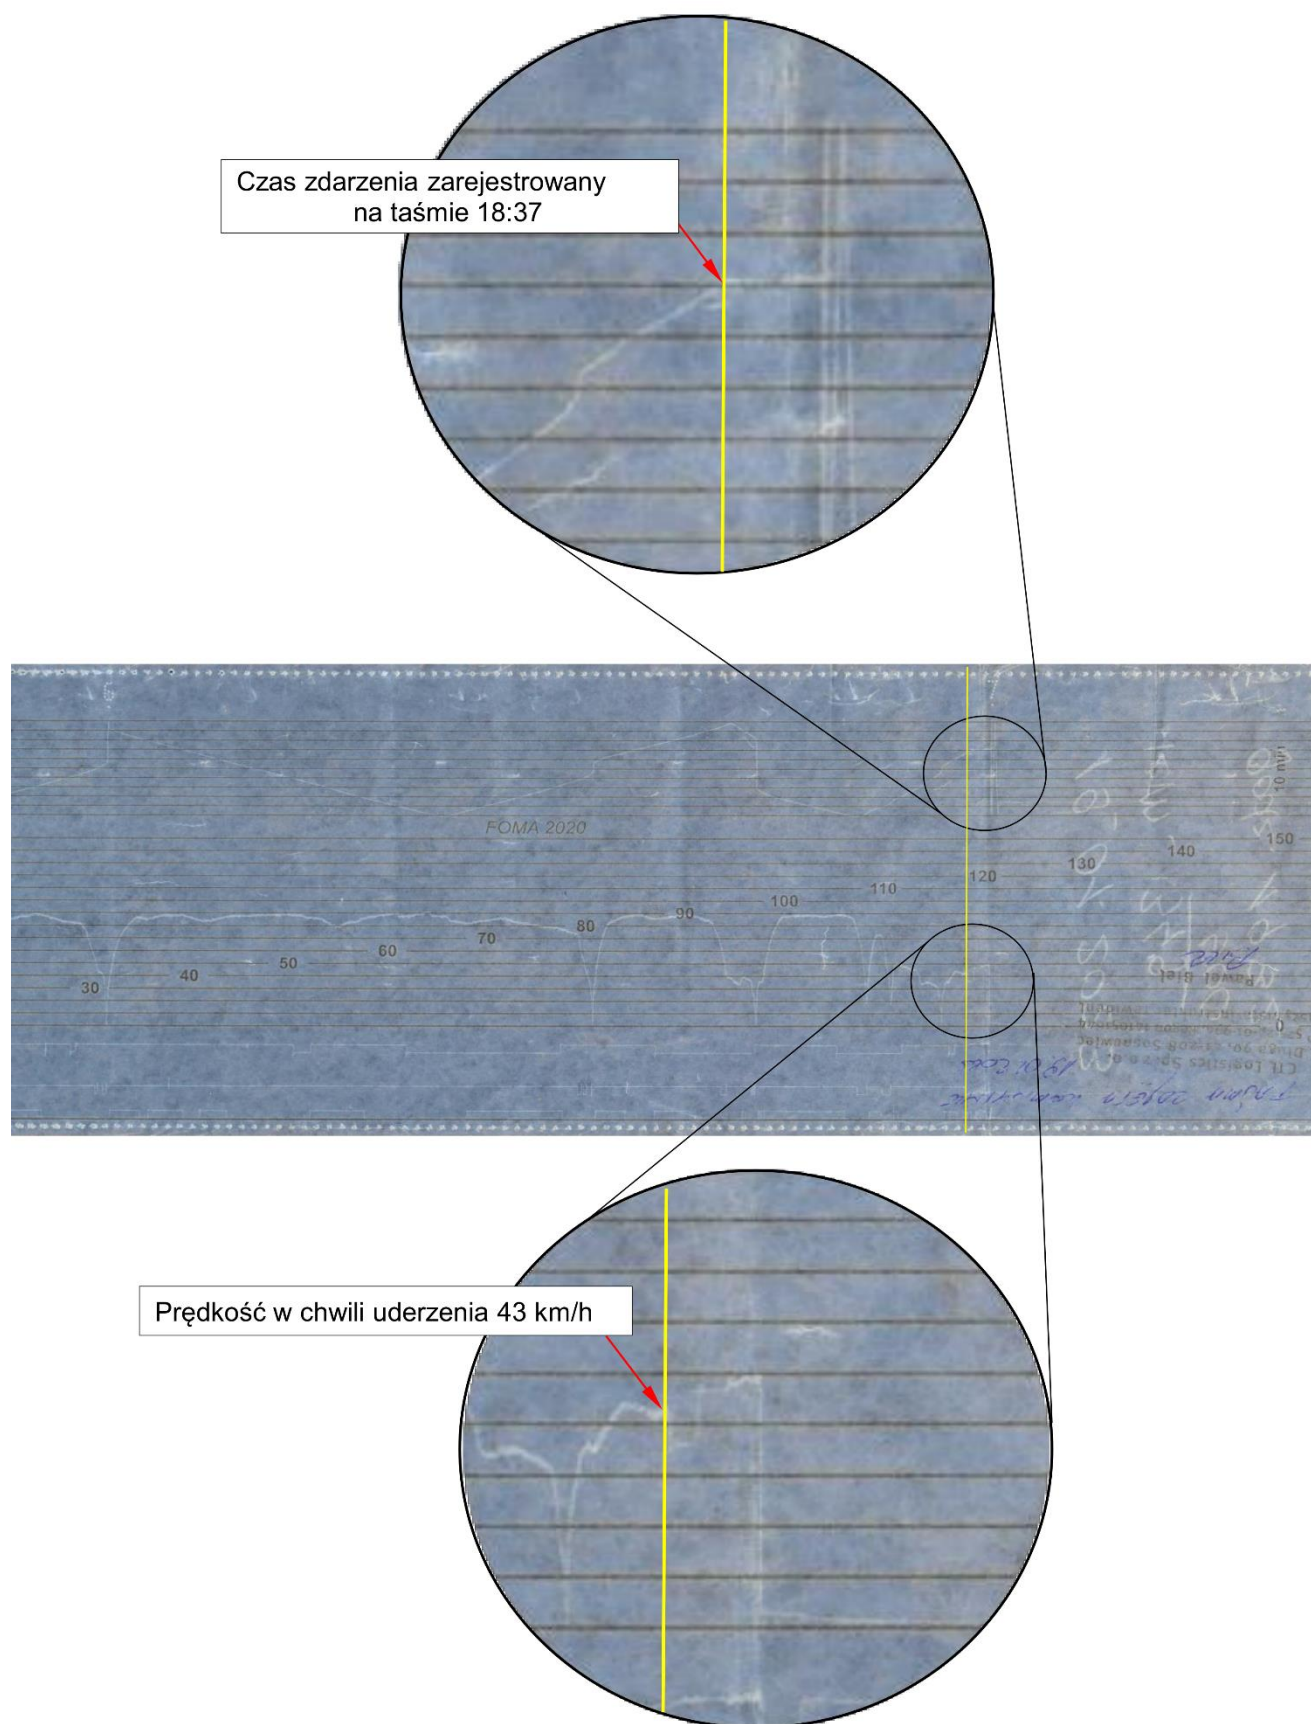
The time recorded on the tape is inconsistent with the actual time – it is shifted by 12 hours.

Photograph 5. A scan of the speedometer tape from the E182 - 055 loc. (prepared by PKBWK)

- 7) Railway carrier CTL Logistics Sp. z o.o. shall ensure supervision of the correct setting of the real time in traction vehicle recorders.
 - 8) The infrastructure managers shall procure that works contractors eliminate visibility of sources of light illuminating their construction sites in the area of active railway tracks which dazzle drivers of rail vehicles.

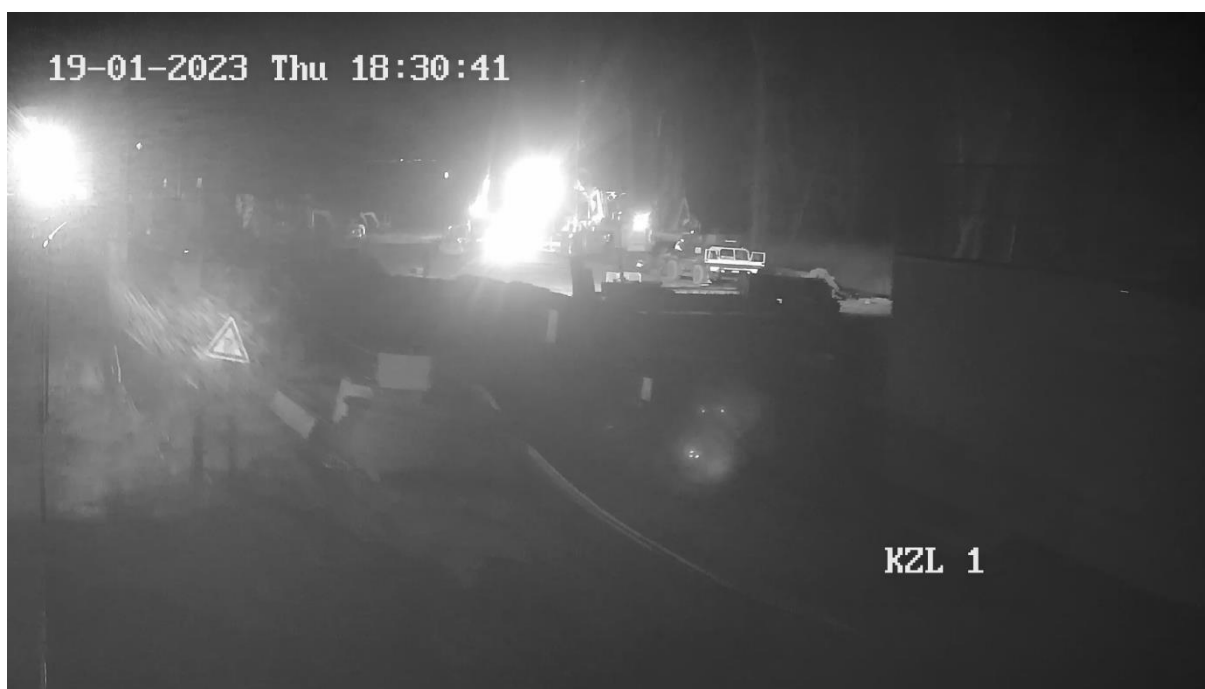
Photograph 6. A general view of the route immediately after clearing the bridge over the Regalicą River (a frame from the footage recorded by the rear right mirror camera of the locomotive of train TME 684013)

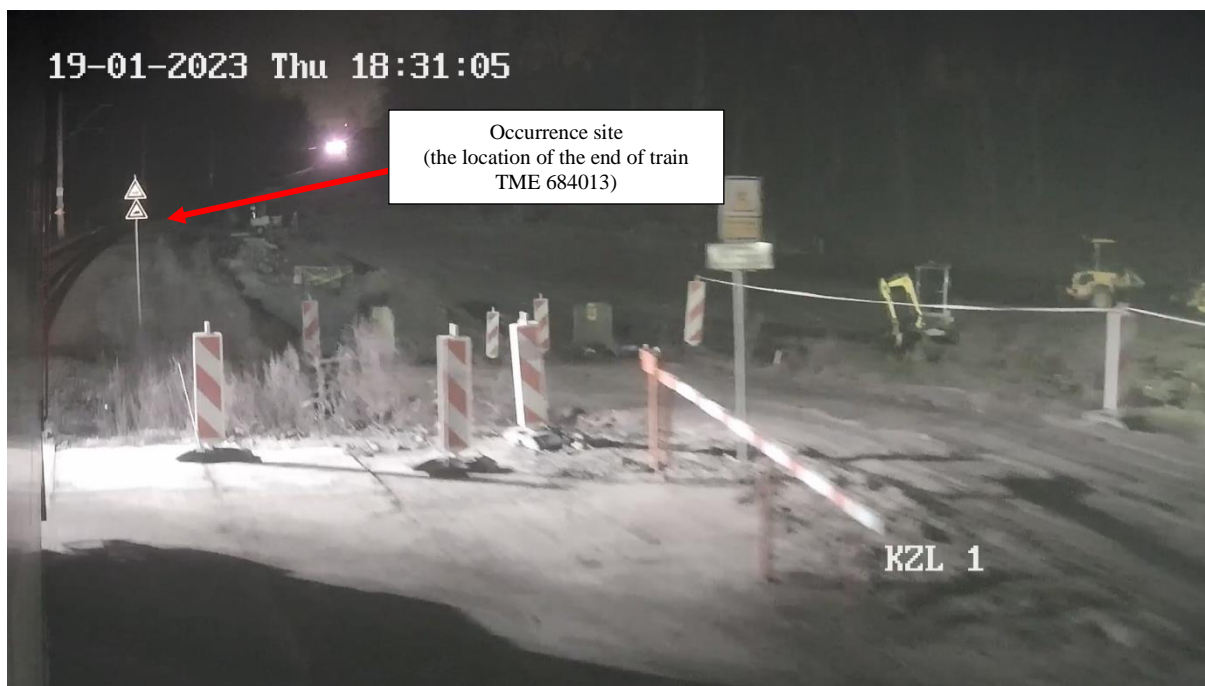
Photograph 7. A view from around 100 m ahead of the occurrence site (a frame from the footage recorded by the rear mirror camera of the locomotive in train TME 684013)
