STATE COMMISSION ON RAILWAY ACCIDENT INVESTIGATION
Ministry of the Interior and Administration

REPORT No. PKBWK 4/2024

on the investigation of a railway incident
which occurred on 8 May 2023 at 07:26 hrs on the Góra Włodowska – Zawiercie route,
track no. 1, km 212.400 of railway line no. 4 Grodzisk Mazowiecki – Zawiercie,
the area of the infrastructure manager PKP PLK S.A. Railway Line Plant
in Częstochowa

Warsaw, 18 March 2024

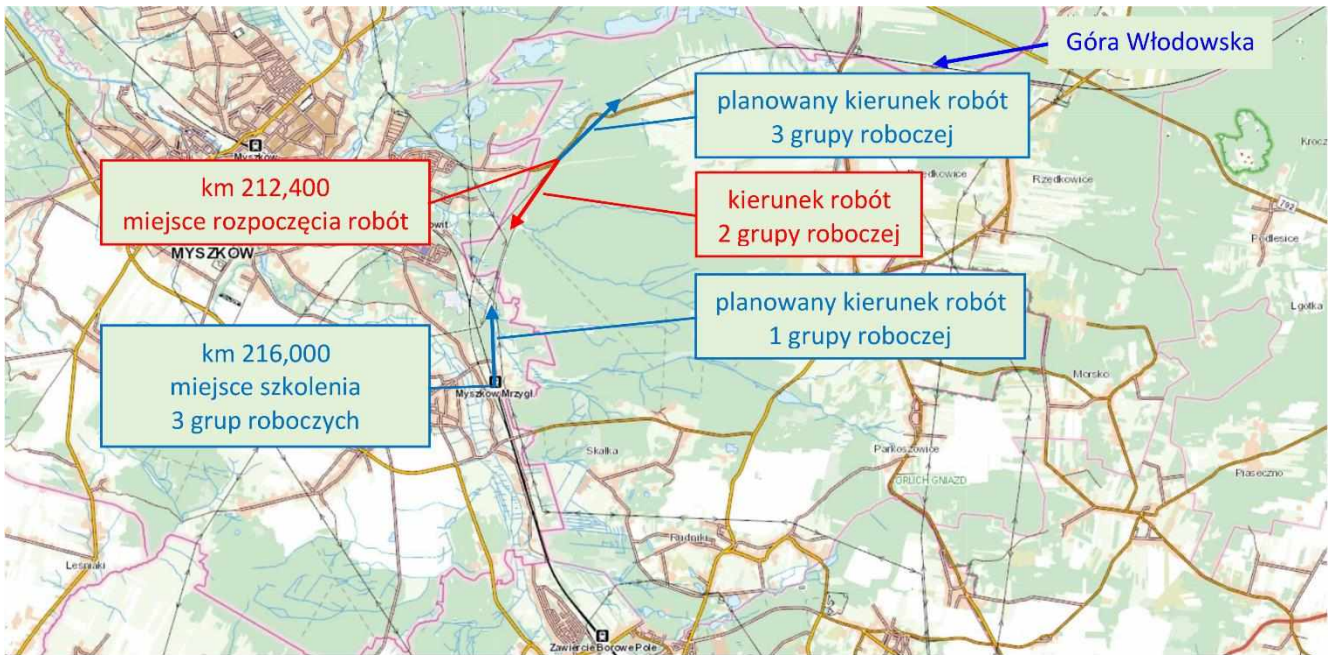
Figure 2 – Planned organisation, start and end location of works as of 8 May 2023 (source: Geoportal)

Approaching the work site from the side of track no. 1, group 2 (see Fig. 2) was the first to arrive and immediately, at 07:00 hrs, commenced dismantling (disengaging) the rail attachments in active track no. 1, instead of closed track no. 2. The work progressed in the direction of the line's ascending chainage. That group had managed to disengage ca. 200 m of track no. 1 when the third group arrived on site. Noticing that the second group was disengaging track no. 1, the supervisor of the third group notified the work organisation manager immediately by telephone, and the latter ordered the trackmaster in the second group by mobile phone to start re-engaging the rails in the track. Meanwhile, at 07:24 hrs, train no. 14001 departed the Góra

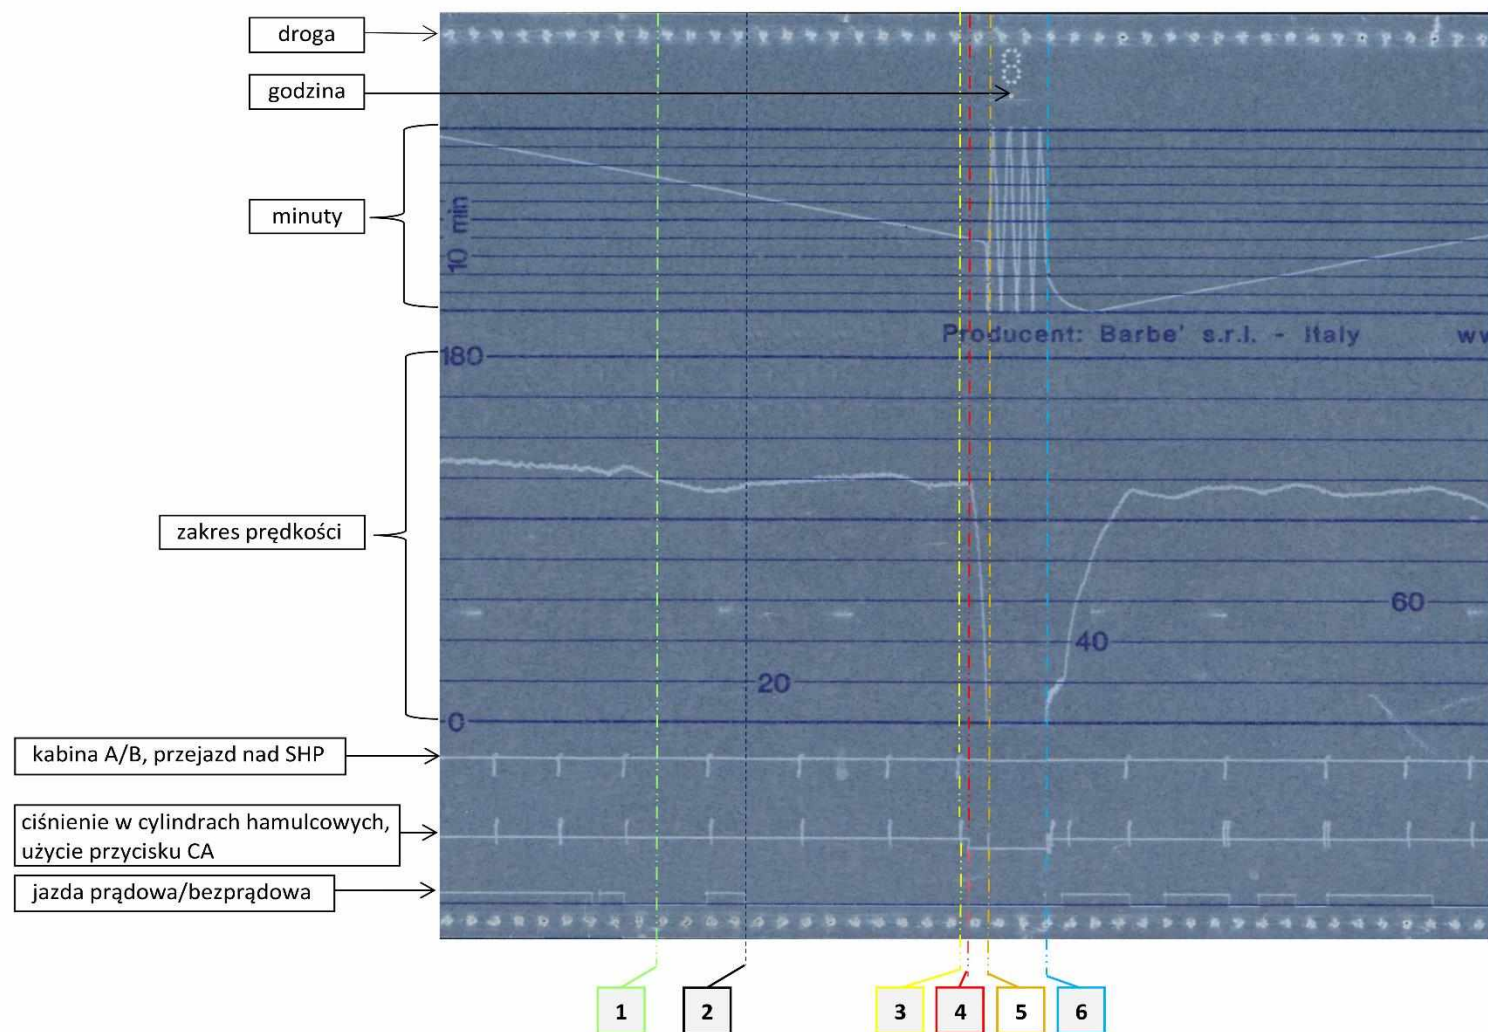
Figure 4 - A chart of the locomotive's driving parameters

A description of the driving characteristics of train IC no. 14001 operated between Warszawa Wschodnia and Bohumin on the section between Włoszczowa Północ and the place of the occurrence (legend for Figure 4).
Departure from the Włoszczowa Północ station at 06:57 hrs, control from Cabin A., electric drive, travel with the speed in the range between 120 km/h and 130 km/h on the distance of 49.5 km until 07:23 hrs;

- 1 - 07:23 hrs, from km 204.900 on - travel at the speed of 120 km/h (an *ad hoc* speed limit imposed for the duration of railworks between km 205.401 and km 222.689),
- 2 - 07:23:30 hrs, non-electric drive, maintaining the speed below 120 km/h,
- 3 - 07:26 hrs, travel over an automatic train stop magnet, non-electric drive at the speed of 120 km/h, use of the vigilance button,
- 4 - 07:26 hrs, at the speed of 119 km/h the system recorded a pressure drop in the train's brake cylinders, non-electric drive, speed down to 0 km/h on the distance of 400 m,
- 5 - 07:26 hrs, the head of the train stops at km 212.200, use of the vigilance button,
- 6 - 08:48 hrs, the train is restarted and continues its travel in the direction of the Zawiercie station.

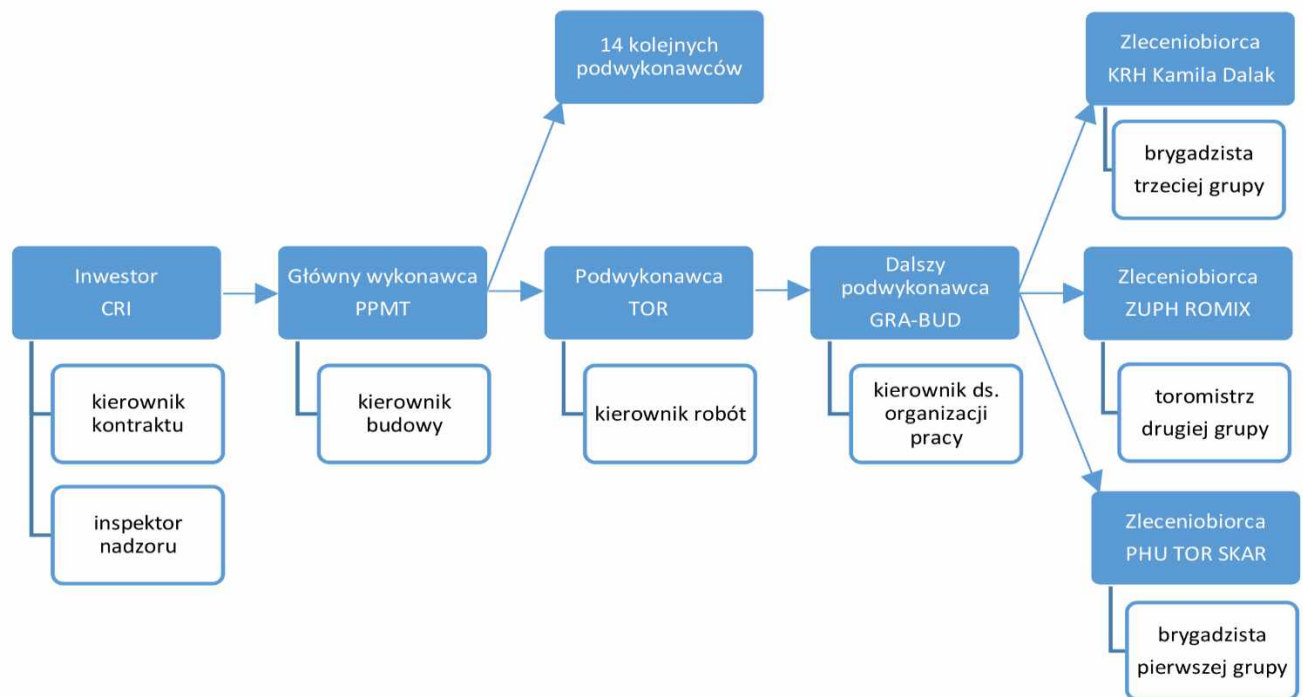
Figure 5– Chain of relations: investor, contractor and further subcontractors

GRA-BUD, as a further subcontractor, was tasked to provide construction services including railworks and accompanying works. The agreement for those works concluded with TOR prohibited any further subcontracting. Despite that provision, GRA-BUD subcontracted a part of the works to *inter alia* KRH Kamila Dalak, PHU TOR-SKAR and ZUPH ROMIX without the knowledge or approval of the investor and main contractor. The Investigation Team found, as a contributing factor, non-compliance by a further subcontractor with the provisions of agreement as regards the prohibition of commissioning work to further subcontractors, and admission of the company workers, without any knowledge or approval of the contracting entity and the main contractor, which had contributed to the lack of immediate supervision over them on the part of the investment supervision inspector.
