INVESTIGATION REPORT

Collision of an ICR with a buffer stop at Laois Train Care Depot, 17th July 2018

RAIU Report No: 2019-R002

Issued: 25th June 2019

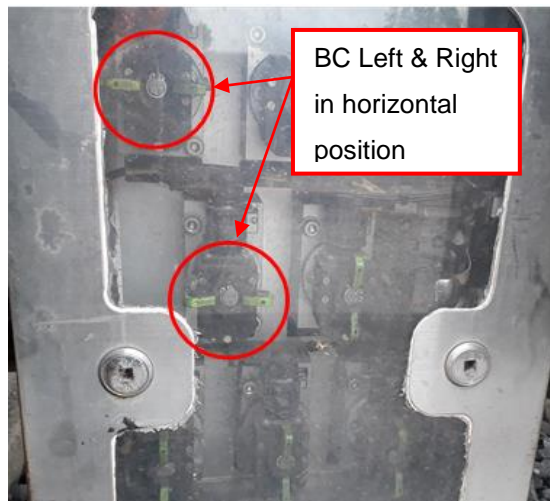
Figure 6 – BC Left & BC Right in the horizontal isolated position

- All four brake isolating boxes of ICR 16 were found to have the brake isolating cocks BC Left and BC Right in the horizontal isolated position (Figure 6 shows one isolation box, there are a total of four) resulting in no brake being present on the entire set;

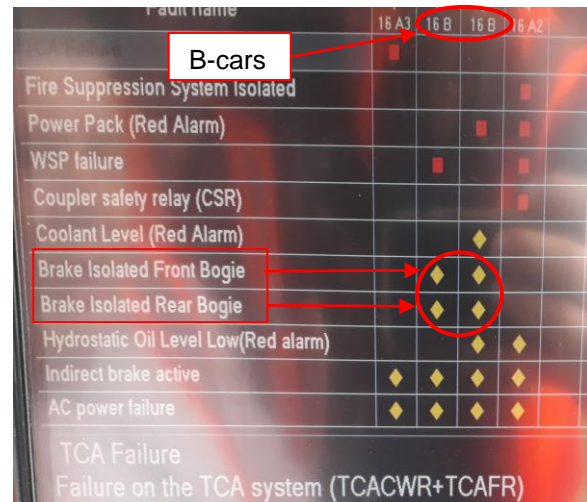
Figure 7 – MMI showing brake isolated front & rear bogies for both B-cars

- The cab brake cylinder gauge was found to have a positive brake cylinder reading;
- The MMI screen showed the message “Brake isolated front bogie” / “Brake isolated rear bogie” for both B-cars (illustrated previously in Figure 7);

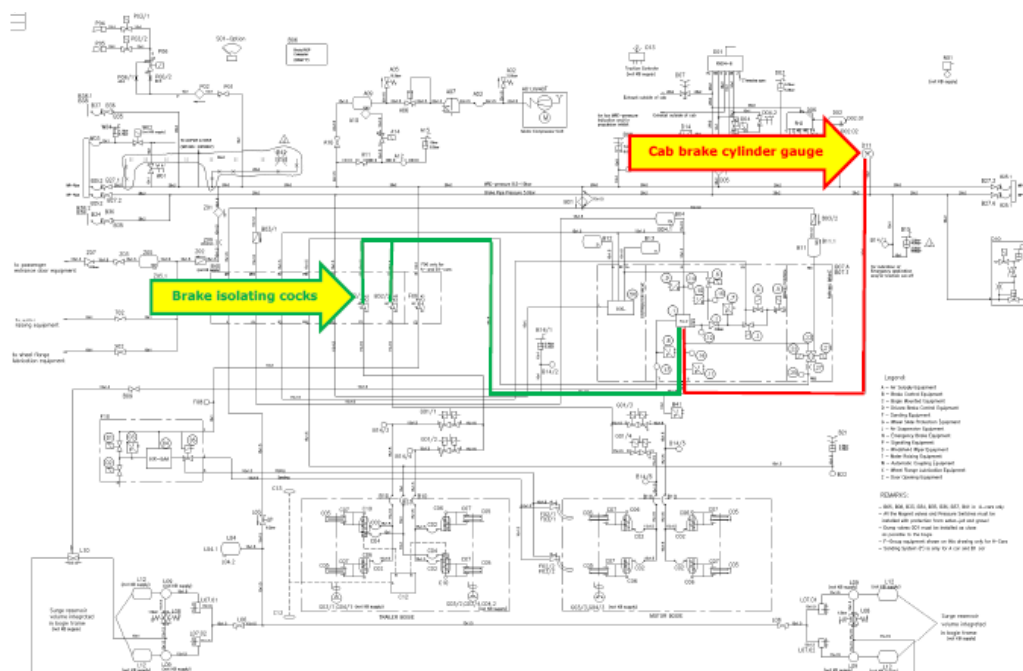
Figure 8 – ICR 22000 Brake system diagram illustrating “Brake isolation cocks (Green Line)” and the “Cab brake cylinder gauge (Red Line)”

- 36 The *cab brake cylinder gauge* (which under normal circumstances displays the amount of air pressure available in the brake cylinder on a gauge in the cab). The ICR cab brake cylinder gauge indicates brake cylinder pressure, the signal is taken from a position upstream of the brake cylinder isolating cocks allowing for a positive brake cylinder pressure reading in the cab even when the brake cylinders are isolated, see Figure 8 (the figure is for illustrative purposes only, and illustrates the position of the brake cylinder gauge in relation to the brake isolation cock) i.e. the cab brake cylinder gauge can show a positive pressure reading even when all the brakes have been isolated.

- 37 The ICR braking system is different to other IÉ fleets. On the ICR fleet, isolation of the brake cylinder cock does not isolate both the cab gauge and the brake cylinder, it only isolates the brake cylinder; this was to allow for the brake pressure to be visible in the active cab when the brakes were isolated on the same unit.
- 38 The RAIU became aware of the presence of cab brake cylinder reading on the ICR fleet even when all the brakes are isolated; the RAIU issued an Urgent Safety Advice Notice on the 17th August 2018 recommending that “IÉ should advise all relevant staff that a positive brake cylinder gauge reading in the cab of an ICR is not an indication that a brake is present”.

125 An unusual feature to the 22000 ICR braking system is that the cab brake cylinder gauge is upstream of the brake isolating cocks; meaning the cab brake cylinder gauge can show a positive pressure reading even when the brakes have been isolated on all cars of the set (paragraph 102). On the 17th July, all four brake isolation boxes had the brake isolation cocks in the horizontal position, with the CME Driver seeing a positive reading on the cab brake cylinder pressure gauge (paragraph 103). The RAIU became aware of the anomaly and issued an Urgent Safety Advice Notice recommending that “IÉ should advise all relevant staff that a positive brake cylinder gauge reading in the cab of an ICR is not an indication that a brake is present” (paragraph 104).

104 The RAIU became aware of the anomaly i.e. the positive cab braking cylinder reading with all brakes and on the 17th August the RAIU issued an Urgent Safety Advice Notice recommending that "IÉ should advise all relevant staff that a positive brake cylinder gauge reading in the cab of an ICR is not an indication that a brake is present" (paragraph 37).
