**Railway Accident
Investigation Unit**

INVESTIGATION REPORT
Vehicle struck by train at Corraun level
crossing, XX024, Co. Mayo,
12th February 2014
RAIU Report No: R2015-001
Published: 30/04/2015

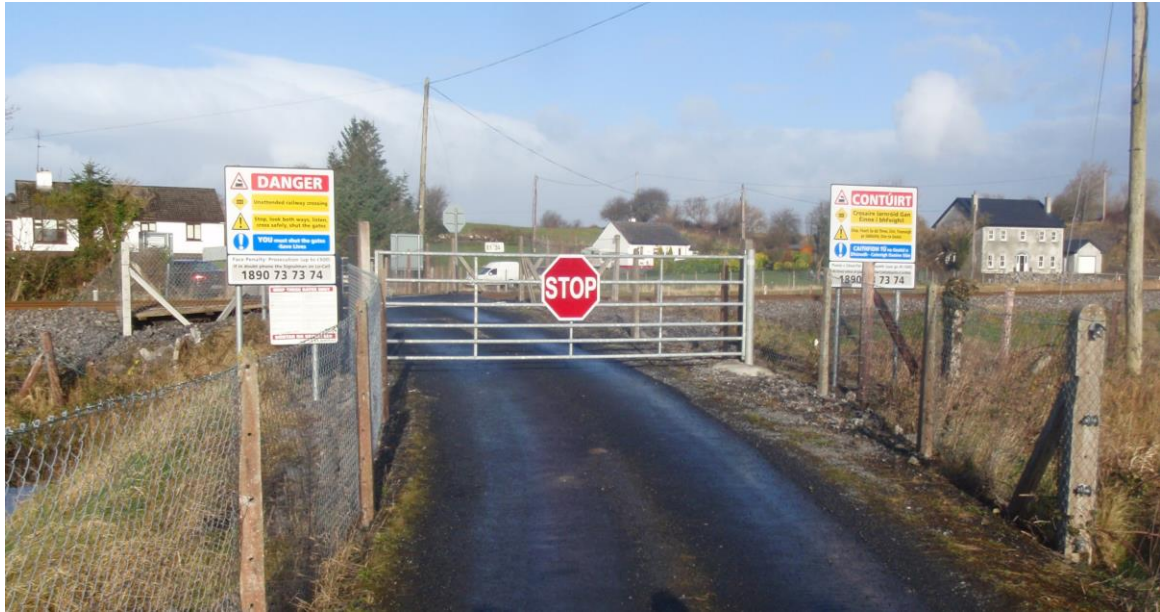
Figure 10 – The Level Crossing

52 The signage on the Level Crossing was replaced by IÉ in January 2013, see Figure 10.

55 The signage at the Level Crossing is compliant with IÉ Technical Management Standard CCE-TMS-380, ‘Technical Standard for the Management of User Worked Unattended Level Crossings’ issued July 2013 (which will be referred to as CCE-TMS-380 for the remainder of the report).

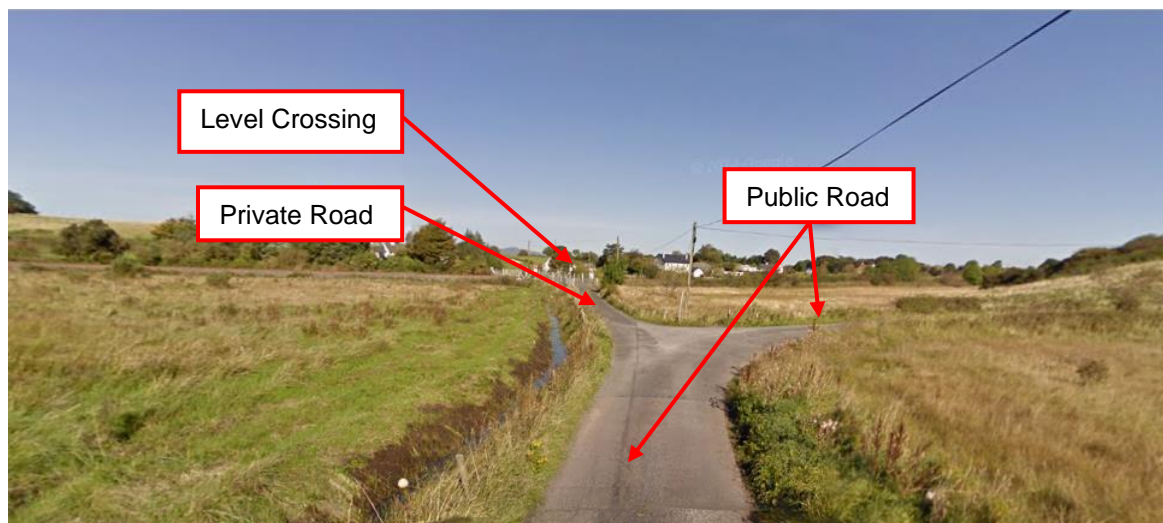
Figure 23 – View from public road onto private road (with the Level Crossing)

128 The Level Crossing is located 450 m from the N5, the national road from Castlebar to Swinford. It is located on a private road, which has unrestricted access from a third class public road L57721, see Figure 23. As a result, it is easily accessible to members of the public (paragraph 44).
