**Railway Accident
Investigation Unit**

INVESTIGATION REPORT
Dangerous occurrence
between Ballybrophy and Portlaoise
12th September 2015

RAIU Report No: R2016 – 002
Published: 6th September 2016

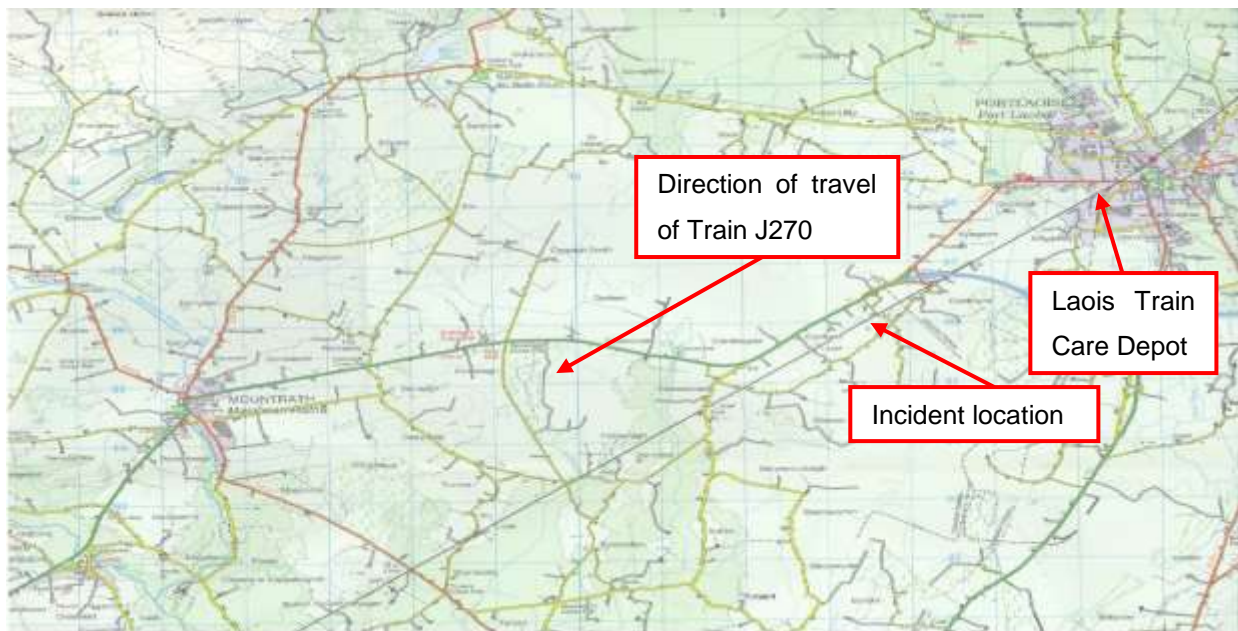
Figure 1 – Location of the incident

- 7 The oncoming vehicle was approximately fifteen yards away when the crew realised it was a train. The train was an empty passenger train, (Train J270) which was travelling from Laois Train Care Depot to Mallow, there was a 40 kilometre per hour (km/h) (25 miles per hour (mph)) TSR in place on the Down Line. As the train passed on the Down Line adjacent to the area where the BBRI and IÉ staff were working, all staff were in a place of safety at the time and as a result there were no injuries.
- 8 There had been no warning of the train and all of the staff working on the line were of the opinion that the adjacent line to where they were working was within a T3 Possession at the time the train passed by (see Figure 1 for location of incident).
