**Railway Accident
Investigation Unit
Ireland**

INVESTIGATION REPORT

Wrongside Door Failure at Ashtown Station,

RAIU Report No: 2019 – R001

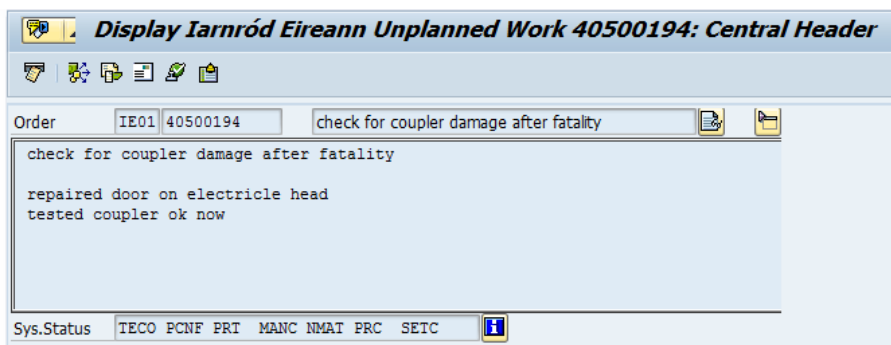
- 55 After the fatal accident on the 6th June 2018, the steps identified in VMI Z1C29A0001 were undertaken. CME generated an unplanned ‘work order’ to “check for coupler damage after fatality”. After which the coupler was checked, repaired and tested, with the work order stating: “repaired door on electrical head” and “tested coupler ok now”, see Figure 13.

Figure 13 – CME Work Order generated for coupler on the 6th June 2018

113 In terms of the unscheduled maintenance, VMI Z1C29A0001 was carried out after the collision on the 6th June 2018. The collision which directly impacted the coupler of car 29415. VMI Z1C29A0001 does not directly request the inspection of the coupler, but does have an all-encompassing step for checking for damage sustained (paragraphs 52 - 54); as a result, the external parts of the coupler was checked, damage was found to the door of the electrical head which was repaired and tested (paragraph 55). There were no checks carried out to the internal parts of the electrical head.

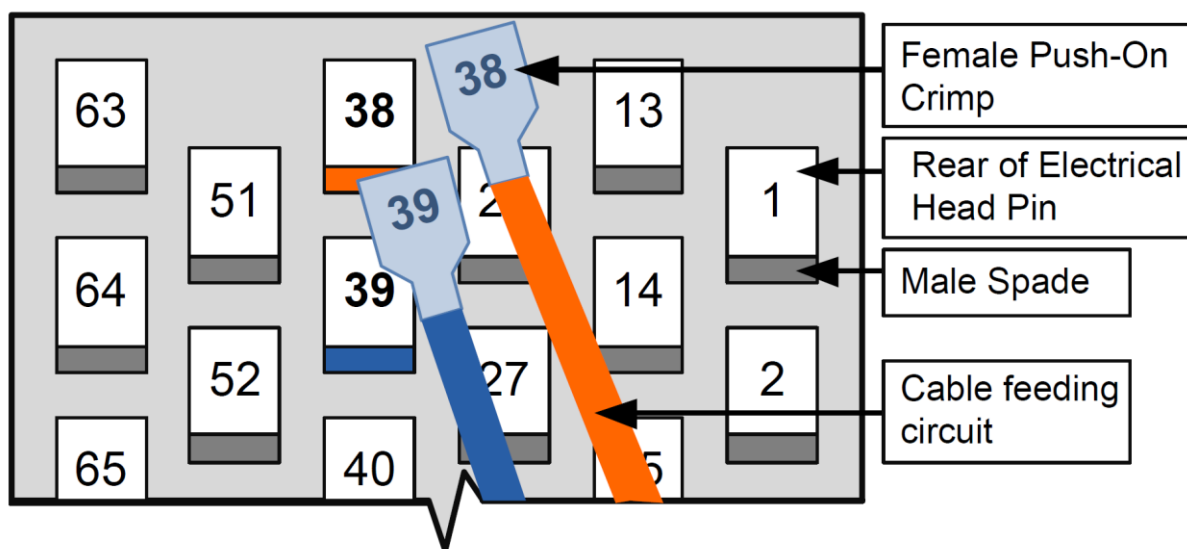
Figure 14 – Illustration of rear of coupler head

57 A further inspection of the rear of the coupler electrical head on car 29415 found that Crimp 38 (battery positive) and Crimp 39 (door interlock loop) were detached from Spade 38 and Spade 39, respectively; with Crimp 39 (door interlock loop) now touching Spade 38 (battery positive). See Figure 14 for an illustration of the contact and Figure 15 for a photograph taken after the incident (which shows the detachment, however, Crimp 39 is no longer touching Spade 38).

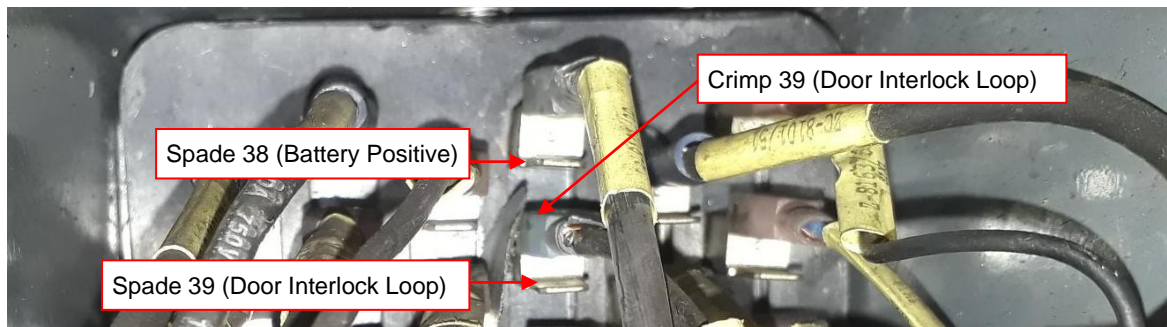
Figure 15 – Photograph taken after the incident (Crimp 39 is no longer touching Spade 38)

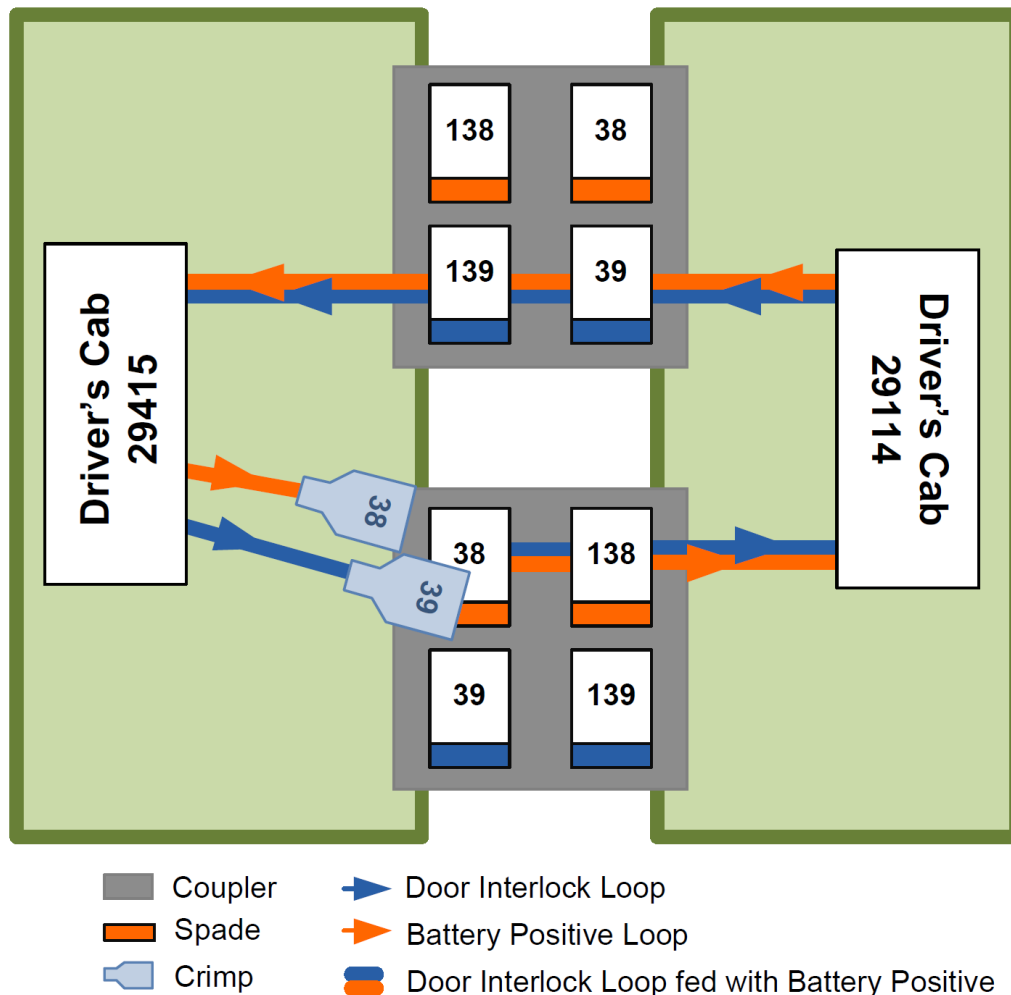
58 The contact resulted in the Door Interlock Loop (from Crimp 39) being supplied with a 24V Direct Current (DC) from the battery positive contact (from Spade 38), effectively meaning that the Door Interlock Loop circuit and the battery positive circuit became one combined circuit, see Figure 16. This resulted in the Door Interlock Loop circuit completing, when a door was opened by a passenger on the front set and the doors of the rear set remained closed.

Figure 16 – Door Interlock Loop fed with Battery Positive

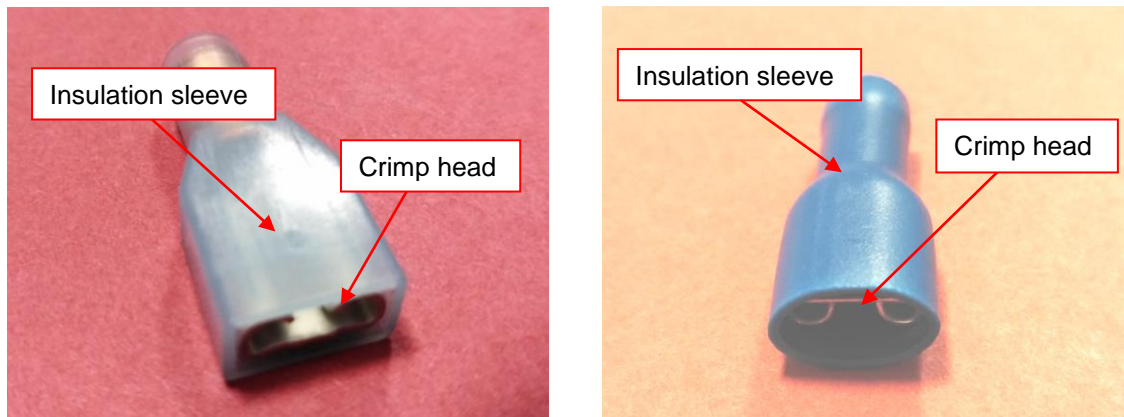
Figure 17 – Push-on Crimp Spades

59 The physical condition of the crimps and spades showed no signs of wear. When they were reconnected to the correct terminals, both were found to be a tight fit and required force to make the connections. An inspection of the crimps found that the insulation sleeve did not protrude beyond the head of the crimp (see white insulation sleeve in Figure 17); this allowed the crimp to make direct contact with the spade. Figure 17 also illustrates a crimp with a protruding sleeve (see blue insulation sleeve covering the head of the crimp).
