**Railway Accident
Investigation Unit
Ireland**

INVESTIGATION REPORT

**Dangerous occurrence involving a Double SPAD at
Clontarf Road Station,**

RAIU Investigation Report No: 2023-R001

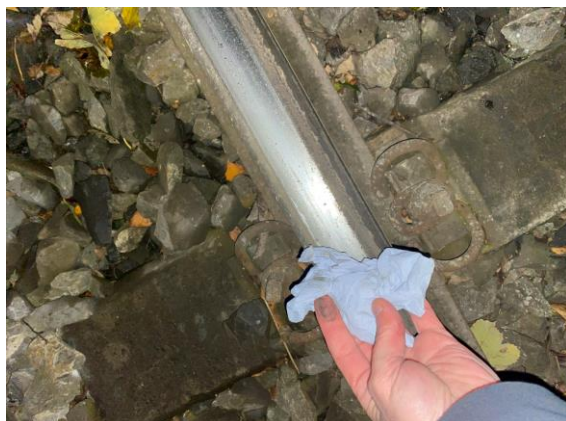
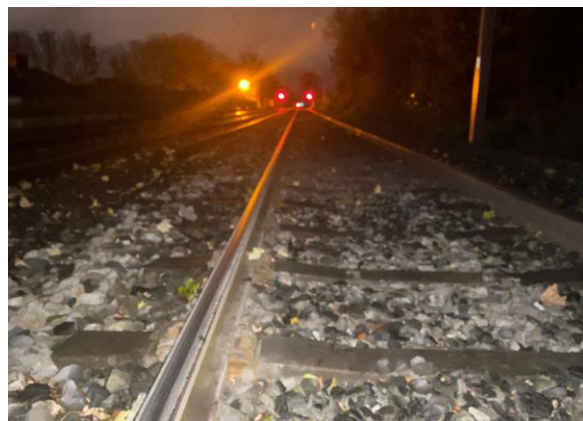
Figure 11 – Dry railhead prior to Clontarf Road Bridge

- 87 The CCE Department scrubbed the railhead when peak-time passenger rail services were over; the locations scrubbed were the Up Road between the 1 MP 550 yards to the 1 MP 233 yards; the process included applying orange cleanse to the rail followed by scrubbing the head of the rail with handheld rail scrubbers.
- 88 No contamination of the track was found prior to Clontarf Road Bridge (UBB5) 1MP 503 yards on the Up Road, see Figure 11.

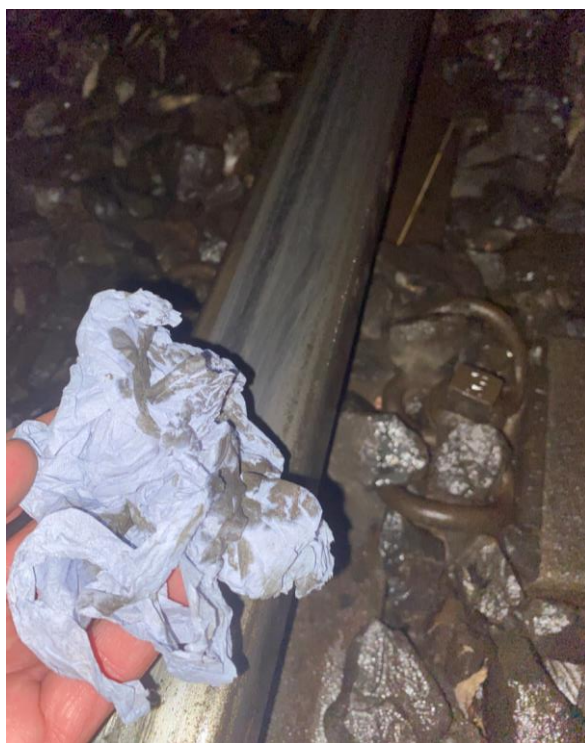
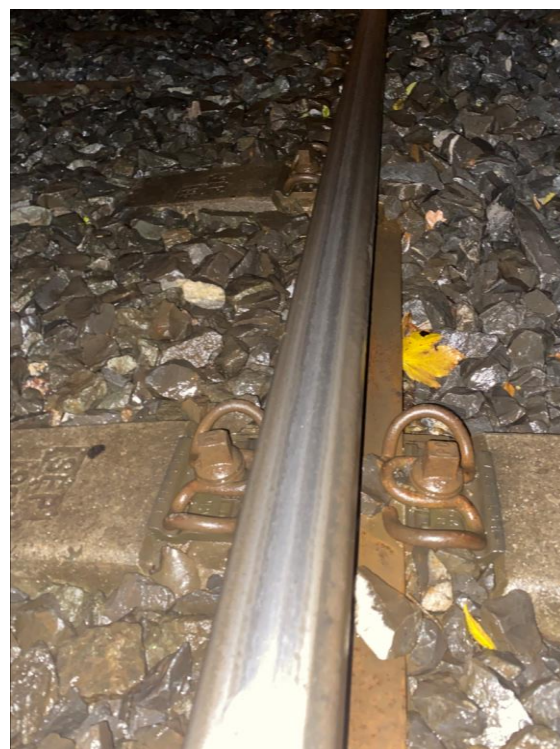
Figure 12 – Contaminated railhead on the Up Road

- 89 Track contamination was found on the Up Road past Clontarf Road Bridge and through Clontarf Road Station, see Figure 12.

- Safety Recommendation 2023001-05 – Iarnród Éireann Infrastructure Manager (IÉ-IM) Chief Civil Engineer (CCE) should consider, based on a risk-based approach, the introduction of *Traction Gel Applicators* (TGAs) at more locations.

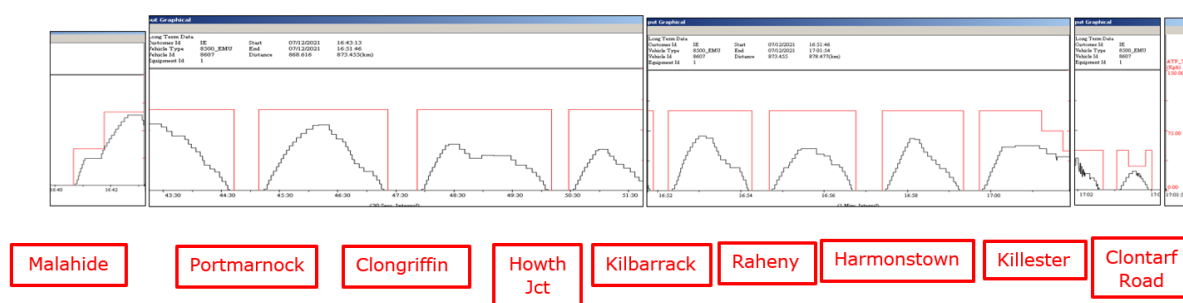
Figure 17 – Train E120 Actual Speed (Black Lines) and ATP Target Speed (Red Lines)

144 By way of comparison, a screen shot of the OTDR data²⁰ for Train E120's (operated by Driver E120a) journey from Malahide to Clontarf Road, Figure 17, shows the actual speed (black line, Figure 17) staying within the bonds of the ATP target speed (red line, Figure 17) for the entire journey with no ATP penalty brake application.

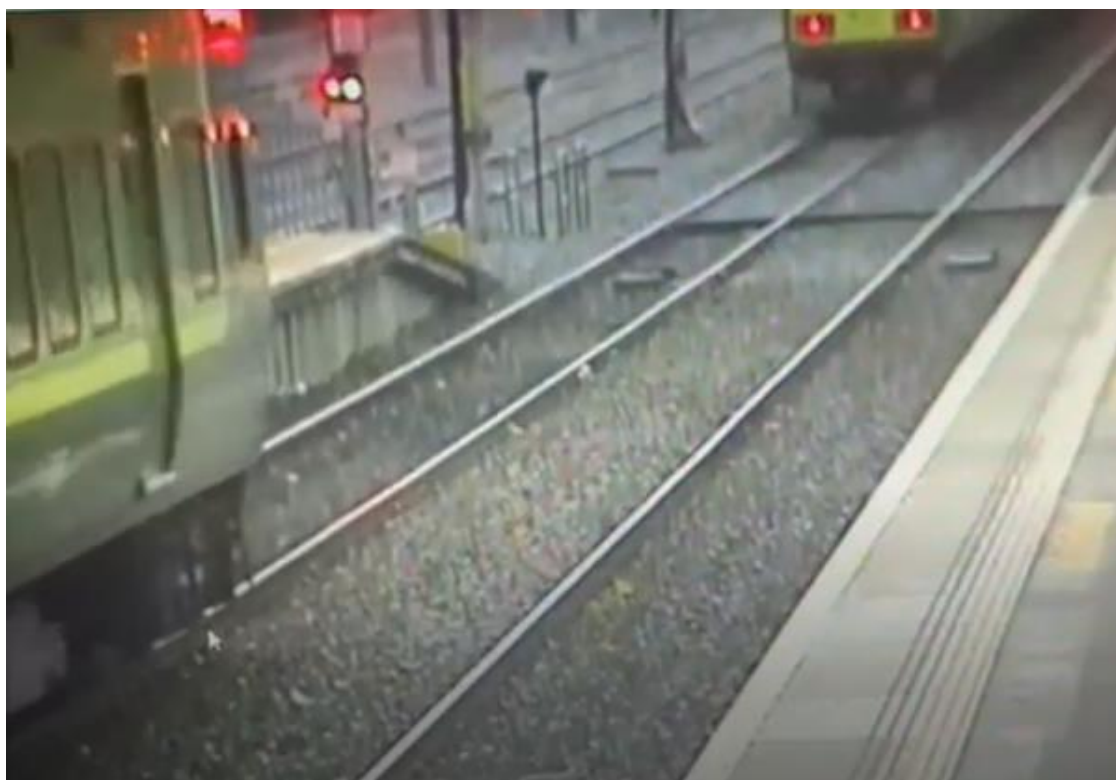
Figure 20 – Train E240 approaching Train E120

155 At 16:03:14 hrs Driver E240 rings the Central Signalman direct rather than making an emergency call through the Global System for Mobile Communications – Railway (GSMR)^{24,25} train radio. At 16:03:22 hrs the call connects and Driver E240 advises the Central Signalman that Train E240 had passed a signal (Signal DN287) at danger and was skidding towards the train that was at the Crew Ramp in Fairview (Train E120), Figure 20.

- Safety Recommendation 2023001-12 – IÉ-RU Ops should brief all drivers on the importance of making an open call in an emergency situation rather than calling the Signalmen direct.

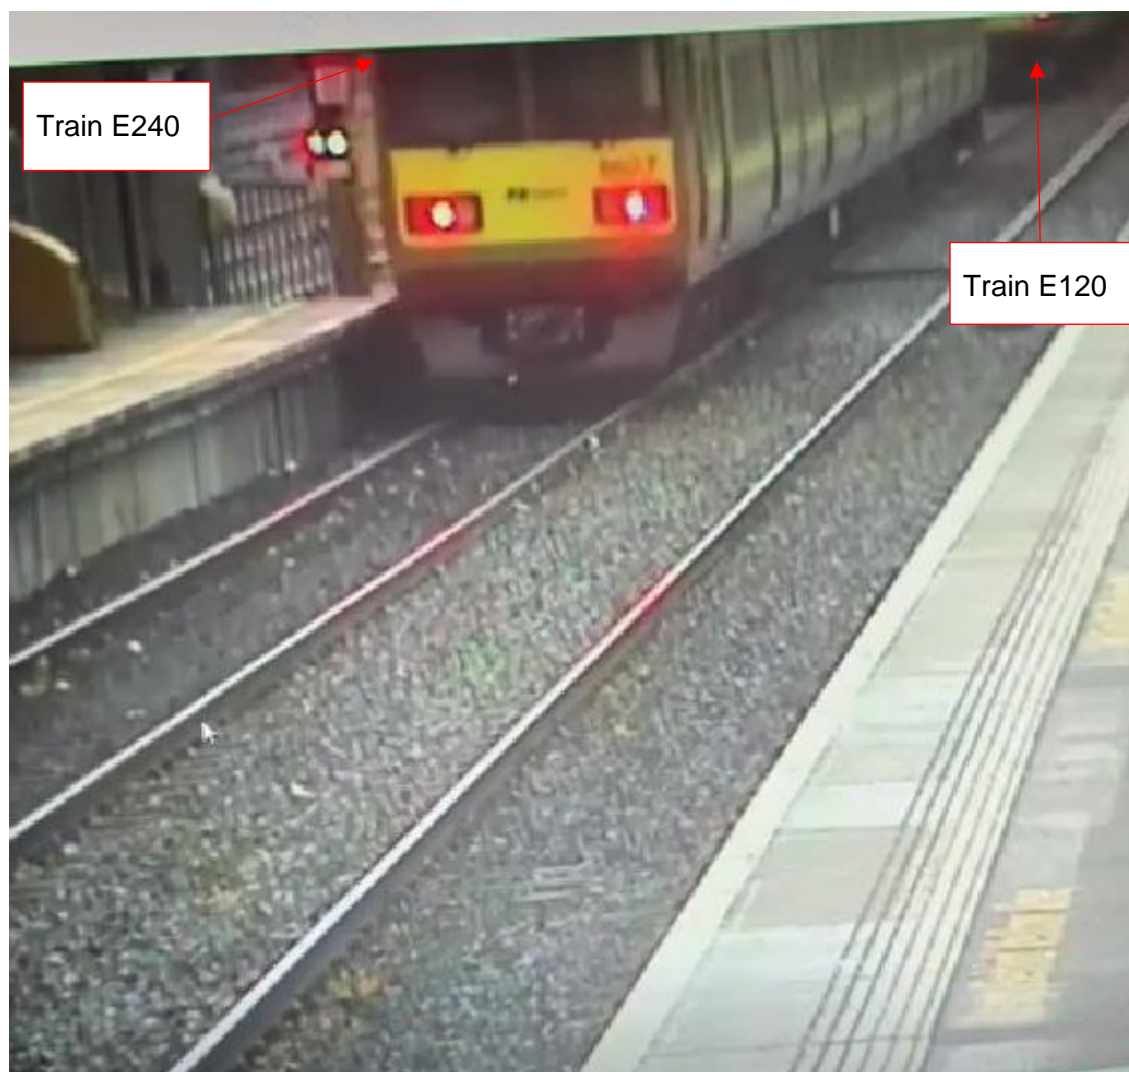
Figure 21 – Train E240 coming to a stop

- 156 The Central Signaller advised Driver E240 that he was going to hang up and contact the driver of the train (Driver E120b) at the Crew Ramp in Fairview; the Central Signaller hangs up at 16:03:56 hrs.
- 157 At 16:04:05 hrs the Central Signaller phones Driver E120b, the call connects at 16:04:11 hrs. Driver E120b confirmed that their train (Train E120) was moving, and the Central Signaller requested Driver E120b to keep moving.
- 158 Train E240 continued through Clontarf Road Station and also passed Signal DN295 (at the south end of Clontarf Road Station) at danger, travelled to within an estimated 5 m of Train E120, see Figure 21.

159 Train E240 came to a stop past Signal DN295, it is estimated that a collision with the rear of Train E120, was avoided by five seconds.
