**Railway Accident
Investigation Unit**

INVESTIGATION REPORT
Vehicle struck by train at Cartron level
crossing, XM220, Co. Mayo,
17th August 2018

RAIU Report No: 2019 – R003
Report Published: 03/09/2019

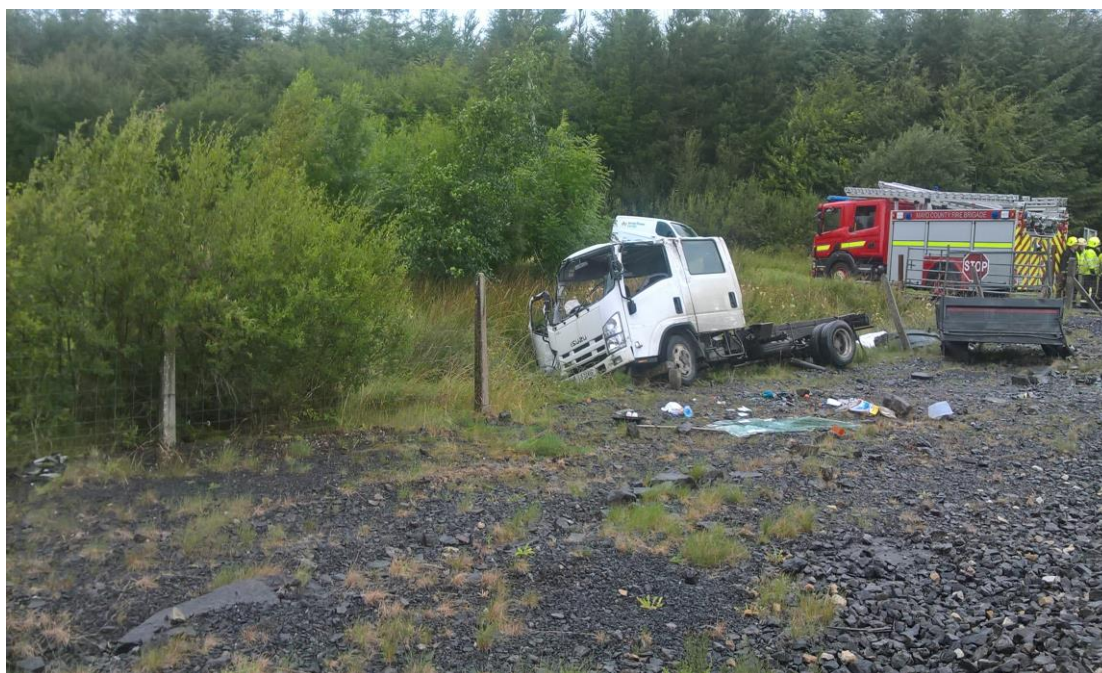
Figure 2 – Scene of the accident

- 2 At the same time, the 08:15 hrs goods train from Ballina to North Wall International Warehousing and Transport Dublin (train identification number K801) was travelling towards LC XM220 and struck the Truck. On impact, the Truck was thrown clear of the train and into the adjacent boundary fence before coming to a stop. The train came to a full stop 482.43 metres (m), measuring from the front of the train, past LC XM220, see Figure 2.

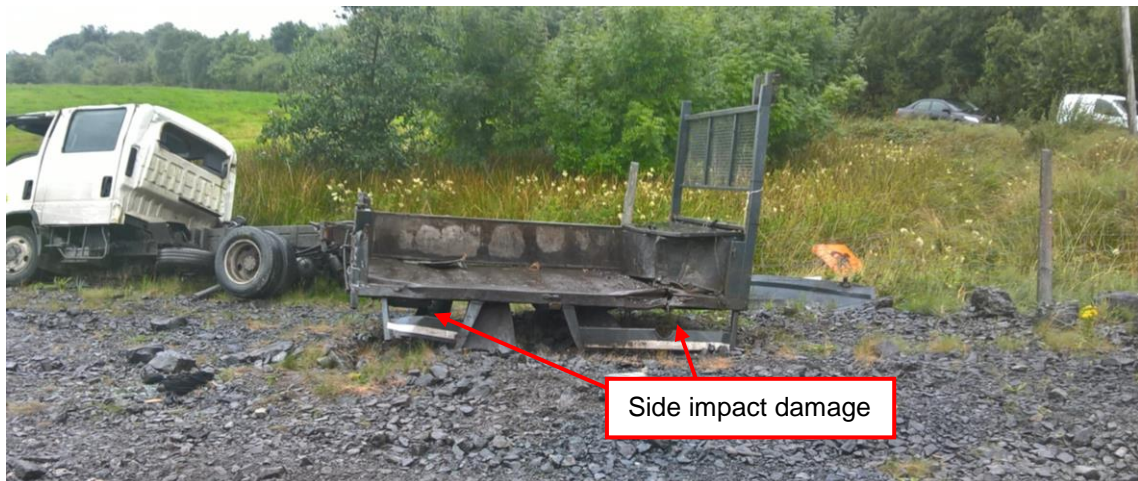
Figure 5 – Damage to the Truck and fencing

- 22 The Truck suffered side and frontal damage in the impact and the rear goods carrying flat-bed behind the crew cab was dislodged by the impact, see Figure 5 illustrating where the buffers collided with the Truck.

- 23 There was damage to LC XM220 infrastructure boundary fence and cattle grid because of this accident.
- 24 The front of the train was not damaged, there were however scuff marks where the front buffers had contacted with the side of the Truck, see Figure 6.

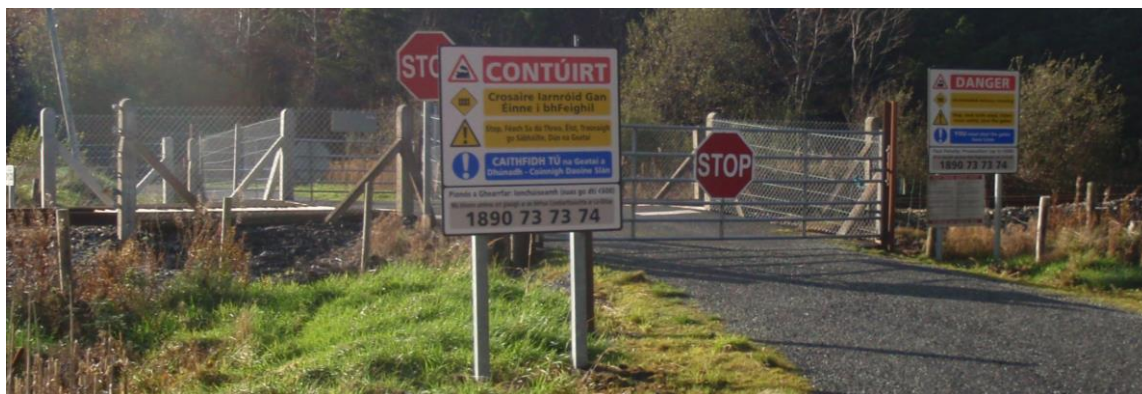
Figure 11 – Signage at LC XM220 (photograph taken on the 21st August 2018)

- 47 The signage at the LC XM220 is required to be compliant with CCE-TMS-380.
- 48 The signage at LC XM220 was replaced by IÉ-IM in January 2010, see Figure 11; cattle grids were replaced in 2013 and vegetation boards and ‘no trespass’ signs were erected in 2014. The signage at LC XM220 at the time of the accident is illustrated in Figure 11 (photograph taken on the 21st August 2018, after the accident).

- 49 The signage present at LC XM220, on the day of the accident, was as follows:
- ‘Stop’ signs located within the railway boundary, on poles to the driver’s nearside behind the gates; as required by Chapter 6 of the Traffic Signs Manual (paragraph 44);

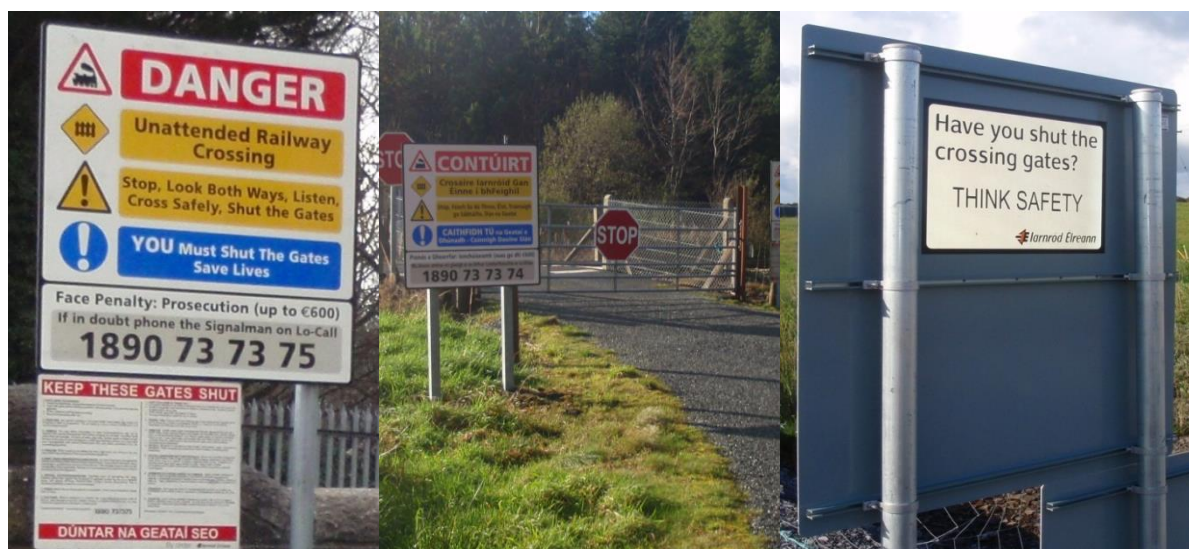
Figure 12 – Signage at LC XM220

- IÉ-IM ‘Danger’ sign in the Irish language, including the above statements in Irish, see Figure 12 (centre signage);
 - IÉ-IM ‘Keep these gates shut’ sign which includes requirements related to closure of the gates and penalty notices associated with the failure to close gates, see Figure 12 (signage on left).

- 50 Signage on exiting LC XM220 includes the:
- IÉ-IM “Have you shut the crossing gates?” signage, which is located on the rear of the IÉ-IM “Danger” signage, see Figure 12 (signage on right).

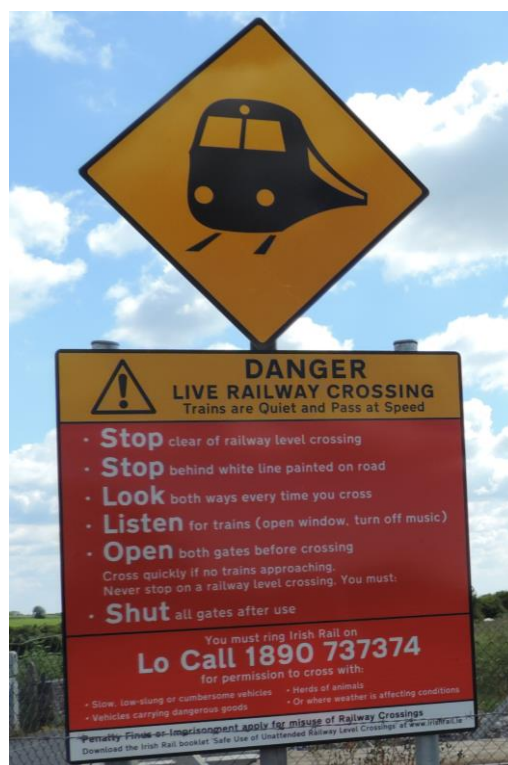
Figure 13 – New signage design

53 In relation to the new train signage (top of Figure 13), this is not an official road traffic sign as set out in the Traffic Signs Manual and it not recognised as such in the current edition of the Rules of the Road.

52 IÉ are currently in the process of fitting all O/OP crossings with the new signage. The new signage has been erected at LC XM220, see Figure 13 and Figure 14 which were photographed on site by the RAIU on the 22nd May 2019.

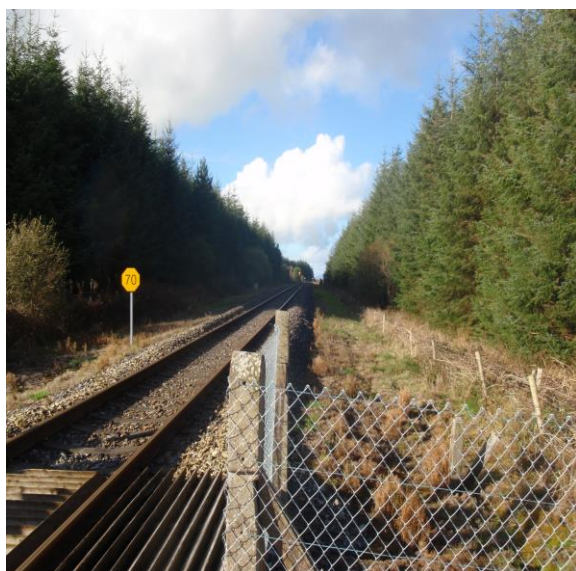
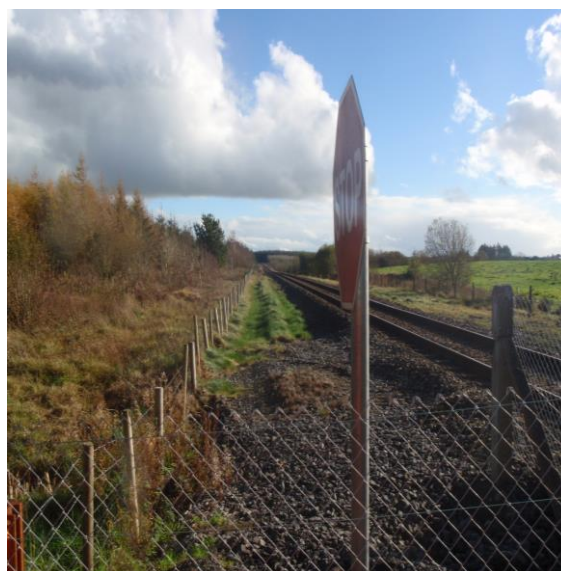
- 58 The maximum permitted line speed for the section of railway line through LC XM220 is 70 mph (110 km/h) in the Up Direction and 60 mph (95 km/h) in the Down Direction; meaning that the required *viewing distances*, as set by CCE-TMS-380, are 350 m and 300 m, respectively.
- 59 The viewing distance at LC XM220 were measured at 403 m in the Up direction and 698 m in the Down direction, which means that the required viewing distances are within tolerance in both directions.

132 In terms of the Truck Driver's viewing distances at LC XM220; viewing distances are good and exceed IÉ-IM's requirements; and, despite the weather conditions at the time of the accident the train would have been visible (headlights were illuminated).

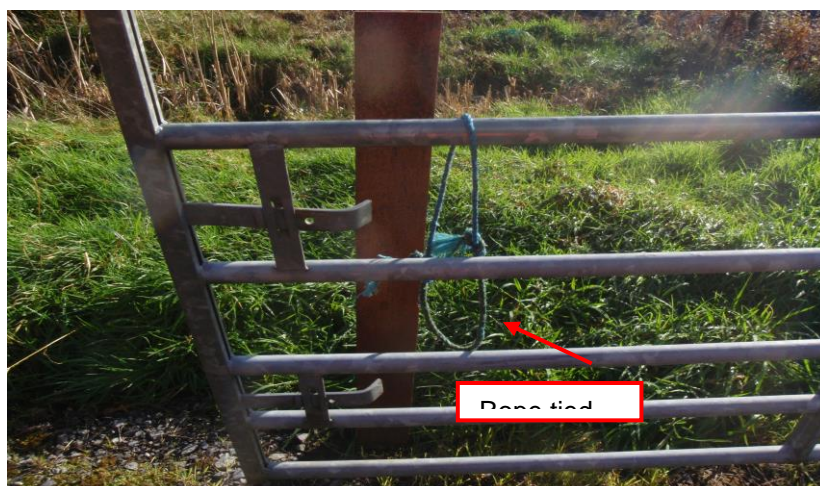
Figure 25 – LC XM220 gates tied to keep level crossing open

- 90 The route including the level crossing is routinely inspected by a patrol ganger once a week, usually on a Monday. Report sheets filled out by the Patrol Ganger in the previous six months show that the gates are found to be open on each visit. The gates at LC XM220 were last reported as open on Monday 13th August 2018 (four days before the accident). As mentioned previously, the Patrol Ganger fills in a report sheet on each crossing on the route and if any are found to be left with the gates open, the gates are closed; and, details noted and sent to the Regional Manager and Infrastructure Manager.
- 91 During an RAIU visit to LC XM220 a rope was seen tied around both gates to allow local level crossing users to keep them open, see Figure 25.

- 99 LC XM220 had a history of frequent misuse related to gates being left or tied open; with the gates being found to be open on every track patrol inspection in the previous six months; with the gates last being reported open on Monday 13th August 2018 (four days before the accident); on this day, the Patrol Ganger closed the gates and recorded no other faults were recorded at LC XM220.

- Recommendation 2019003-01 – IÉ should consider options to upgrade LC XM220 to minimise the requirement of direct action by the users.
- Recommendation 2019003-02 – IÉ-IM should carry out a full review of known misused user worked level crossings on public and private roads and should develop a programme to either close or upgrade the level crossings to minimise misuse; where possible, level crossings with the highest risks should be addressed first;
