# Safety Investigation Report

## Double overrunning of signals by an international train Antwerpen-Luchtbal - 1 November 2015

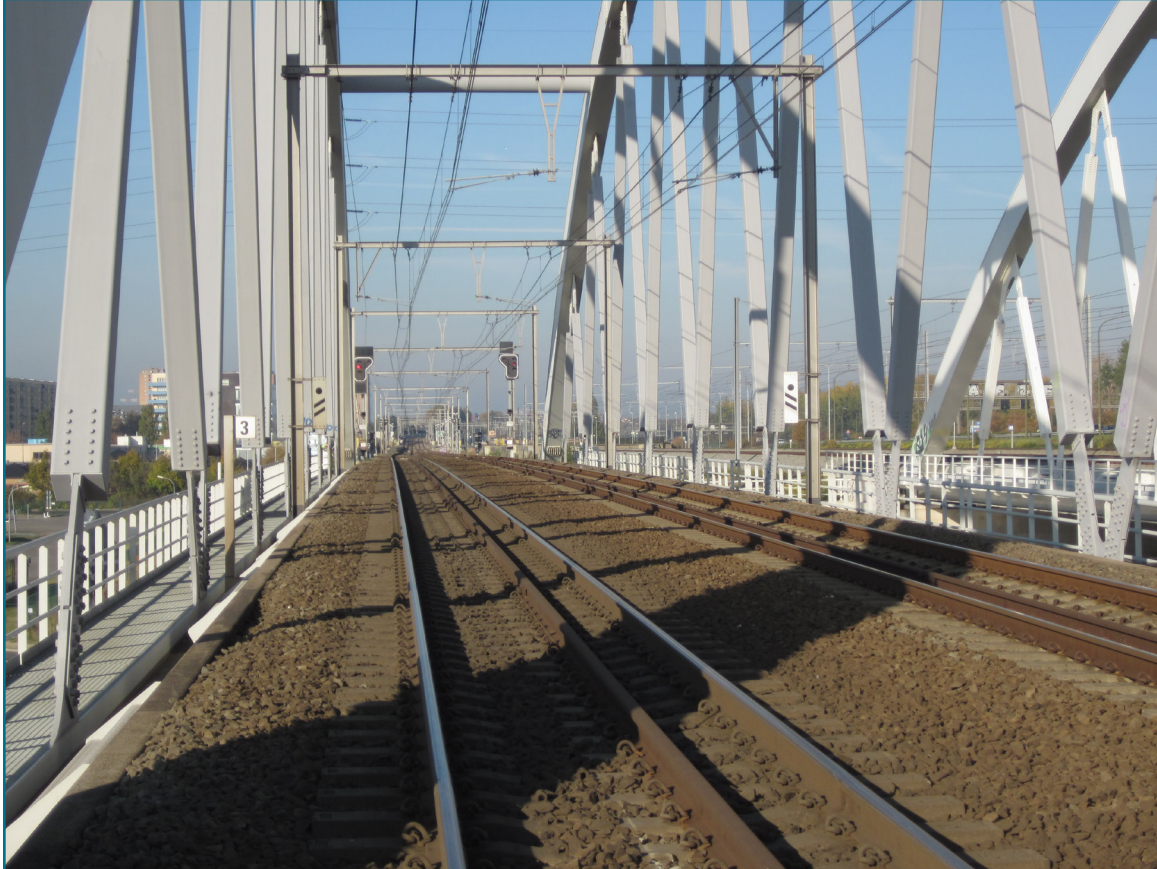
The signal G-R.12 is located 885 m after the signal A455 and 100 m after the end of the bridge on the Albert Canal.

The visibility of the signal G-R.12 is good.

Coming from Antwerp, the track goes up to this bridge. After the bridge, the track descends in the direction of the Netherlands. The signal G-R.12 is oriented towards the south and is raised so as not to be hidden by the “crest of the bridge”.
