# **Railway Accident Investigation Unit**

## **INVESTIGATION REPORT DART Wrongside Door Failure, Salthill & Monkstown Station, 10<sup>th</sup> August 2013**

**RAIU Report No: R2014 – 003  
Report published: 30<sup>th</sup> July 2014**

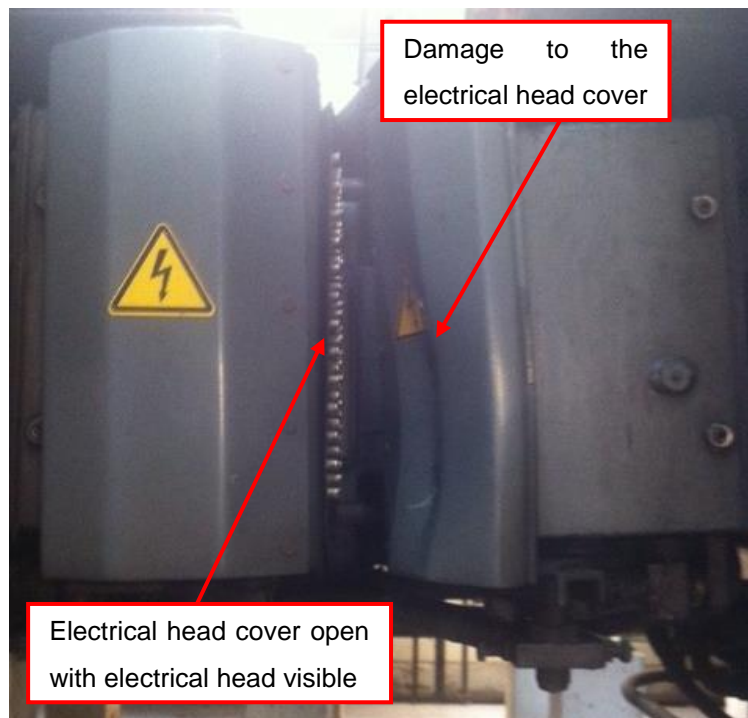
**Figure 3 – Damage to coupler electrical head cover**

18 Figure 3 shows the damage to the electrical coupler head cover, preventing the door opening. No other coupler mechanisms on the train were found to be damaged.

- 76 At some after the last maintenance inspection on the 6<sup>th</sup> August the electrical coupler head cover was damaged. This damage is likely to have been caused by impacting with the cone of another coupler during a previous coupling activity.

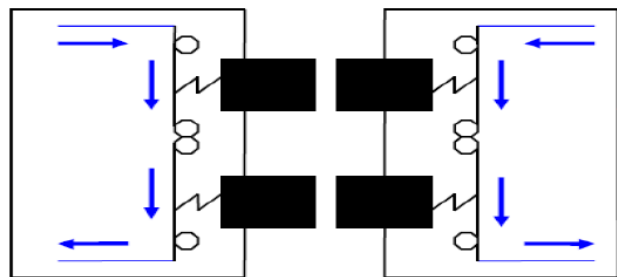
- 33 The CME FTS August 2012 Report includes the two diagrams below. Figure 7 shows that when the coupler heads are correctly coupled, the pins press together to open the normally closed contacts, which sends the circuit through to the next car. Figure 8 shows that when the coupler heads are uncoupled or incorrectly coupled, the pins do not press together, leaving the normally closed contacts closed; which returns the circuit signal to the leading/driving cab, omitting any connected carriages.

**Figure 8 – Uncoupled or incorrectly coupled autocoupler**

- 36 Two recommendations made in the CME FTS August 2012 Report are as follows:
- A review of the door closed indication circuit with a view to a modification to remove the dependence upon the autocoupler pin spring loaded normally closed switches should be undertaken;

- Testing the integrity of Door Closed Indication Circuit should be considered for EMU trains after vehicles have been coupled.
- 37 In relation to the first of these recommendations, relating to the review of the Door Closed Indication Circuit. The CME Drawing and Design technicians commenced the review in November 2012, which requires the CME to request an Engineering Change Instruction (ECI). Due to the requirements involved in the coupler design, seven iterations of ECI were required with the finalised design being agreed and validated on the 26<sup>th</sup> March 2014 (after the incidents in August and September 2013). Between November 2012 to September 2013 (the date of the introduction of the ‘Coupler Head Integrity Test’ no other mitigations (design or operational) were introduced to prevent the re-occurrence of incidents similar to those in February, despite the risk of re-occurrence being identified in August 2012 (in the CME FTS August 2012 Report).

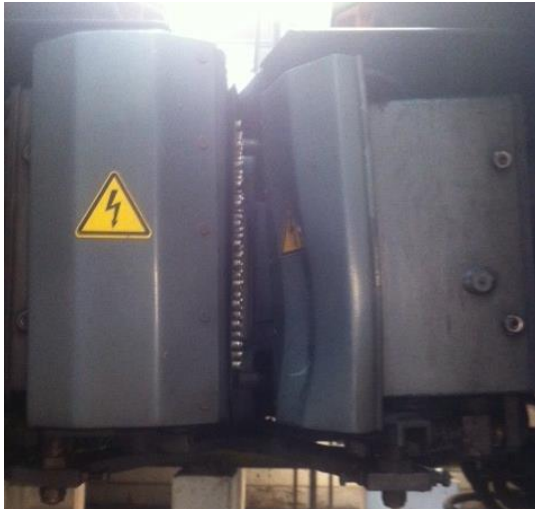
**Figure 9 – Damage to electrical head cover**

- 49 The autocoupler was examined when returned to Fairview depot on the 10<sup>th</sup> August 2013. One of the electrical coupler head covers was damaged (Figure 9) which prevented the electrical coupler head from moving in either direction (Figure 10); this resulted in the opposing electrical pins not connecting, resulting in the autocoupler being incorrectly coupled.

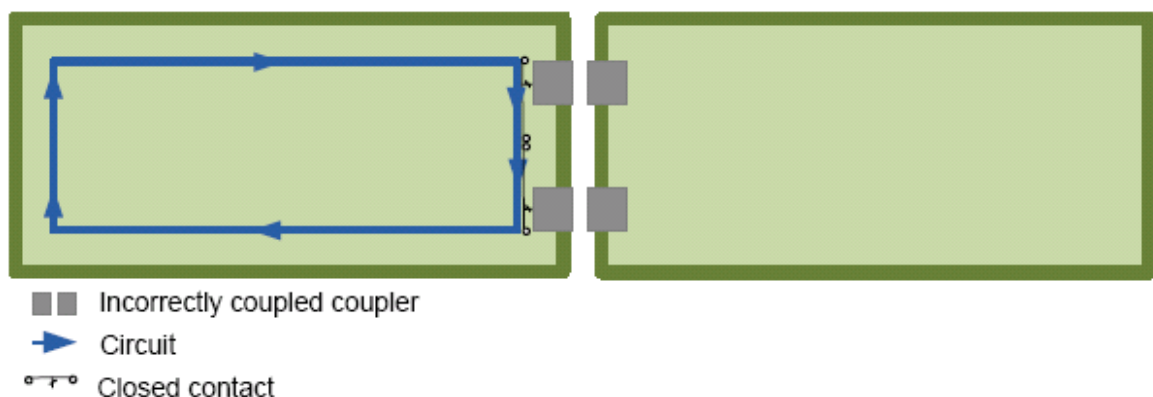
**Figure 11 – Electrical coupler incorrectly coupled, with circuit not flowing through the uncoupled carriages**

- 50 A door interlock integrity test was carried out; and it was found that it was possible for the blue Door Interlock Light to illuminate in the leading cab when a door was open in the trailing carriage.
- 51 The testing by CME also identified that a gap of three millimetres (mm) between the autocouplers can cause unwanted isolation of certain safety critical circuits. Therefore, when the electrical coupler head is not coupled, or incorrectly coupled, the circuit is returned via the normally closed contacts behind the moveable pins, see Figure 11.

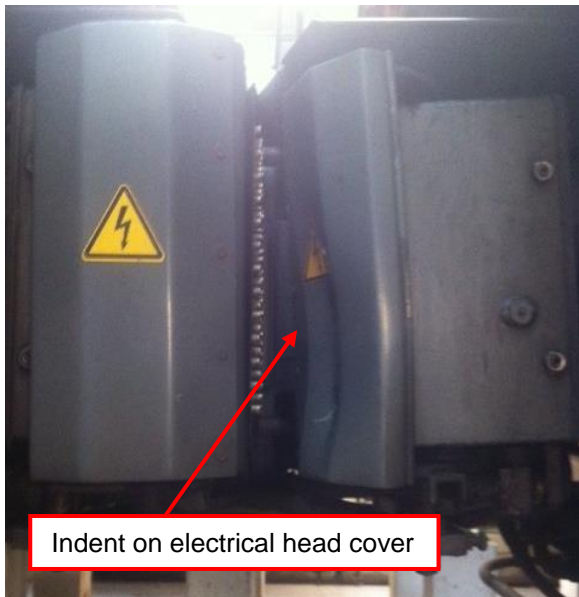
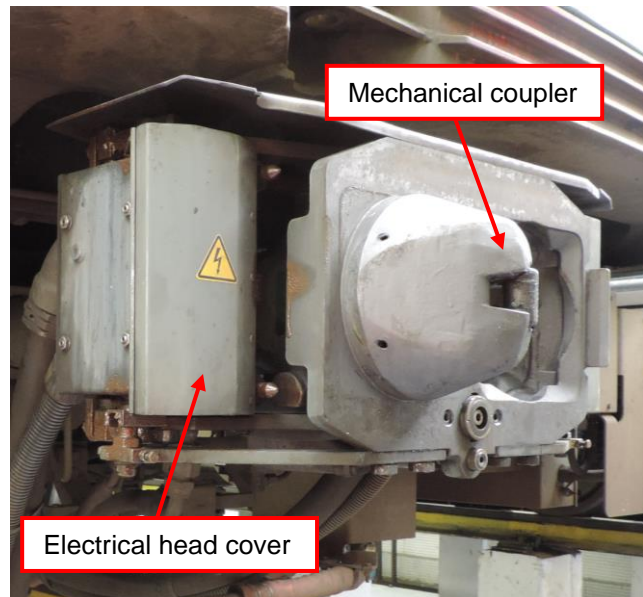
- 52 The size, shape and position of the indentation on the electrical head cover (Figure 12) is consistent with the cover coming into contact with the mechanical coupling cone section (see Figure 13) of another autocoupler.

**Figure 12 – Indentation on electrical head cover**

**Figure 13 – Electrical head cover and mechanical mating cone**

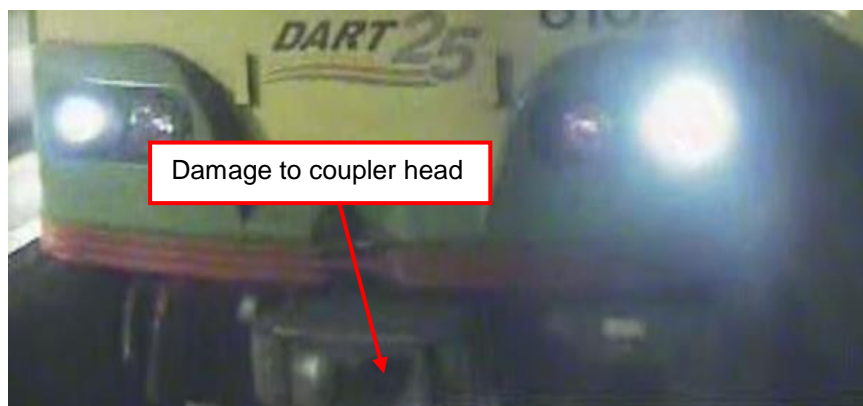
**Figure 23 – CCTV still showing damaged and closed autocoupler electrical head door**

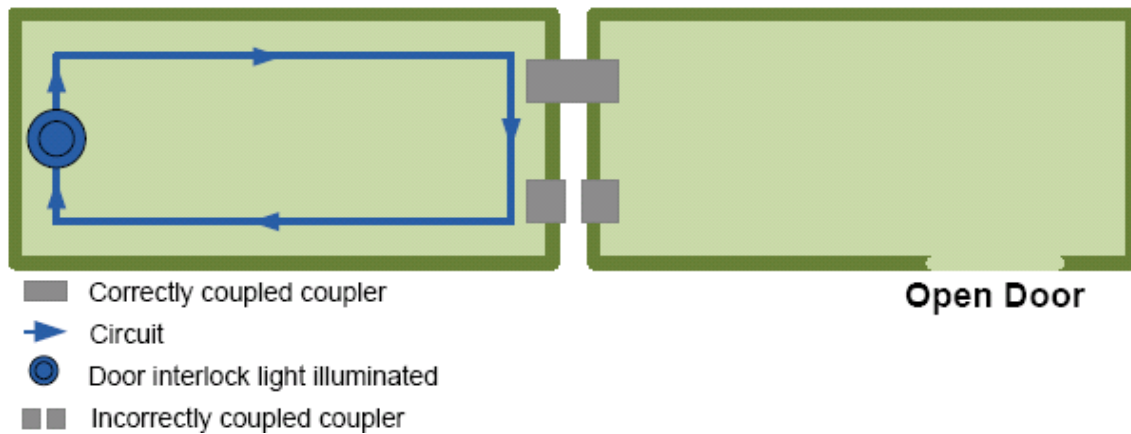
- 99 However, on the day of the incident, the electrical coupler heads were not coupled correctly, which resulted in the Door Interlock Circuit not being sent through to all the carriages and the circuit looped through the coupled carriages, resulting in a complete circuit for those carriages, omitting the incorrectly coupled carriages, see Figure 26.

**Figure 26 – Incorrectly coupled units, with door open and blue Door Interlock Light illuminated**
