Stellaris® LM3S9B92 RevB1 Errata

This document contains known errata at the time of publication for the Stellaris® LM3S9B92 microcontroller. The table below summarizes the errata and lists the affected revisions. See the data sheet for more details.

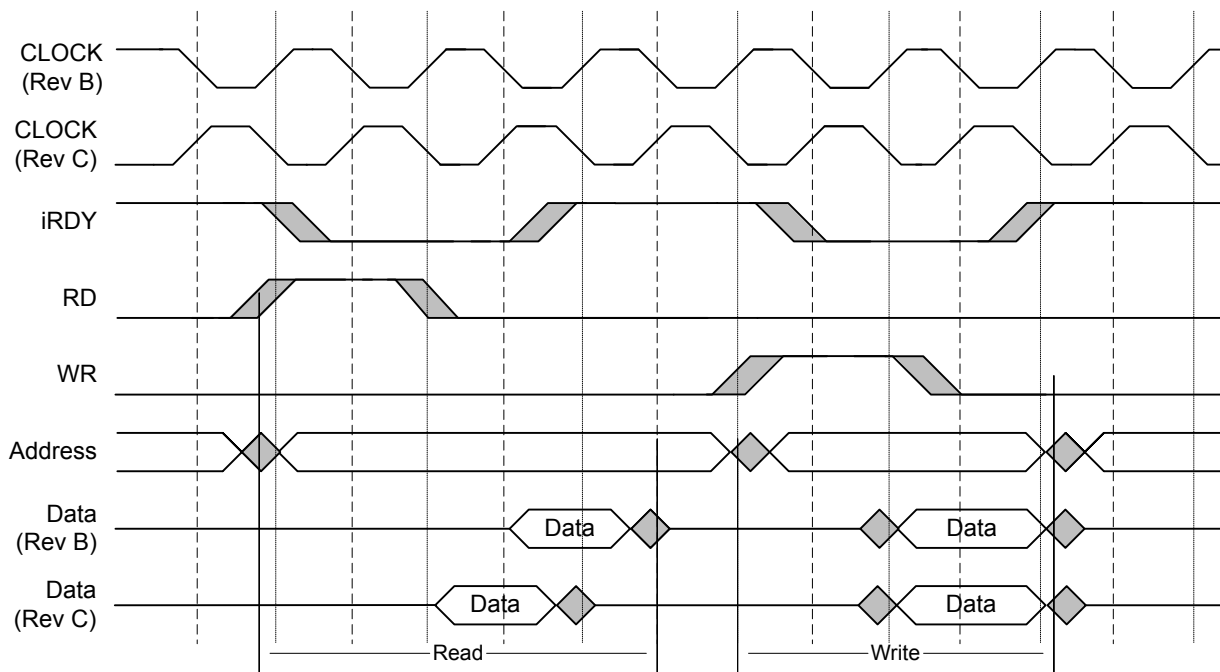
Figure 1. Timing Differences Between Rev B and Rev C Devices

Description:

The clock signal that is output on the EPIOS31 signal in General-Purpose mode is inverted. Figure 1 on page 13 shows the timing differences between Rev B parts and Rev C parts.

Use the opposite edge for timing when designing with this interface. During read cycles, ensure that the data meets set up and hold times for the appropriate edge as shown in the diagram above.

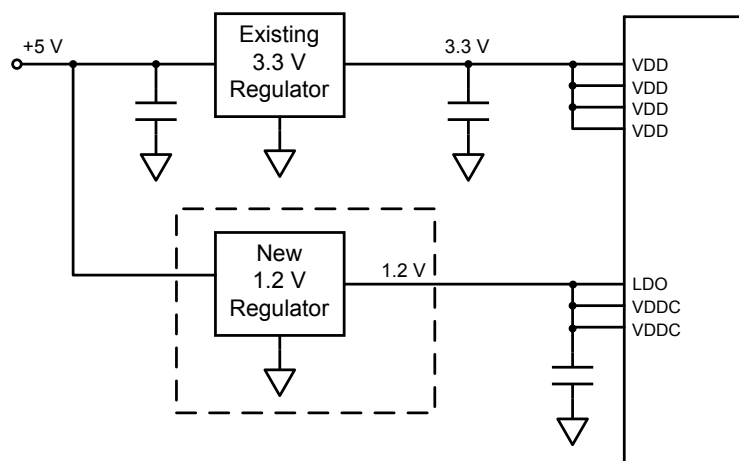
Figure 7. Configuration of External Regulator

Incorrect power sequencing during power up can disrupt operation and potentially cause device failure.

V_{DDC} must be applied approximately 50 μ s before V_{DD} . Normally V_{DDC} is controlled by the part's internal LDO voltage regulator. The workaround requires the addition of an external regulator (see Figure 7) to ensure that V_{DDC} sequencing requirements are met (see Figure 8). A recommended regulator is the TI TPS73101DBVR.

This fix mitigates the on-chip power issue, but does not solve it completely. During development, the Flash memory should also be reprogrammed (using LMFlash or another programming tool) at least once a week.
