Inspection Pros

641 Centre Court  
Alameda CA 94502

Client(s): Veale  
Inspection Date: 9/10/2025  
Inspector: Alex Ostroukhov ,

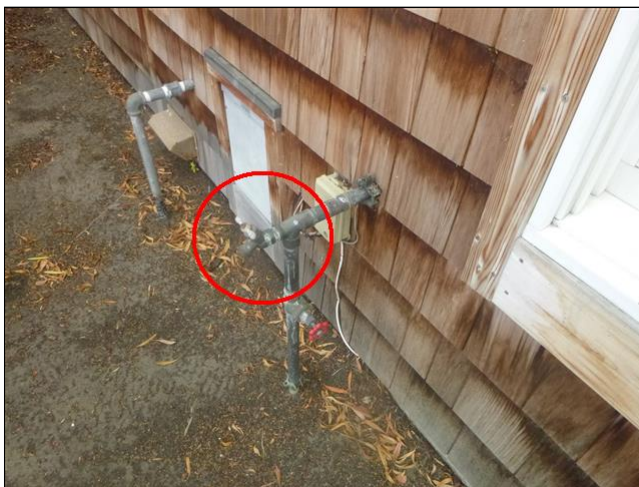
3. A hose bibb valve at the exterior front was leaking when operated at the time of inspection. We recommend repair as necessary to restore proper function and to conserve water.

♦ A hose bibb valve at the exterior front was leaking when operated at the time of inspection. We recommend repair as necessary to restore proper function and to conserve water.

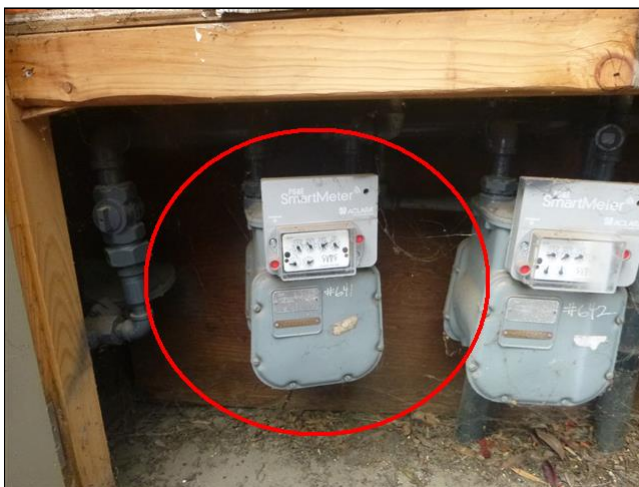
4. There was no gas valve shut off wrench observed near the gas meter. We recommend contacting the HOA to determine whether there is a shut off wrench or other device at the location of the meter.

♦ There was no gas valve shut off wrench observed near the gas meter. We recommend contacting the HOA to determine whether there is a shut off wrench or other device at the location of the meter.

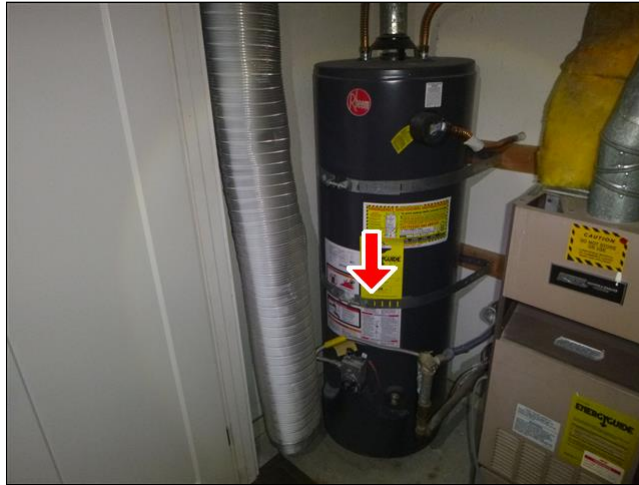
5. The lower strap was not installed in the lower third of the heater. We recommend that the strap be installed in accordance with present standards.

- ◆ The lower strap was not installed in the lower third of the heater. We recommend that the strap be installed in accordance with present standards.

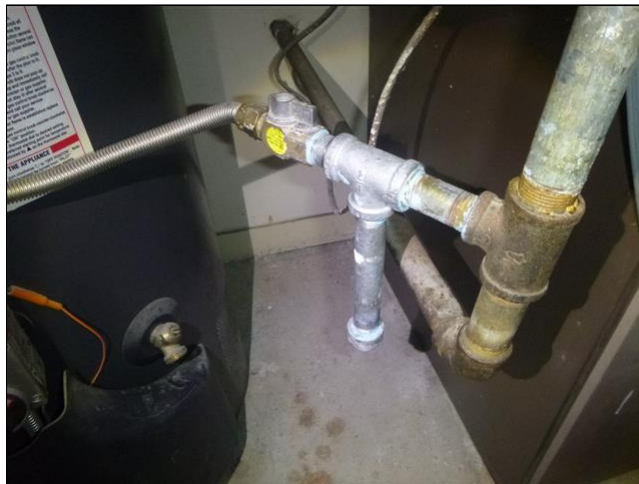
6. The water heater gas supply piping include a T-pipe extension ( "drip leg") to collect debris, as this is considered good practice. However a "drip leg" was not installed in accordance with a regulations and we recommend referral with a licensed plumber and replacement as needed. **A drip leg, also known as a sediment trap, should always be installed vertically in a fuel piping system to prevent sediment and debris from being pushed across the tee by the fuel pressure.**

- ◆ The water heater gas supply piping include a T-pipe extension ( "drip leg") to collect debris, as this is considered good practice. However a "drip leg" was not installed in accordance with a regulations and we recommend referral with a licensed plumber and replacement as needed. **A drip leg, also known as a sediment trap, should always be installed vertically in a fuel piping system to prevent sediment and debris from being pushed across the tee by the fuel pressure.**

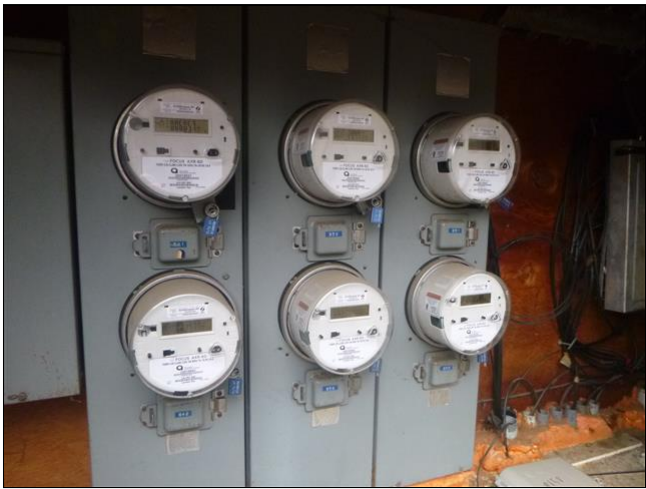
- ◆ The main electrical panel was not opened because of the size and capacity of the system. No particular deficiencies were noted, however we recommend that the panel be inspected if other electrical work is undertaken.

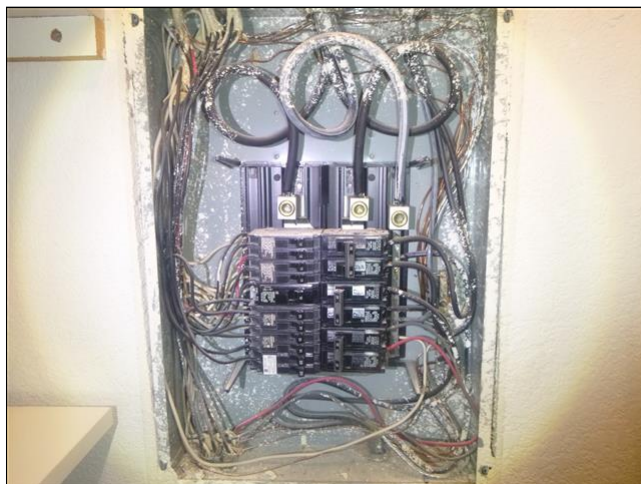
9. There is an electrical subpanel located in a closet. Although this is very common, closet installations are no longer approved. No particular deficiencies were observed, however if the panel should ever need to be replaced, it would have to be relocated. We only recommend that proper clearance be maintained in front of the panel.
10. One or more circuit breakers in the subpanel were shut off at the time of this inspection. We did not activate the breakers, or energize the circuits because doing so could create a hazard. Ask the owner why the breakers are in the OFF position. If they are not functional, a licensed electrician should make appropriate repairs before closing escrow.

- ⚠ ◆ There is an electrical subpanel located in a closet. Although this is very common, closet installations are no longer approved. No particular deficiencies were observed, however if the panel should ever need to be replaced, it would have to be relocated. We only recommend that proper clearance be maintained in front of the panel.
- ◆ We inspected the sub-panel and found it in serviceable condition.

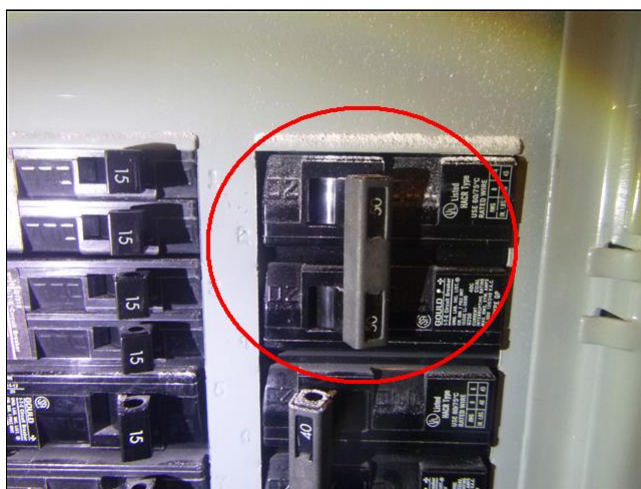
- ◆ One or more circuit breakers in the subpanel were shut off at the time of this inspection. We did not activate the breakers, or energize the circuits because doing so could create a hazard. Ask the owner why the breakers are in the OFF position. If they are not functional, a licensed electrician should make appropriate repairs before closing escrow.

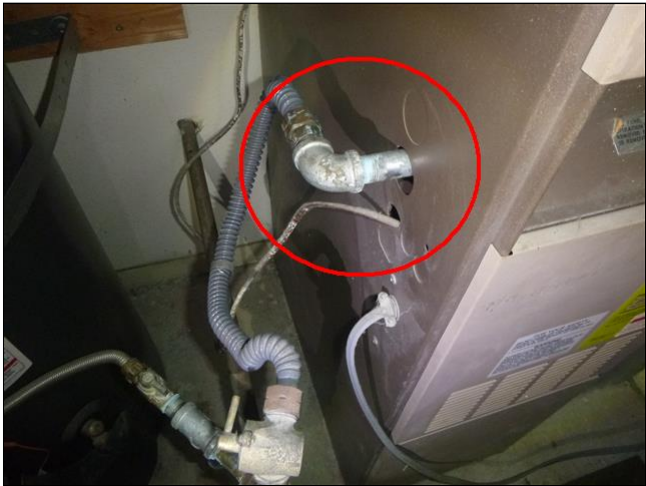
- ⚡ ◆ The gas supply piping for the furnace does not include a T-pipe extension to collect debris that may be in the gas pipe. This is generally required, and is considered good practice. Ideally, a "drip leg" should be added to the gas piping just ahead of the connector when the furnace is serviced.

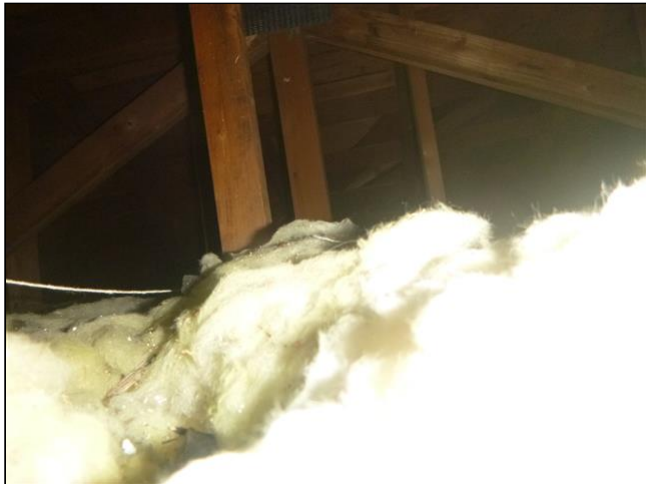
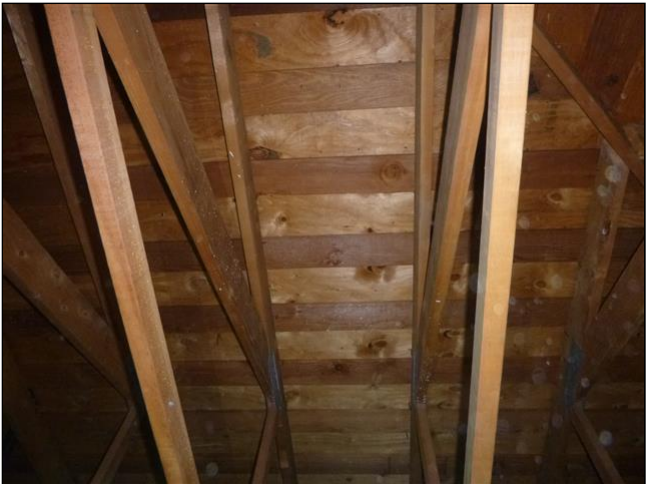
- ◆ NOTE: Due to the lack of installed planking, concealed framing and/or low clearances, the attic was only inspected from the access opening to avoid possible damage to the ceilings below. Therefore, inspection of the attic was very limited, as not all areas were readily visible. Conditions in need of repair may be discovered, if the attic is fully entered and all areas inspected. If desired, we recommend referral with the appropriate contractor who is equipped to inspected the entire attic.

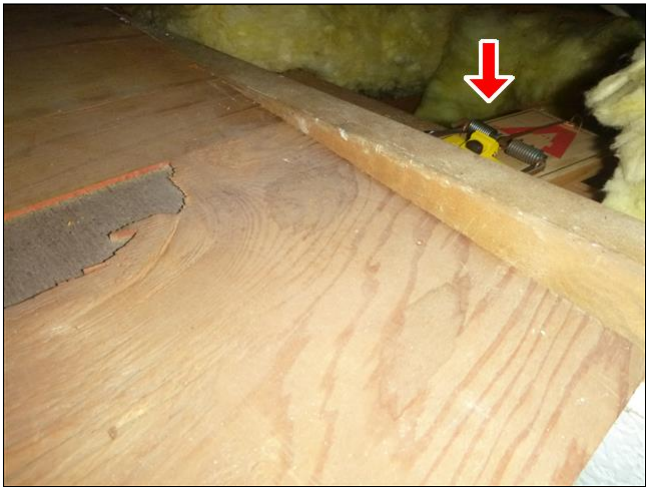
15. Evidence of rodent activity (droppings, bait, traps) was observed in the attic, however we could not determine if there is current infestation. Rodents can damage ductwork and electrical wiring, and they can also be a health hazard. We recommend setting traps or bait, and if necessary, the services of a licensed pest control exterminator.

♦ Evidence of rodent activity (droppings, bait, traps) was observed in the attic, however we could not determine if there is current infestation. Rodents can damage ductwork and electrical wiring, and they can also be a health hazard. We recommend setting traps or bait, and if necessary, the services of a licensed pest control exterminator.

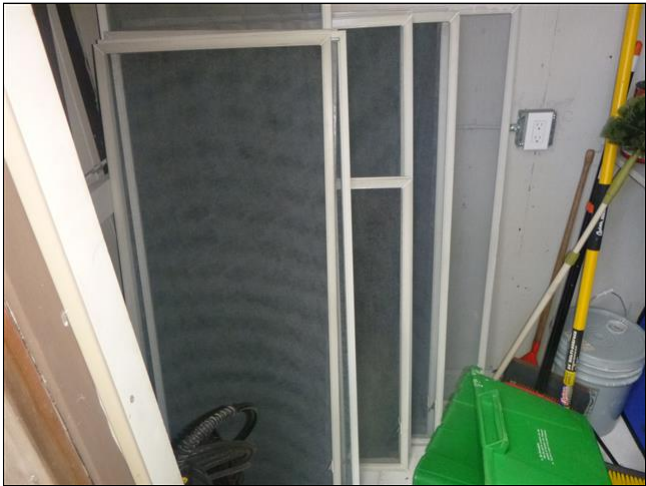
- ◆ Some or all of the window screens have been removed. We observed several stored screens at the time of the inspection, however we did not inventory the screens to ensure that there is a screen for every window. If desired, we recommend referral with the seller, or counting the screens.

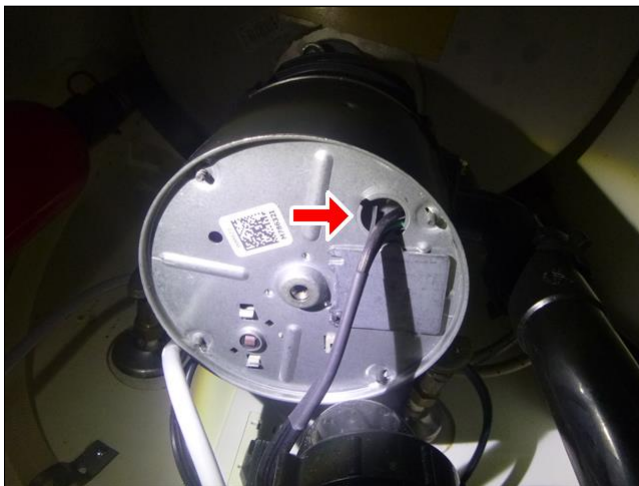
- ❌ 1. The power cord was not secured where it enters the garbage disposal. The cord can be physically damaged, or the wires pulled out of the motor connections. We recommend it be properly clamped and secured as required.

- ✘ ♦ The power cord was not secured where it enters the garbage disposal. The cord can be physically damaged, or the wires pulled out of the motor connections. We recommend it be properly clamped and secured as required.

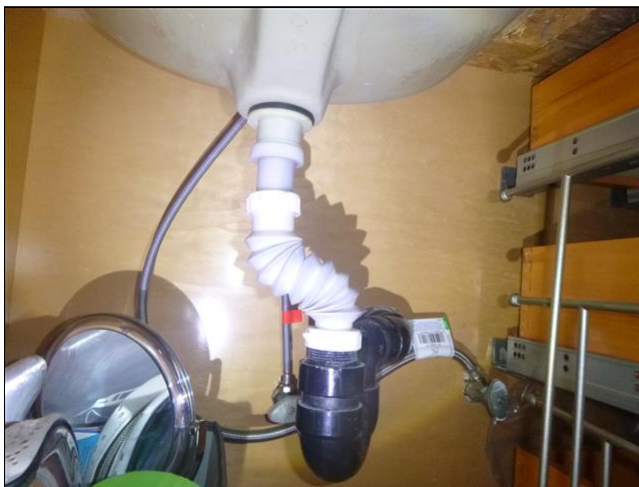
18. A flexible drain assembly arm has been installed under the primary bathroom wash basin. This installation is prone to clogging and leakage, and although no particular deficiencies were noted, we recommend replacement with rigid piping to help prevent leakage and ensure proper function.
19. A flexible drain assembly arm has been installed under the upper hall bathroom wash basin. This installation is prone to clogging and leakage, and although no particular deficiencies were noted, we recommend replacement with rigid piping to help prevent leakage and ensure proper function.

- ⚠ ♦ A flexible drain assembly arm has been installed under the primary bathroom wash basin. This installation is prone to clogging and leakage, and although no particular deficiencies were noted, we recommend replacement with rigid piping to help prevent leakage and ensure proper function.

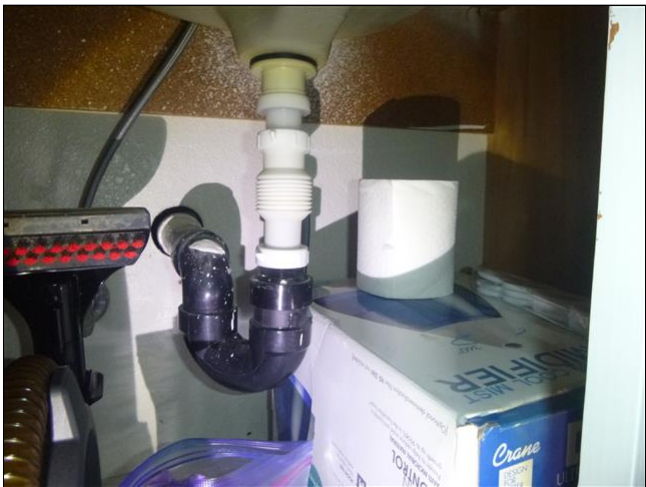
- ◆ A flexible drain assembly arm has been installed under the upper hall bathroom wash basin. This installation is prone to clogging and leakage, and although no particular deficiencies were noted, we recommend replacement with rigid piping to help prevent leakage and ensure proper function.

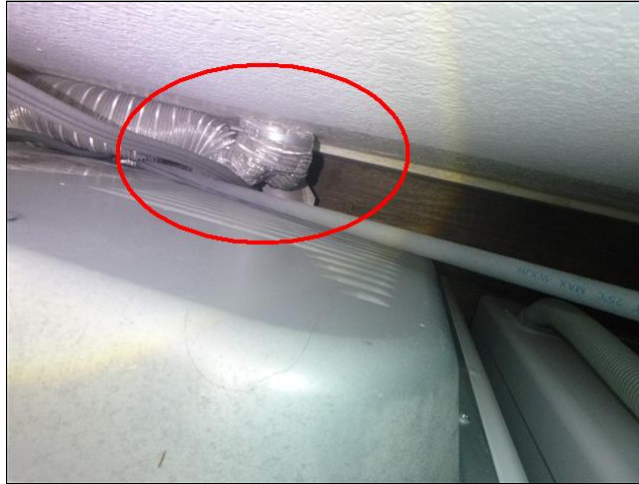
- ❌ 2. The vent was partially crushed behind the dryer. This is restricting the air flow, and can cause a buildup of lint inside the duct. This should be considered a potential fire hazard, and we recommend that the damaged section be repaired or replaced as necessary.

- ◆ The vent was partially crushed behind the dryer. This is restricting the air flow, and can cause a buildup of lint inside the duct. This should be considered a potential fire hazard, and we recommend that the damaged section be repaired or replaced as necessary.
