Lessons Learned from  
Accidents Involving  
Remotely Piloted and  
Autonomous Aircraft

# Crash Course

Peter W. Merlin

pages cm. -- (NASA SP ; 2013-600)

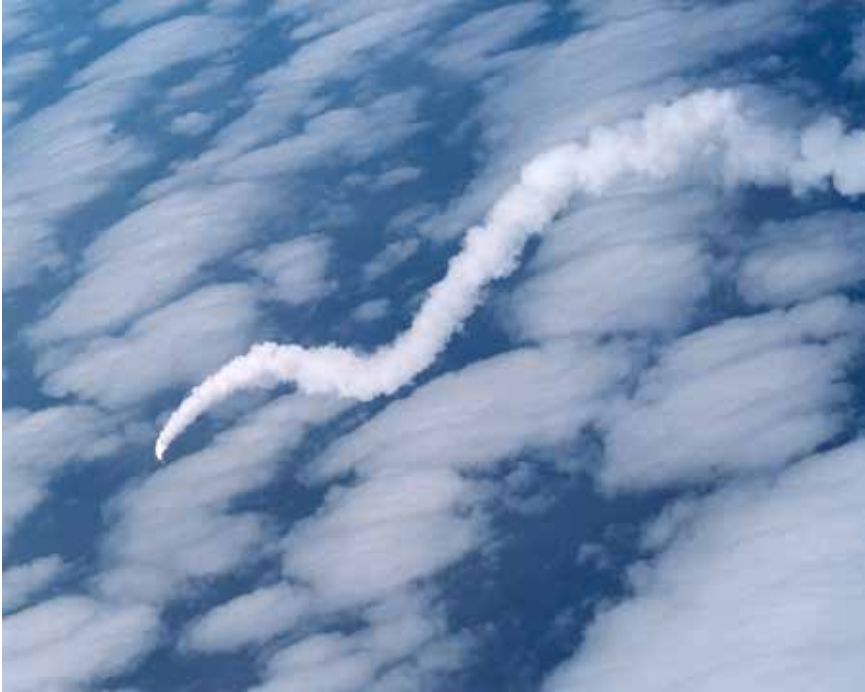
Divergent roll oscillatory motion caused by excessive control-system gain resulted from inadequate analytical modeling that allowed engineers to overestimate system safety margins. NASA

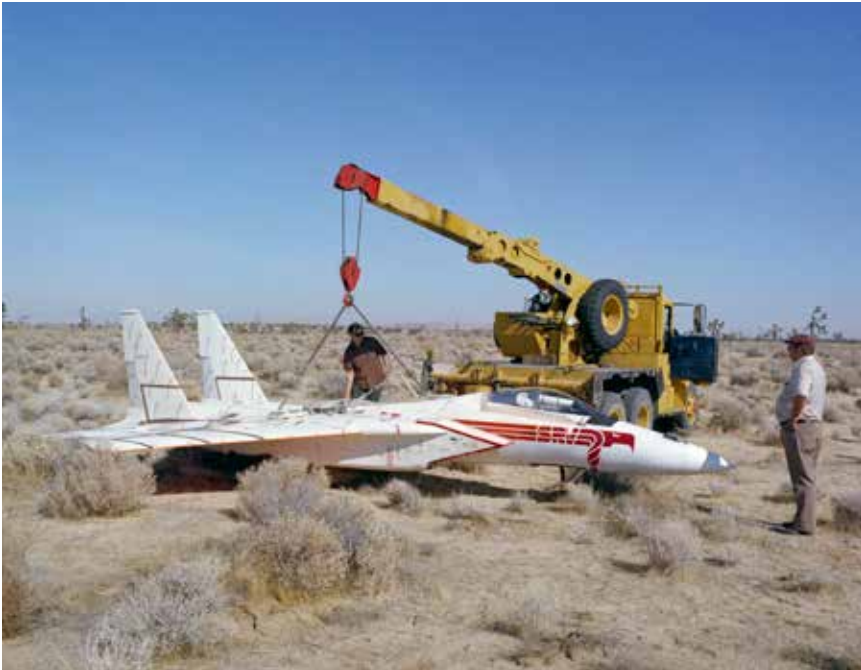
Recovery personnel prepare to lift the F-15 SRV off the Edwards Air Force Base PIRA after the vehicle's spin chute became entangled with the pitot tube. NASA

When flights resumed on February 18, 1981, the new nose parachute caught on the airplane's pitot tube after deployment. Einar Enevoldson guided the vehicle to a landing on the Edwards PIRA with only minor damage. No further problems were encountered during the remaining flights.<sup>25</sup>

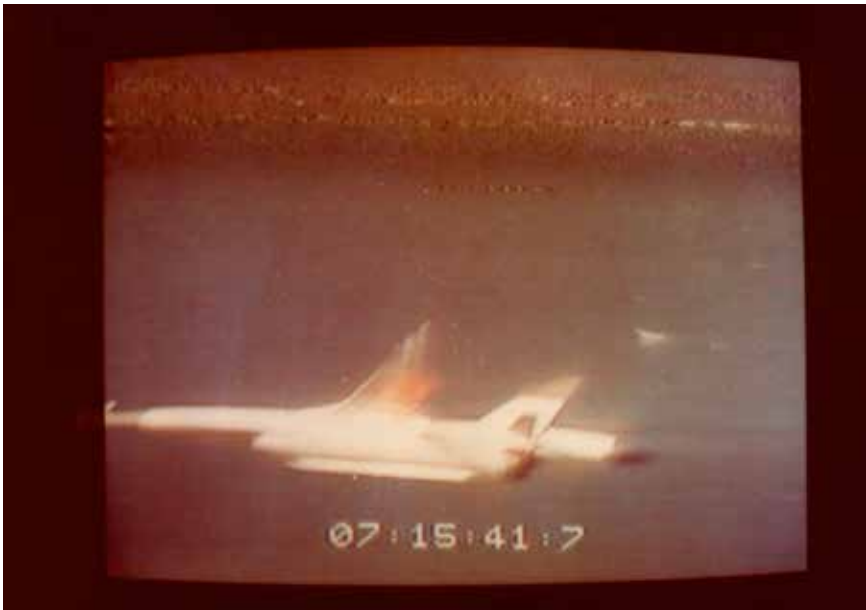
The DAST-1 experienced explosive flutter at Mach 0.825, leading to catastrophic failure of the right wing. NASA

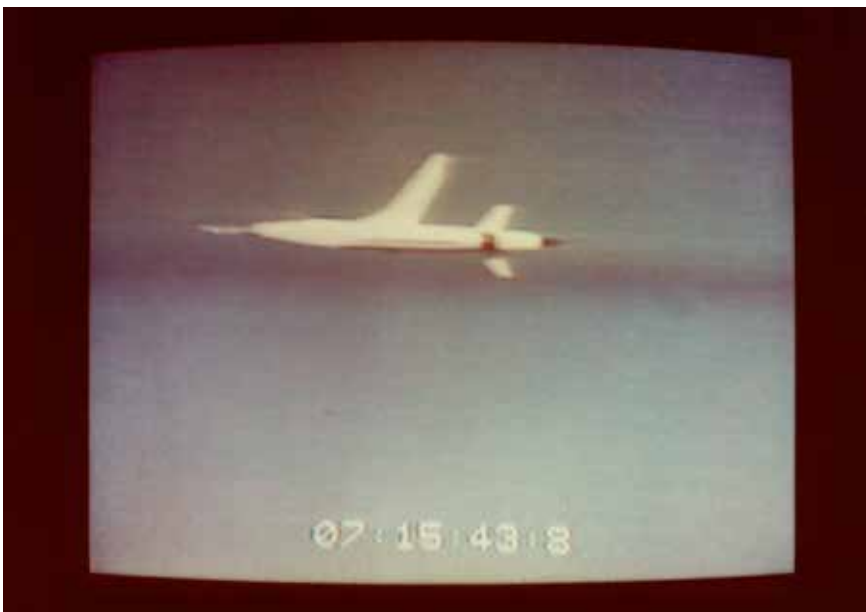
With only one remaining wing, the DAST-1 plummeted toward the ground. NASA

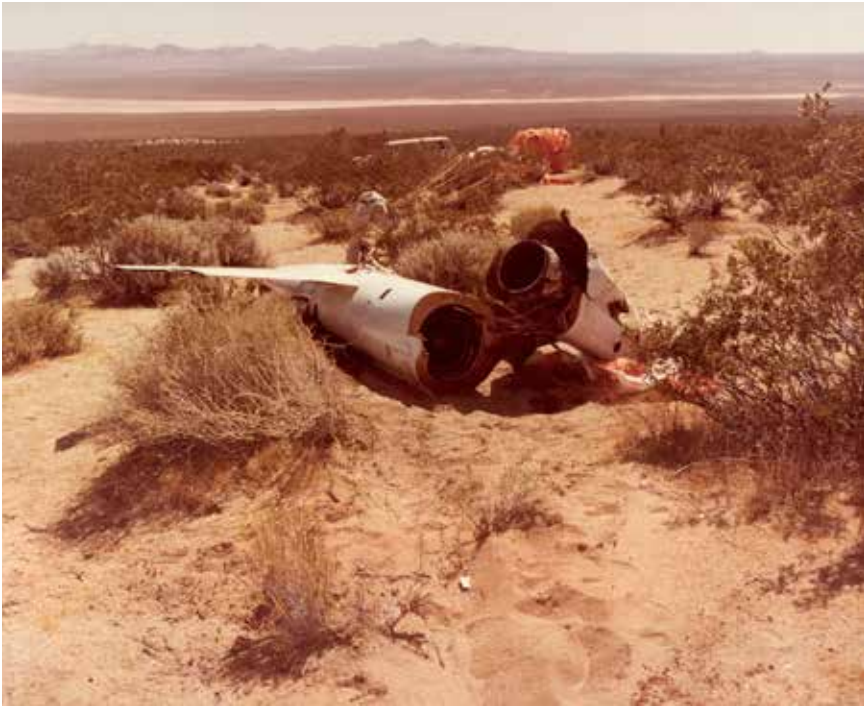
Because high-speed deployment conditions prevented full inflation of the main-parachute canopy, the DAST-1 was badly damaged when it struck the ground. NASA

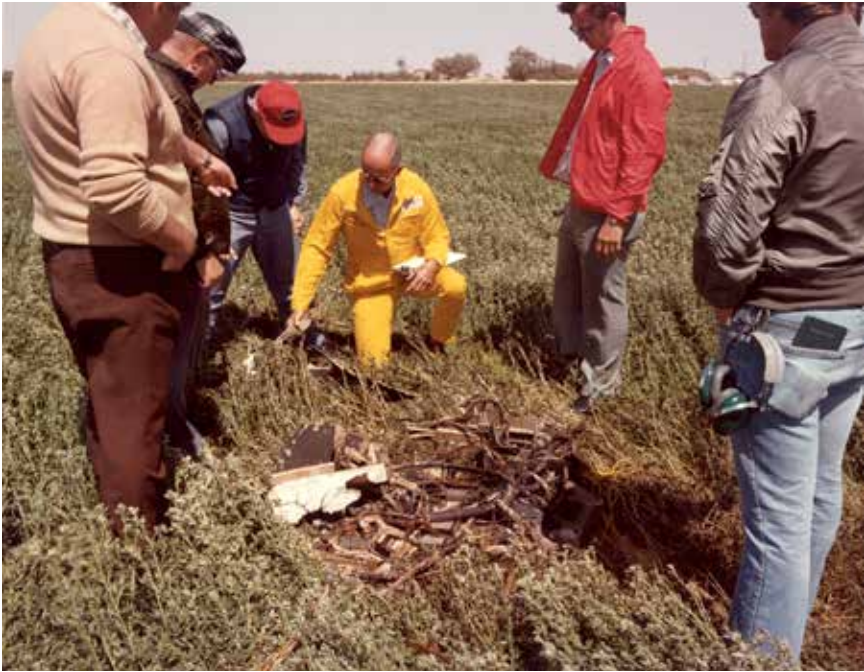
Investigators examine the DAST-2 wreckage at the crash site. The primary cause was traced to an electrical problem. NASA

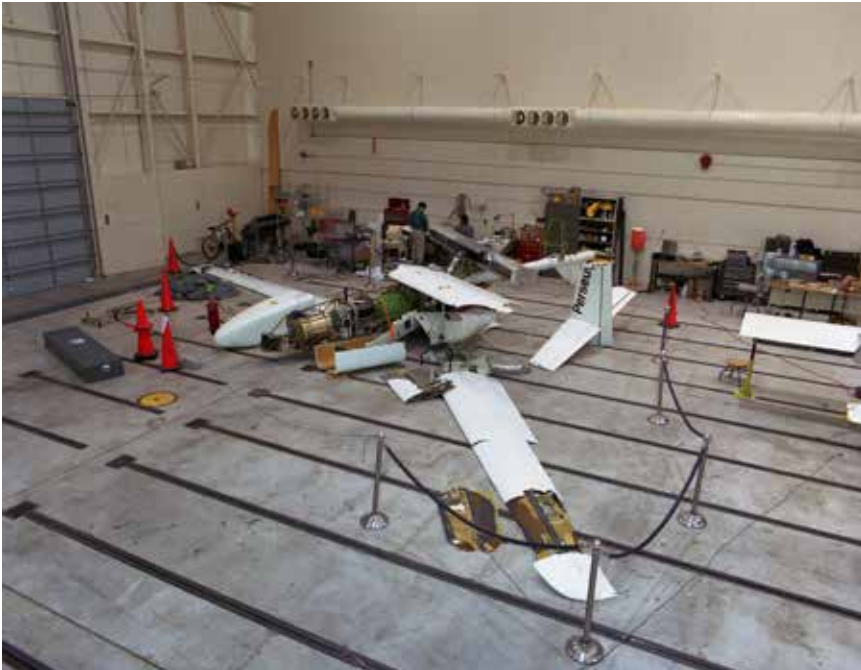
Investigators recommended that the Perseus vehicles not be flown again until the vertical gyro failure was resolved. NASA

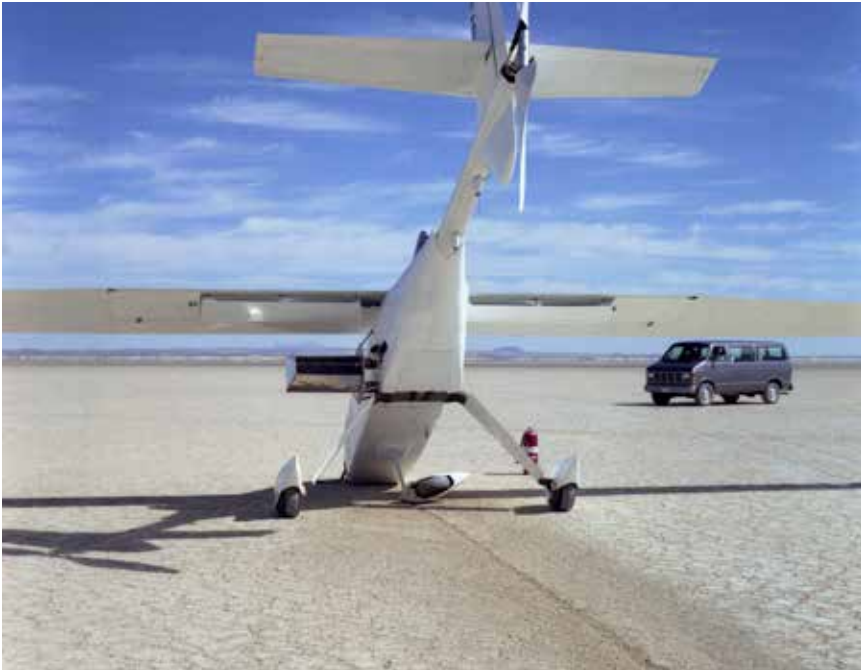
Nose-gear collapse following the maiden flight of Perseus-B damaged the vehicle's composite nose assembly. NASA

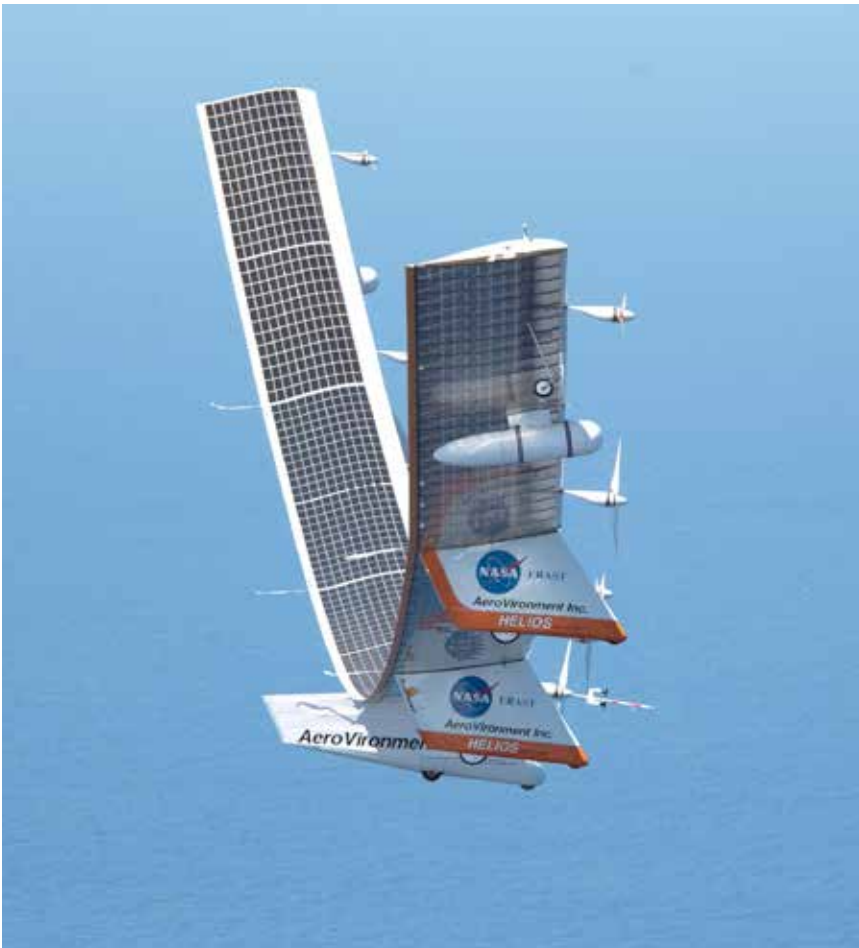
During a flight with excessively turbulent conditions, the Helios Prototype's wing structure experienced extreme dihedral. NASA

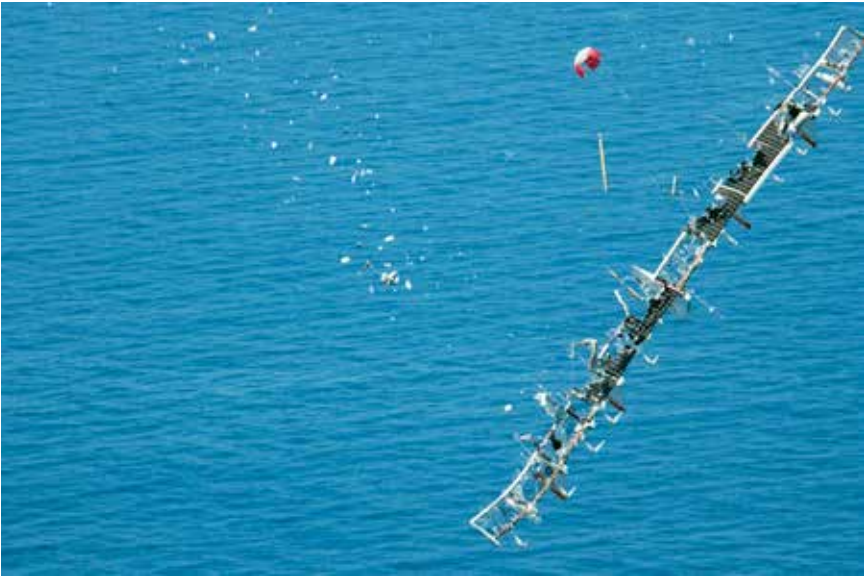
The Helios Prototype sheds parts as it plummets toward the ocean. The FTS worked exactly as designed. NASA

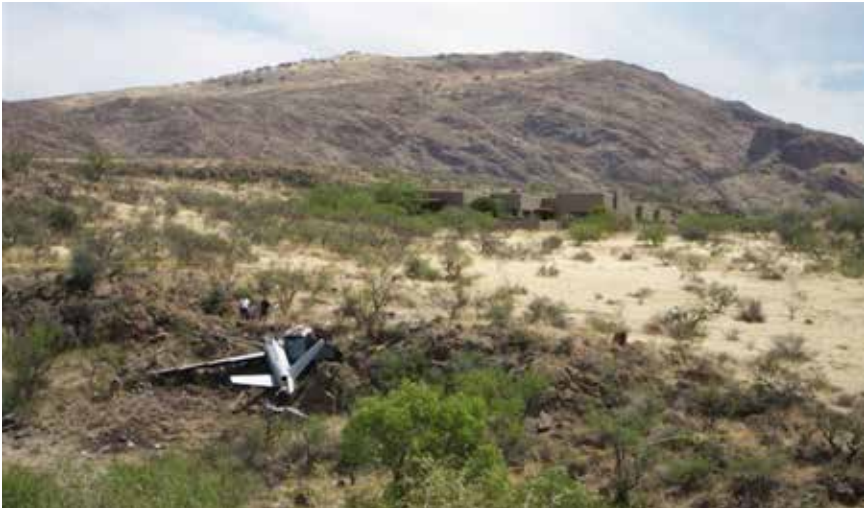
The MQ-9 crashed in a sparsely populated residential area, but there were no injuries or damage to private property. Mae Duggin
