TMS320F28379S, TMS320F28377S, TMS320F28376S, TMS320F28375S, TMS320F28374S Delfino Microcontrollers

Silicon Errata

Literature Number: SPRZ422C
August 2014–Revised October 2015

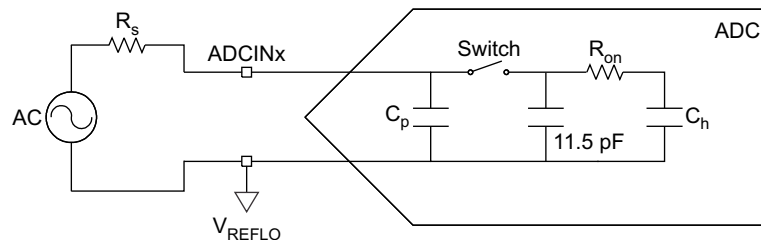
Figure 3. Single-Ended Input Model

Advisory	<i>ADC: 12-Bit Input Capacitance When Switching Channel Groups</i>
Revision(s) Affected	B
Details	The ADC input model should be used to select the sample-and-hold (S+H) duration for each ADC input. For the revisions affected, if the currently converting channel is an even-numbered channel and the previously converted channel was an odd-numbered channel (or vice versa), then the 12-bit input model will not accurately predict ADC input performance. Under these conditions, an additional capacitance should be added to the model. This capacitance has a value of 11.5 pF and should be placed between the S+H switch and R_{on} as shown in Figure 3 .

Workaround(s)	For the revisions affected, when subsequent conversions switch between channel groups, the S+H duration should be chosen to account for the additional capacitance.
----------------------	---
