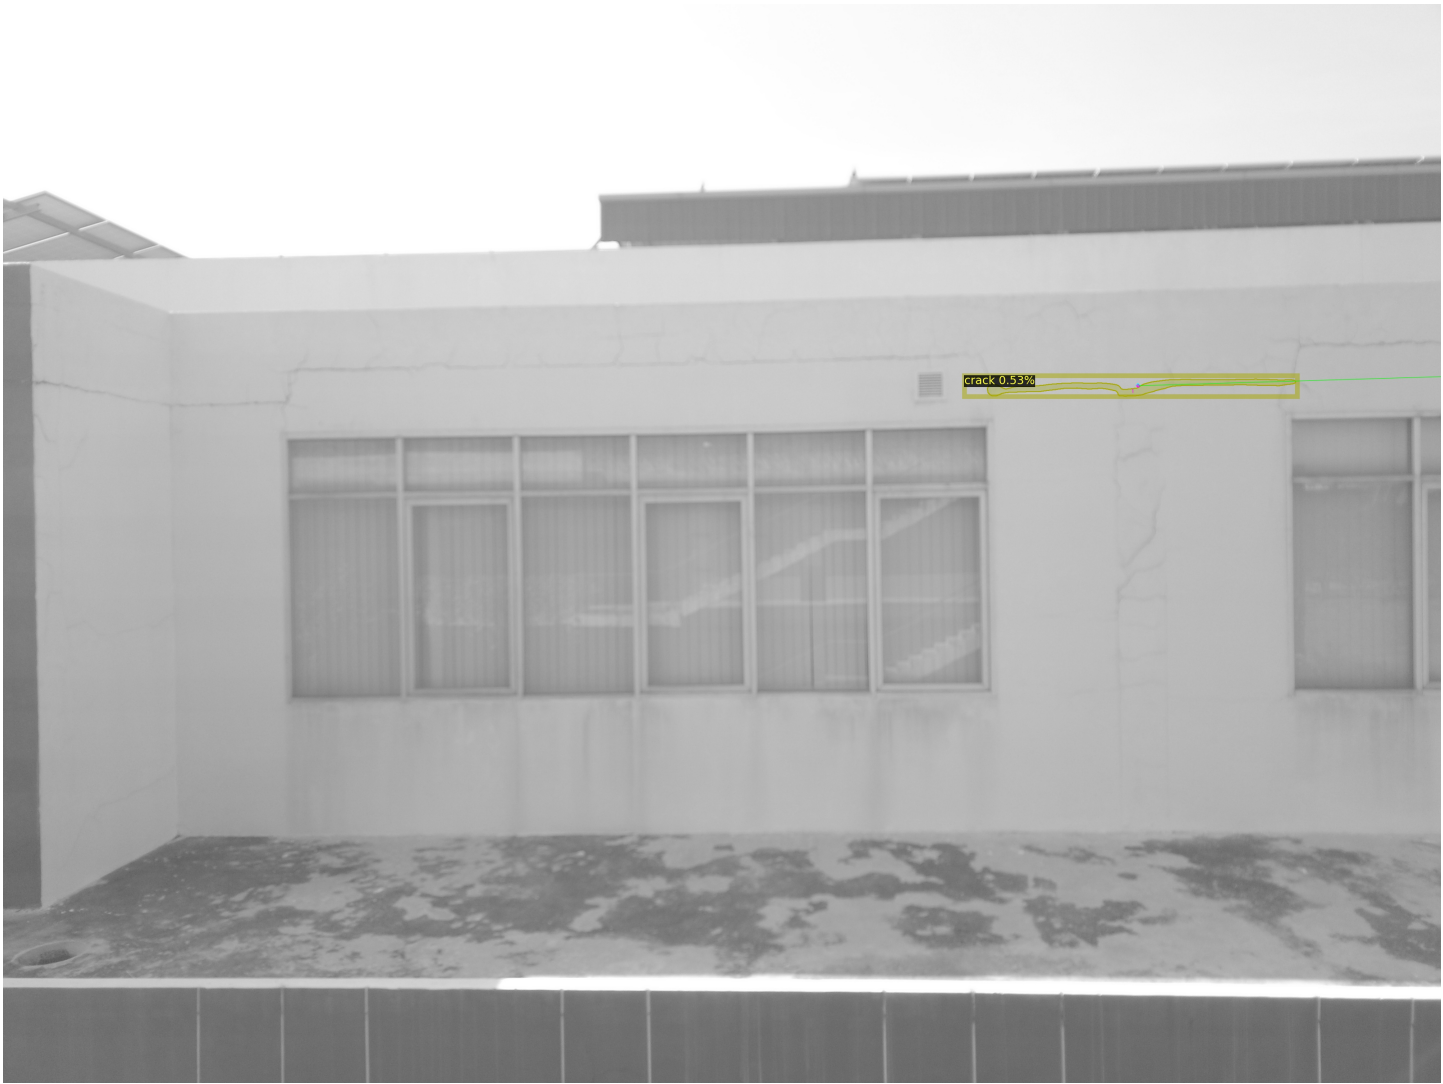
Crack number 1 (confidence score: 0.53%)
The detected crack is on wall component in this image.
Crack density: 0.25%
Crack width: 6.14 mm
Angle wrt horizontal line: 1.69 degree
Configuration: longitudinal
Position: Middle fourths of the wall
Severity index for this crack: 2
Suggested corrective action: General repair but no detailed investigation required
