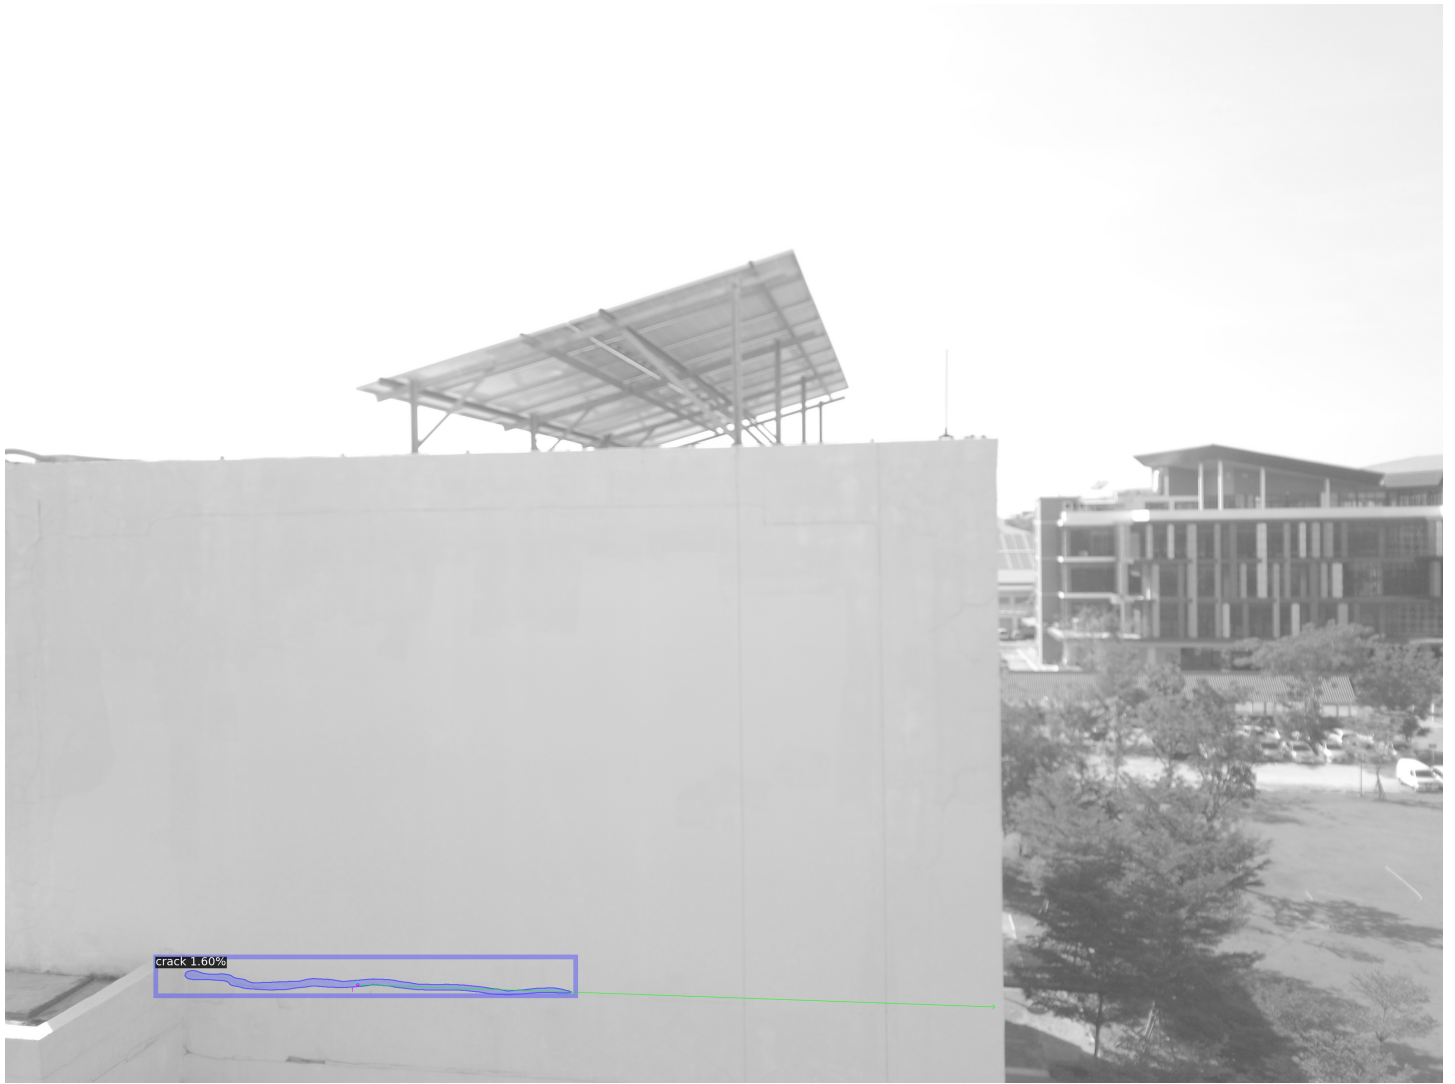
Crack number 1 (confidence score: 1.60%)
The detected crack is on wall component in this image.
Crack density: 0.16%
Crack width: -434.96 mm
Angle wrt horizontal line: -2.01 degree
Configuration: longitudinal
Position: Bottom fourths of the wall
Severity index for this crack: 2
Suggested corrective action: General repair but no detailed investigation required
