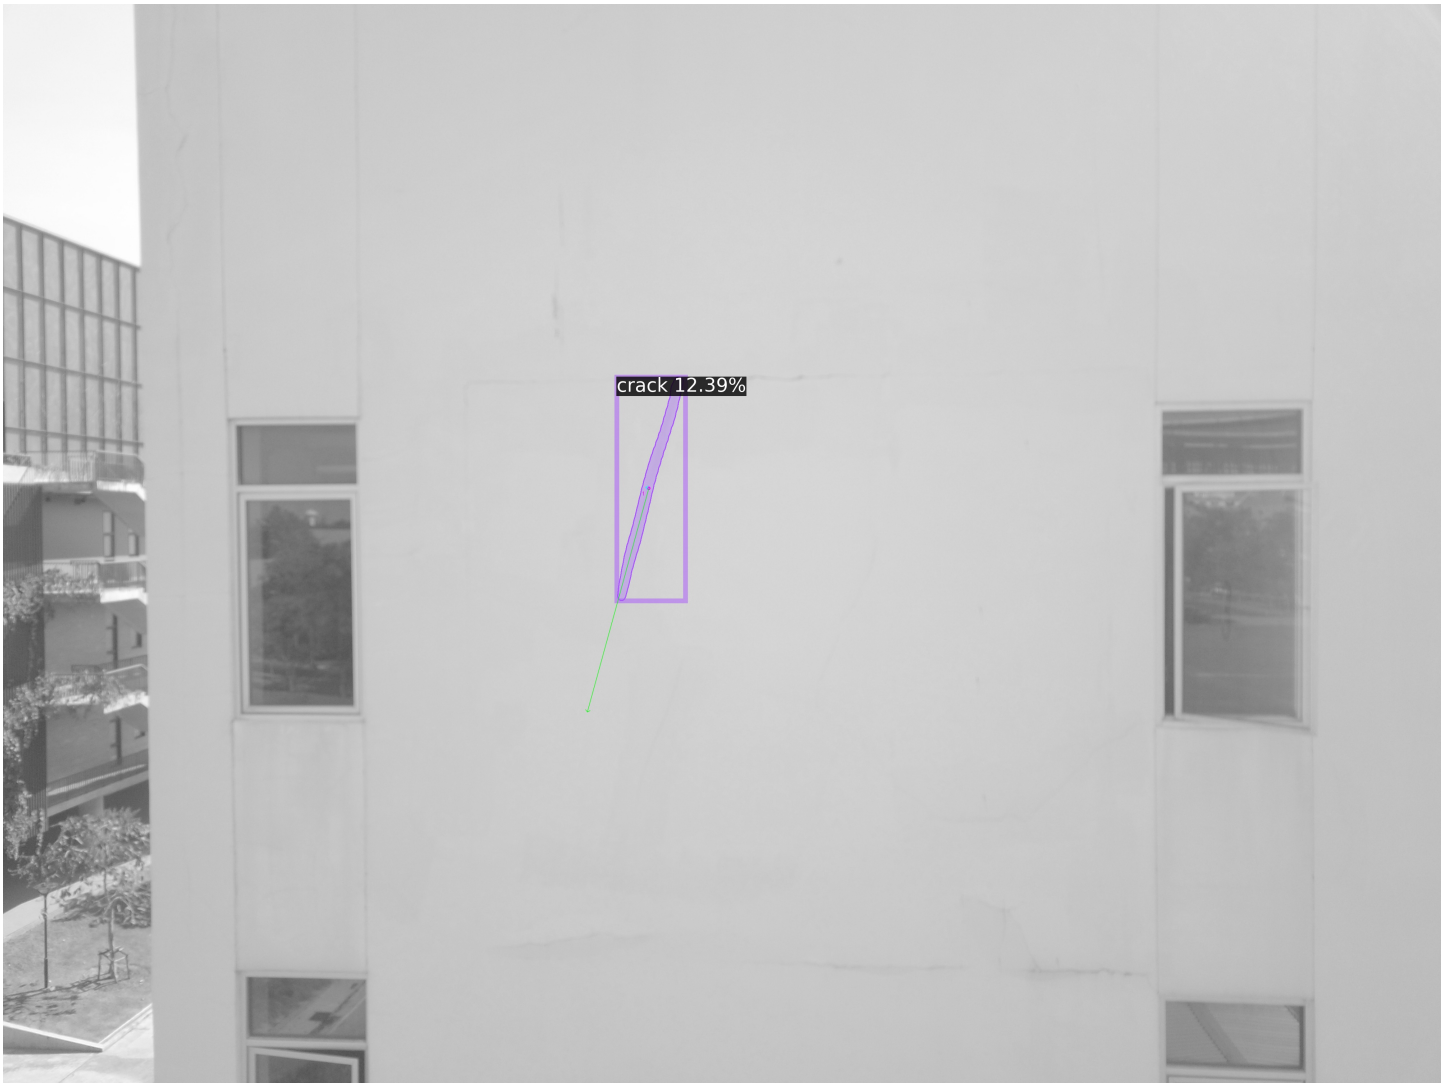
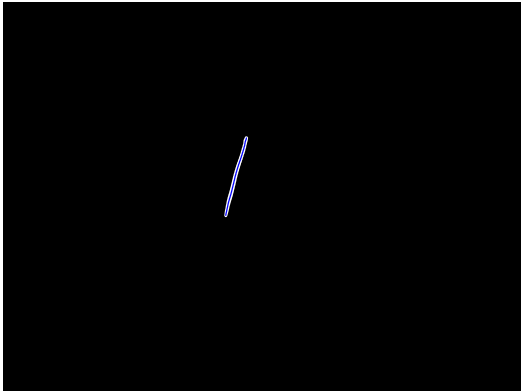
Crack number 1 (confidence score: 12.39%)
The detected crack is on wall component in this image.
Crack density: 0.28%
Crack width: 10.94 mm
Angle wrt horizontal line: -105.33 degree
Configuration: transverse
Position: Middle fourths of the wall
Severity index for this crack: 2
Suggested corrective action: General repair but no detailed investigation required
