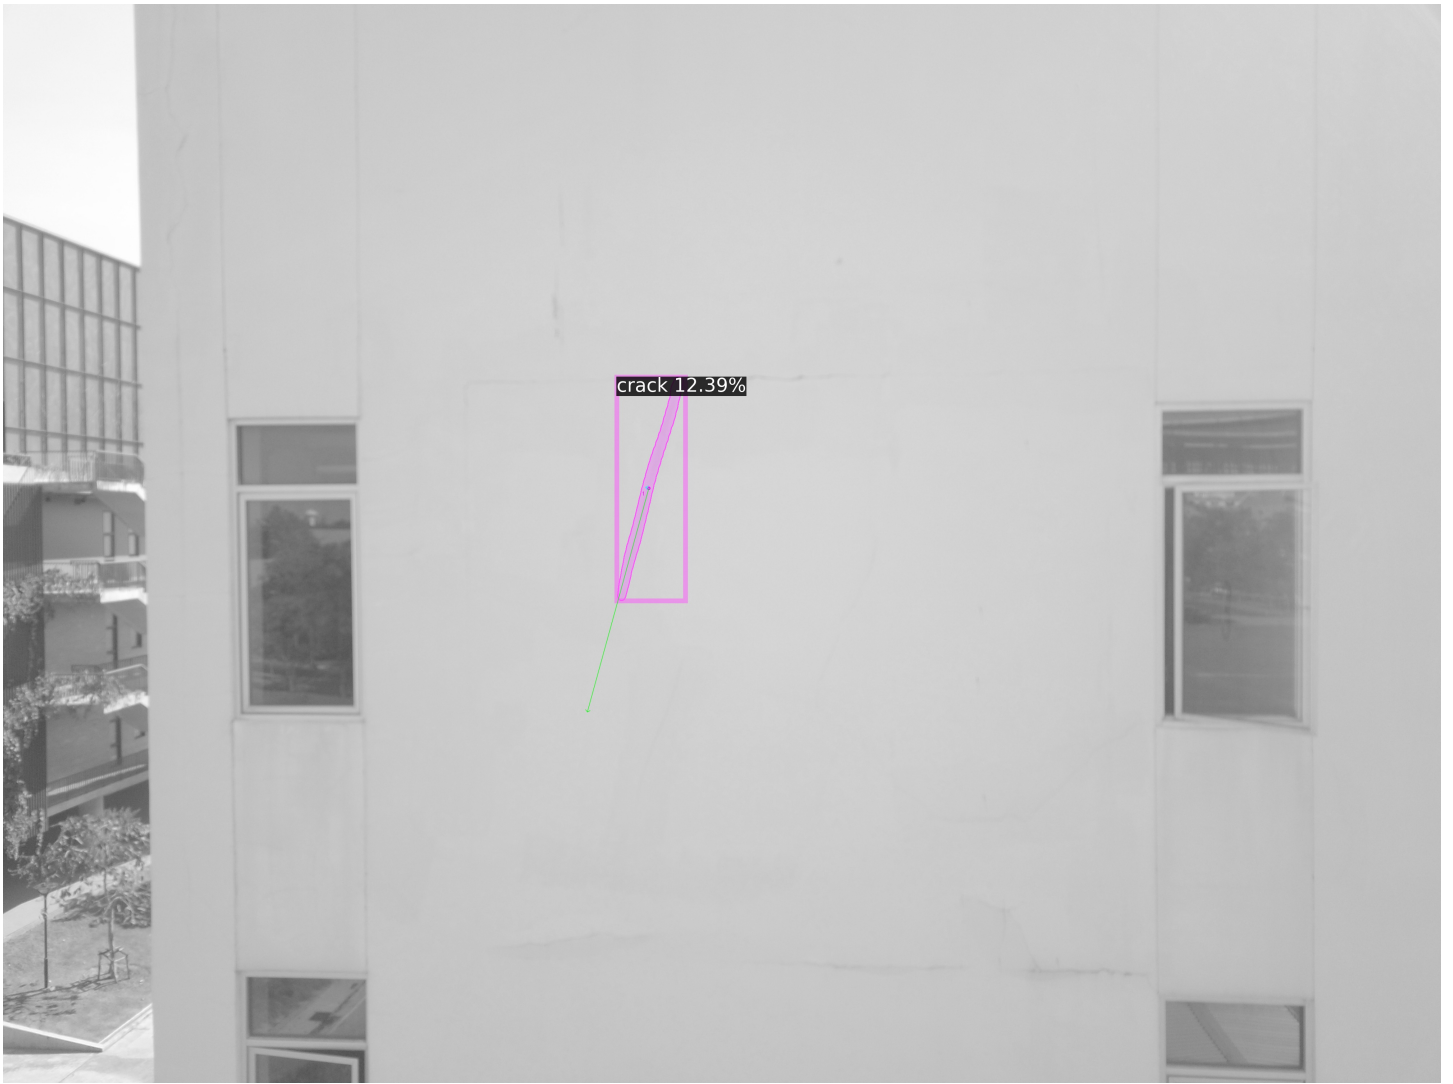
Crack number 1 (confidence score: 12.39%)  
The detected crack is on wall component in this image.  
Crack density: 0.28%  
Crack width: 10.94 mm  
Angle wrt horizontal line: -105.33 degree  
Configuration: transverse  
Position: Middle fourths of the wall  
Severity index for this crack: 2  
Suggested corrective action: General repair but no detailed investigation required
